Terramor Outdoor Luxury Campground

Expanded EAF Narrative

Town of Saugerties, New York

December 6, 2022

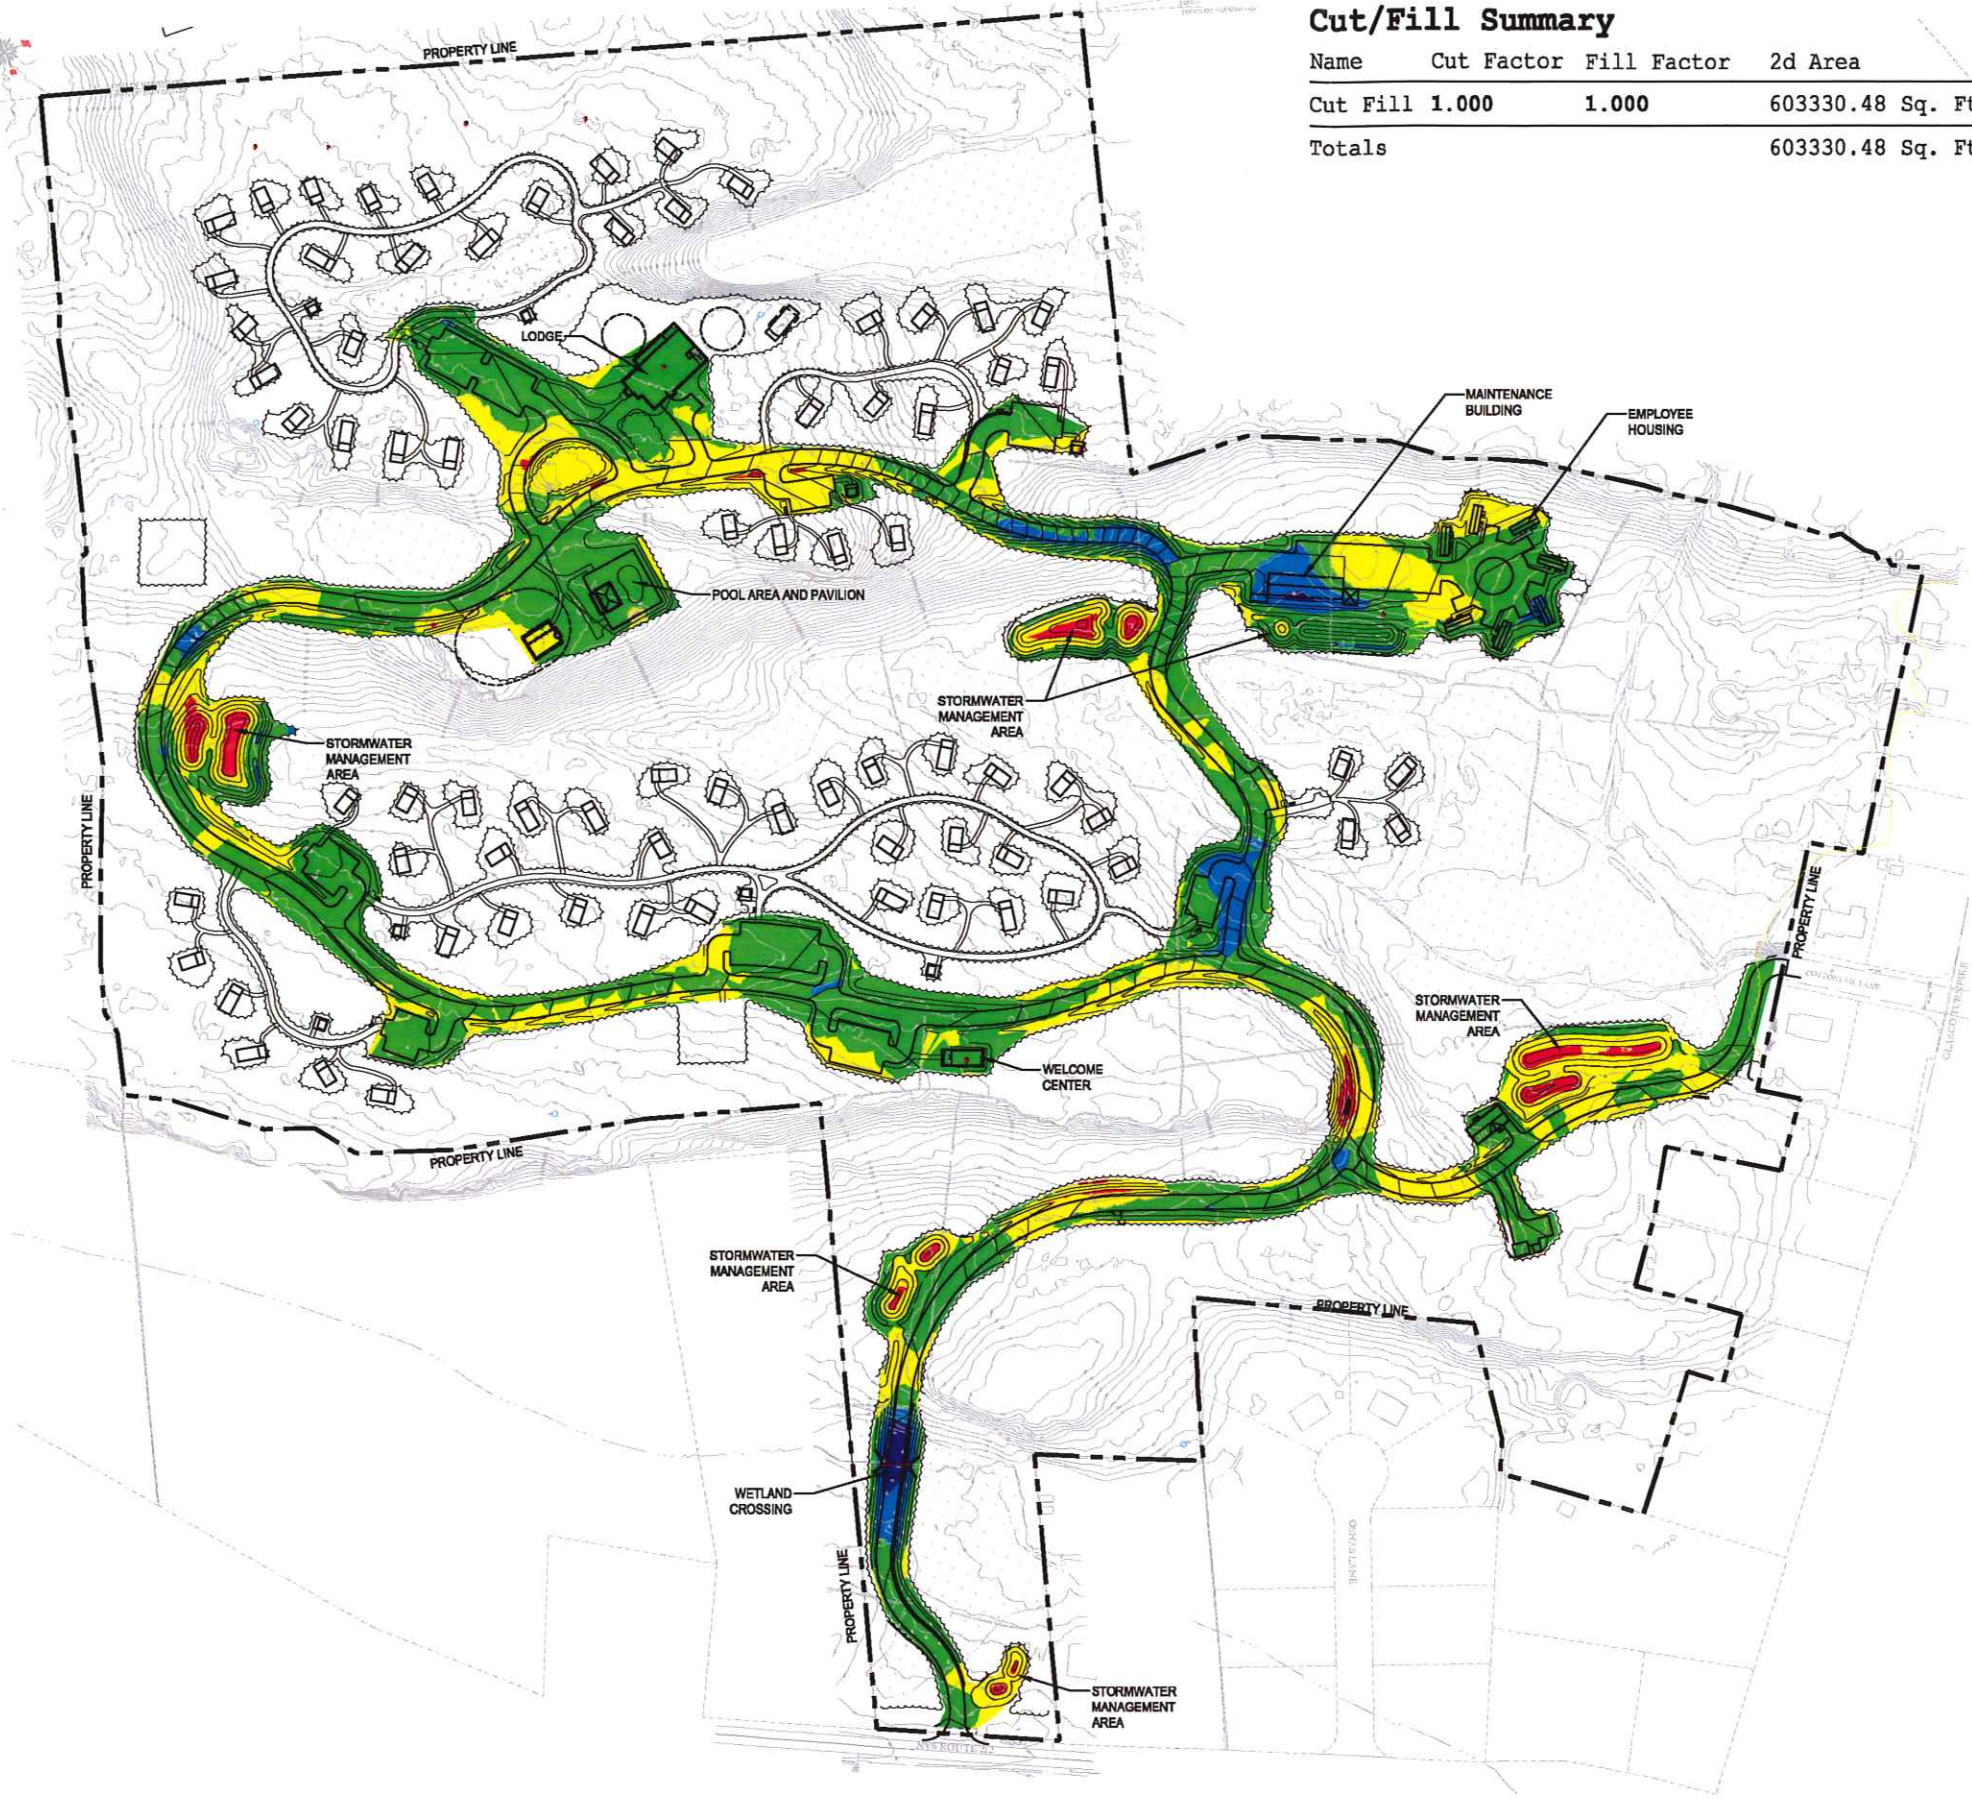
Cut/Fill Summary

Name	Cut Factor	Fill Factor	2d Area	Cut	Fill	Net
Cut Fill	1.000	1.000	603330.48 Sq. Ft.	10436.44 Cu. Yd.	24302.69 Cu. Yd.	13866.25 Cu. Yd.<Fill>
Totals			603330.48 Sq. Ft.	10436.44 Cu. Yd.	24302.69 Cu. Yd.	13866.25 Cu. Yd.<Fill>

[Red Box]	CUT 4'-8'
[Yellow Box]	CUT 0'-4'
[Green Box]	FILL 0'-4'
[Blue Box]	FILL 4'-8'
[Dark Blue Box]	FILL 8'-12'

The Project Sponsor has prepared a "Cut/Fill Diagram" dated December 1, 2022, which was generated using the current grading and drainage plan estimates. See **Exhibit C** [Cut/Fill Diagram]. As noted in the Cut/Fill Diagram, the Project will require approximately 13, 866 cubic yards of "fill" material to achieve finished grades. This would include general fill, stone sub-base materials and pavement materials. All fill be will sourced in compliance with all local, State and Federal regulations.

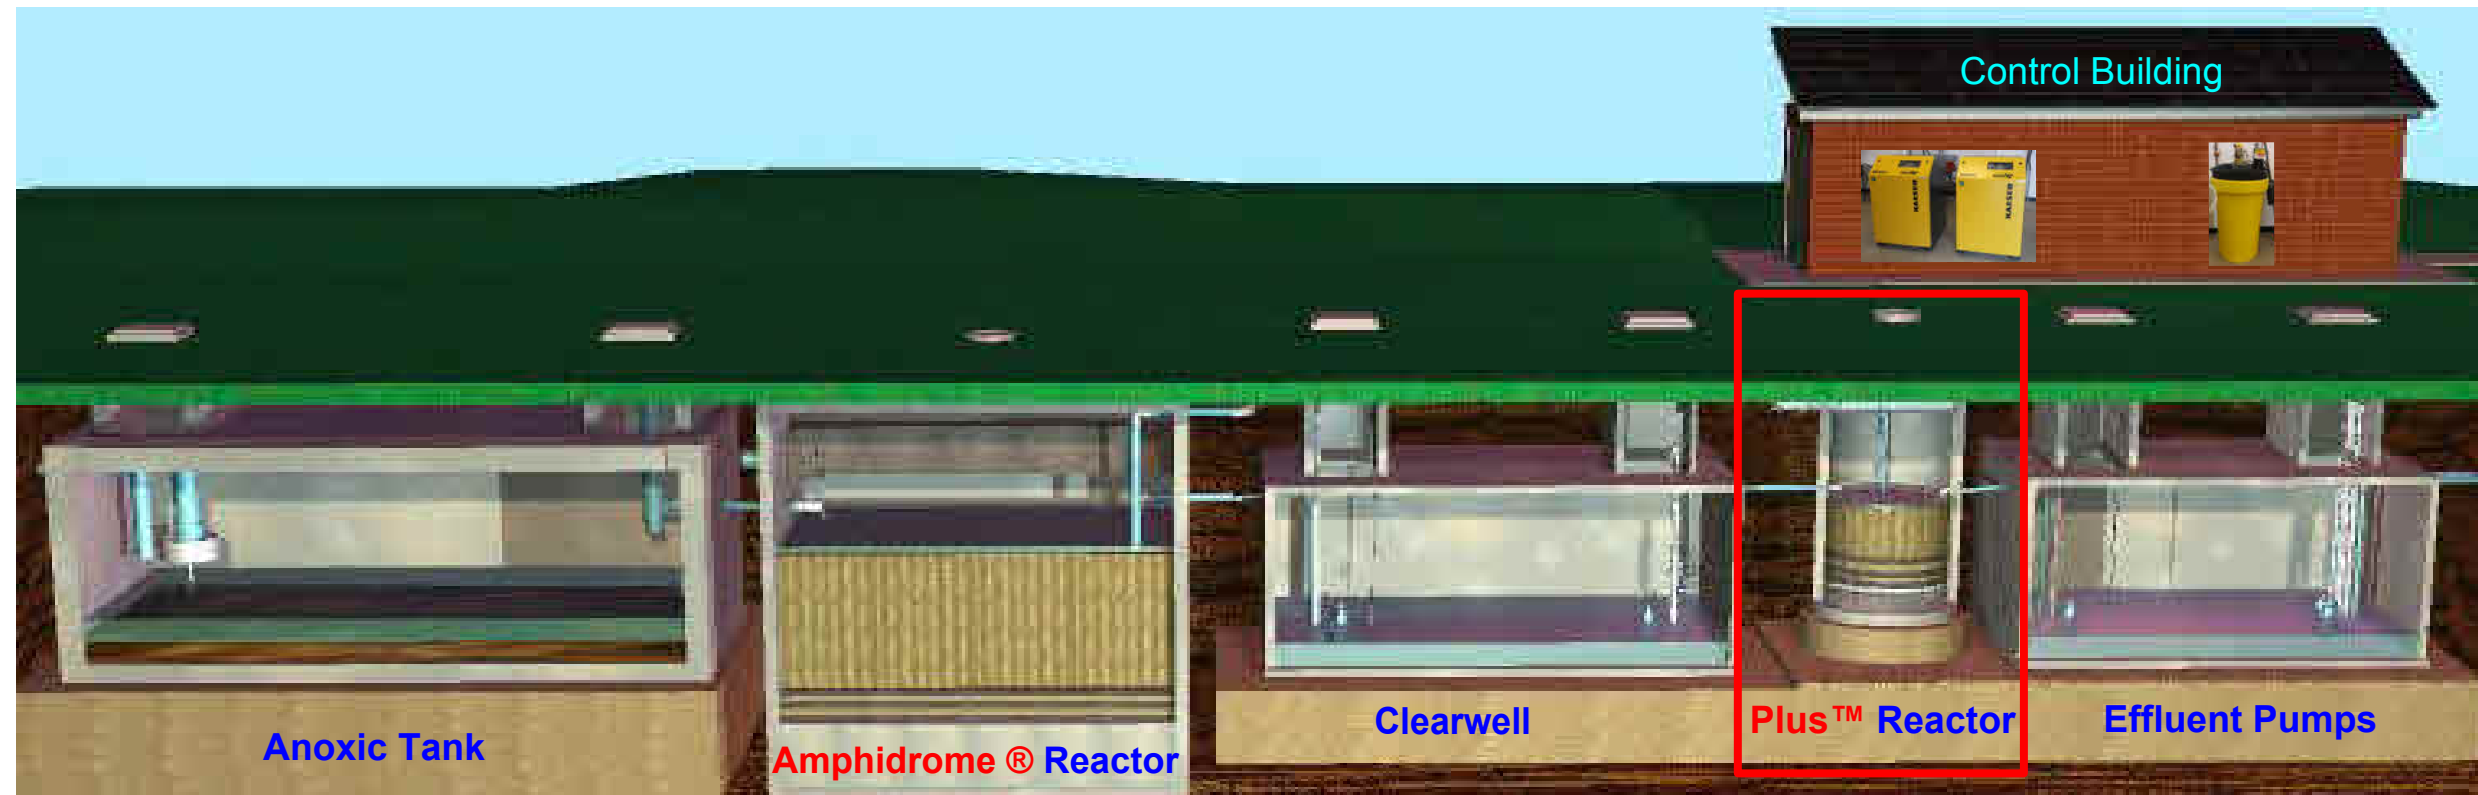
Amphidrome® System

The **Amphidrome® System** is a Submerged Attached Growth **B**ologically **A**ctive **F**ilter (BAF) providing BOD reduction, superior nitrification, denitrification, phosphorus reduction and filtration of suspended solids in a single reactor.

A spherical sand media provides maximum surface area for microorganisms to attach themselves. The microorganism environment is manipulated with intermittent aeration.

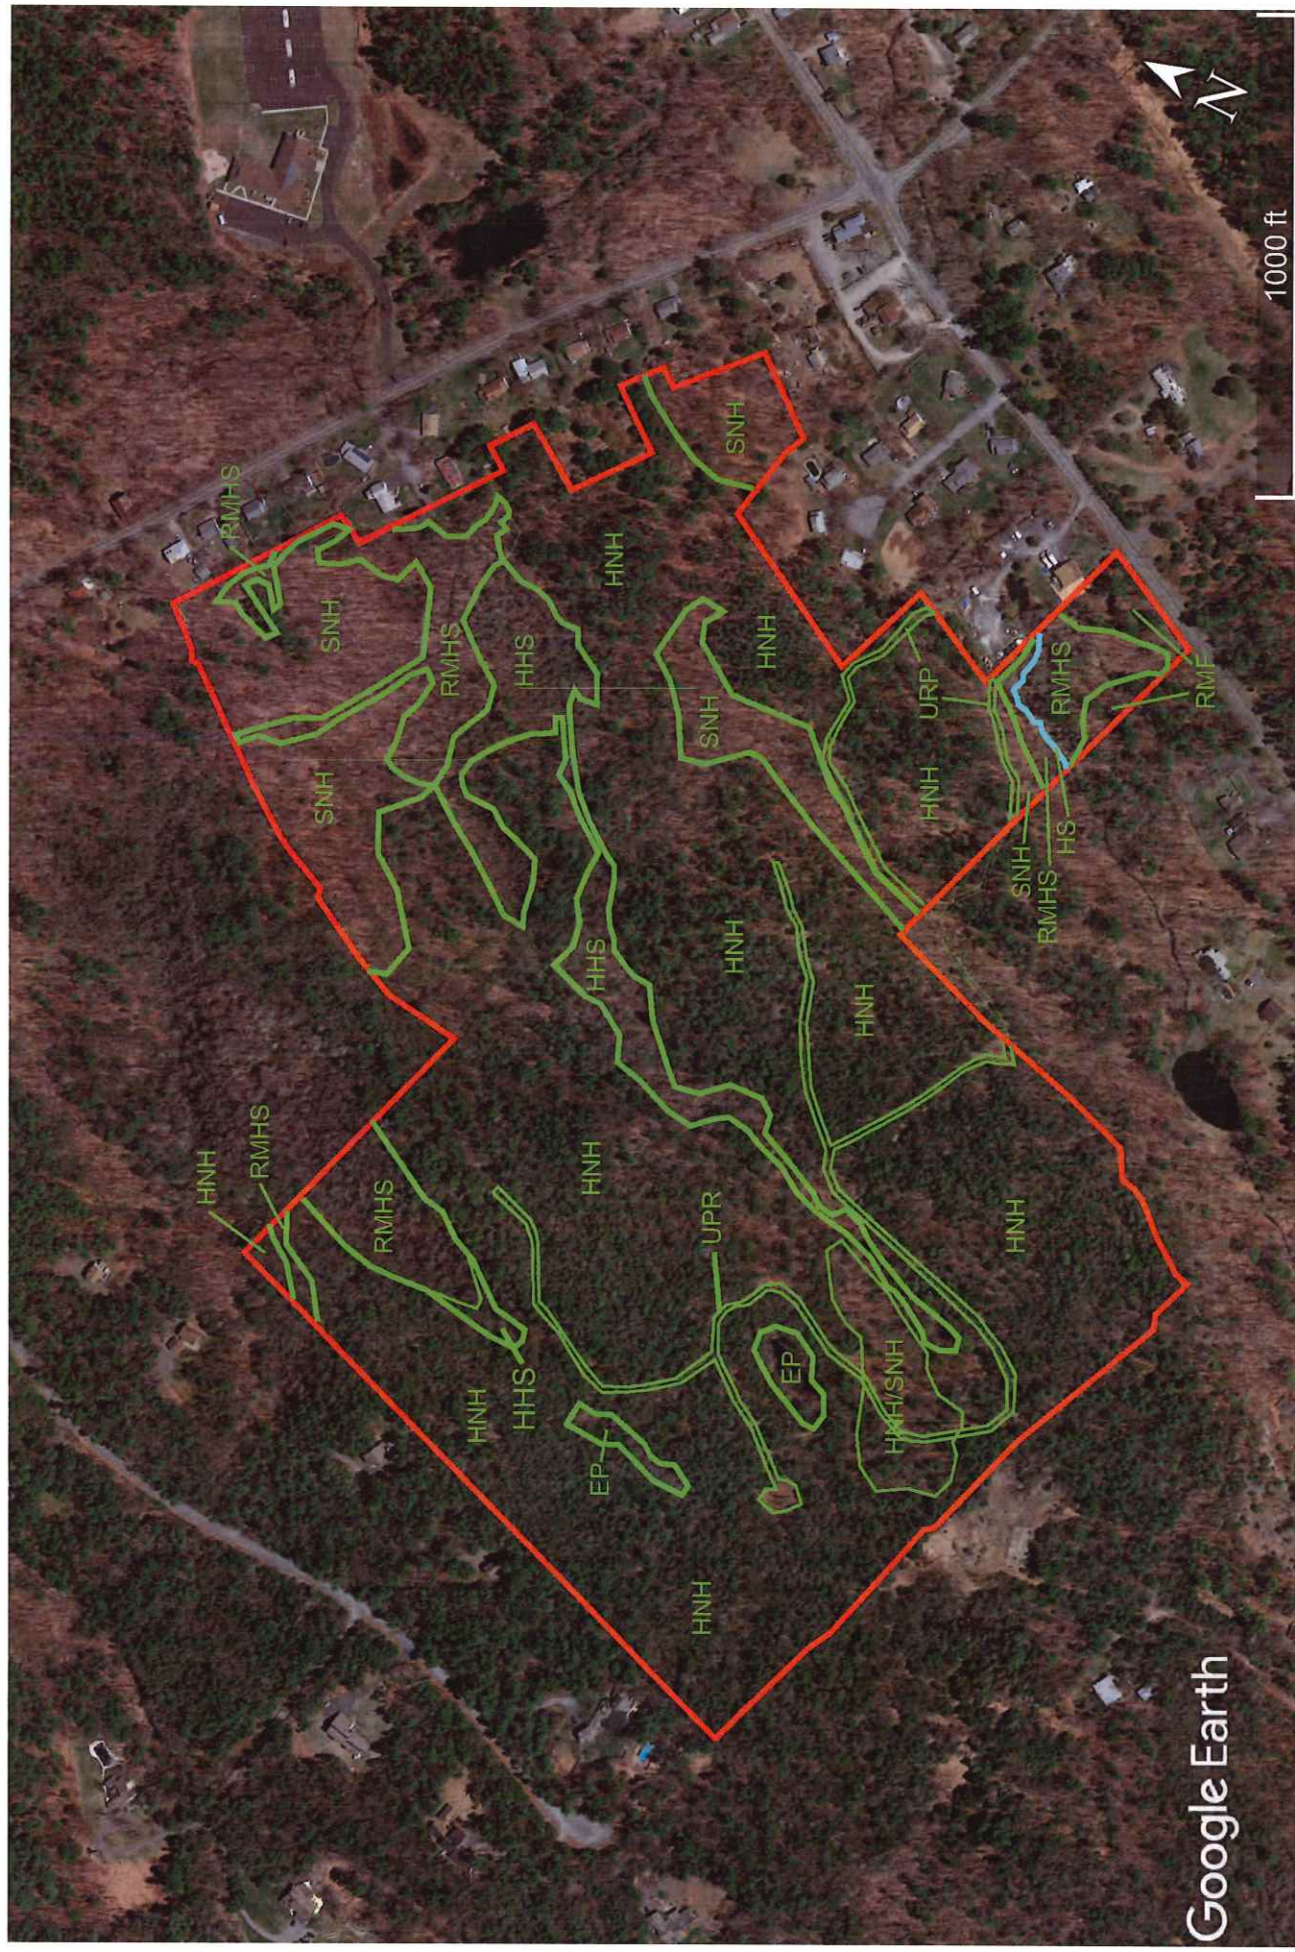
Figure 2. Habitat Cover Type Map
Terramor Catskills Site
Town of Saugerties, Ulster County, New York
Terramor Outdoor Resorts

EP-Eutrophic Pond	RMHS-Red Maple-Hardwood Swamp
HHS-Hemlock-Hardwood Swamp	RMF-Rich Mesic Forest
HNH-Hemlock-Northern Hardwoods	SNH-Successional Northern Hardwoods
HS-Headwater Stream	URP-Unpaved Road/Path

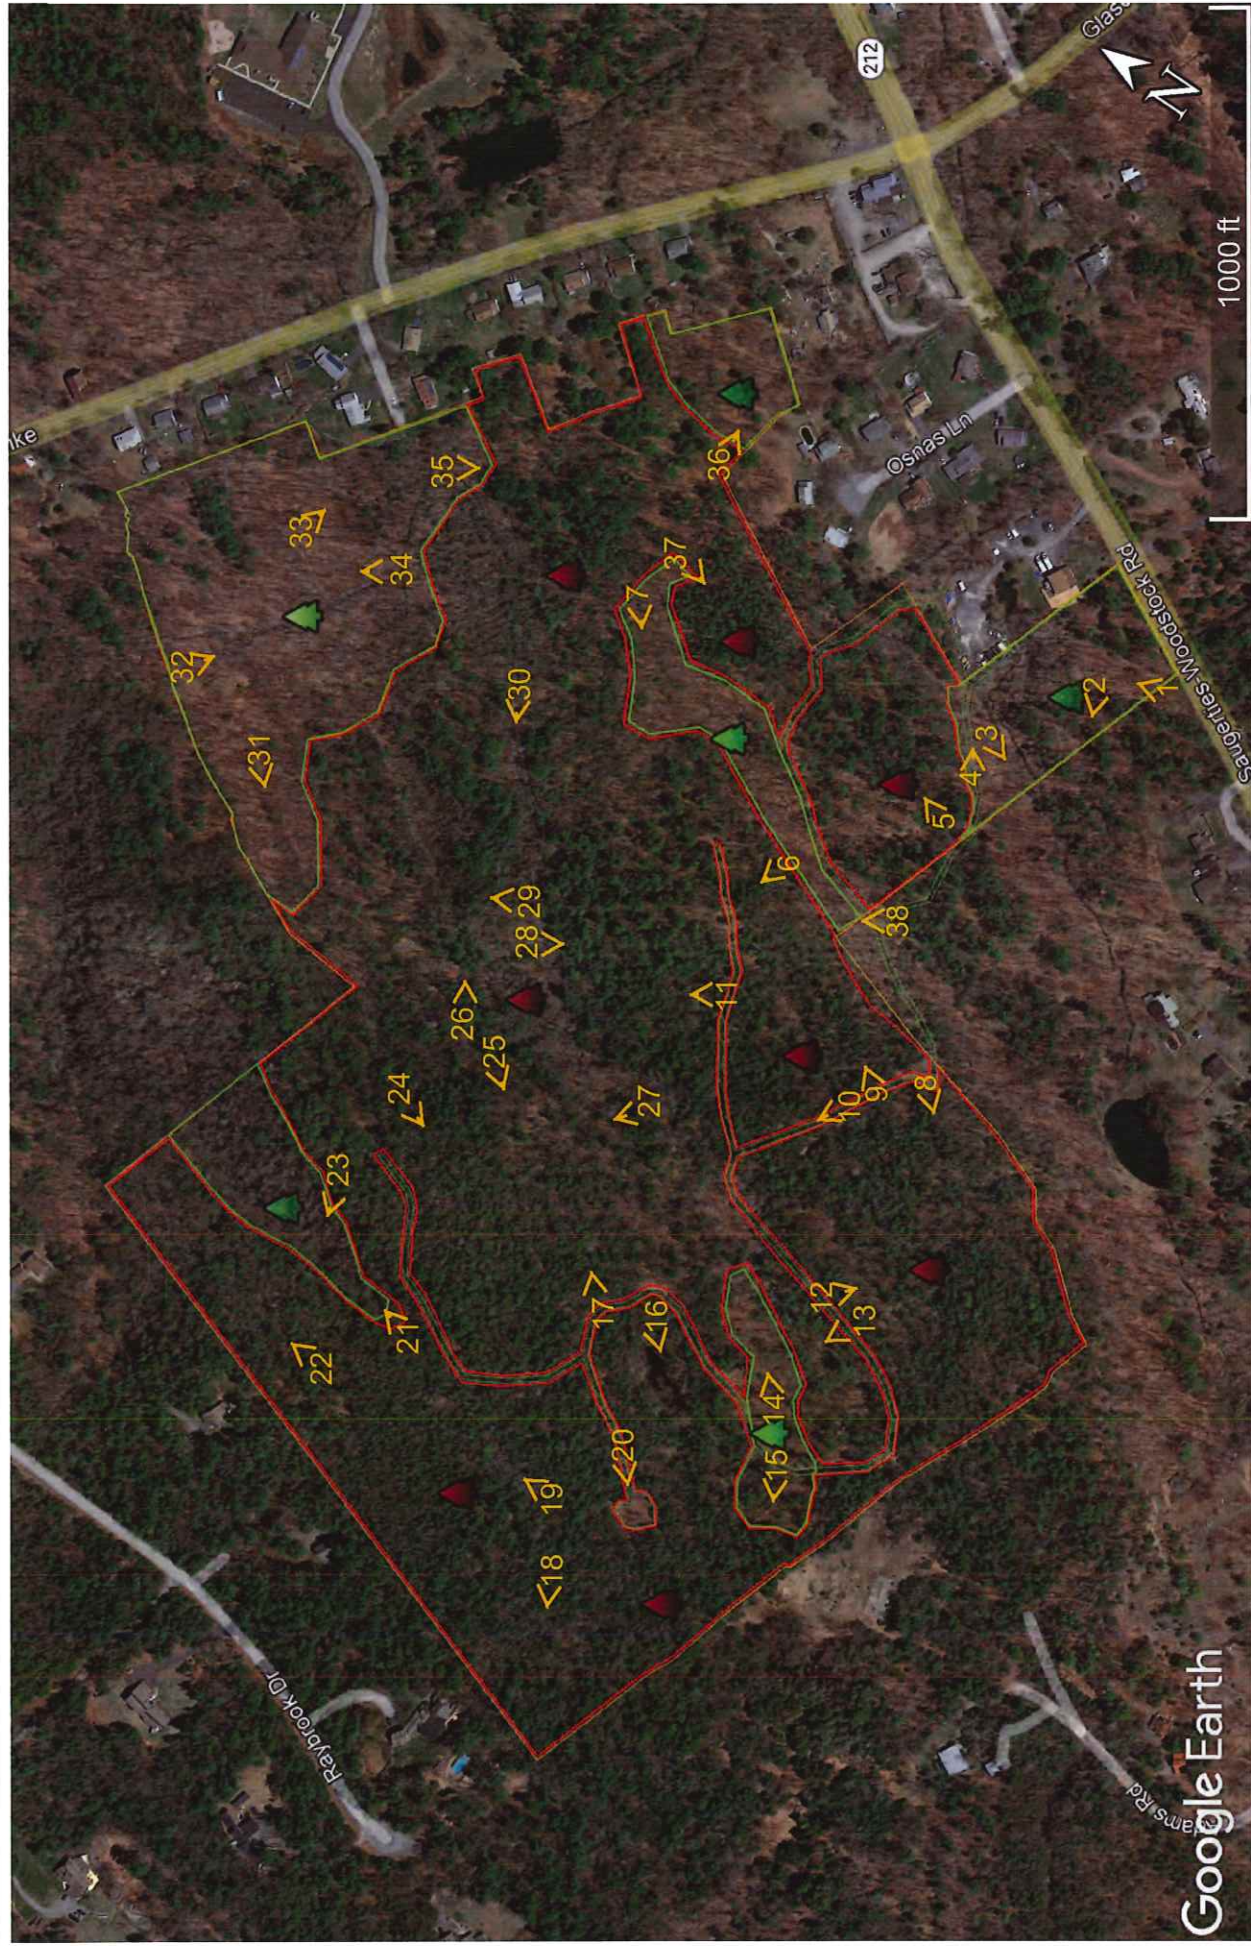
Figure 3. Potential Bat Habitat Map and Photo Location Key

- ▲ Potential Bat Habitat
- ▲ Not Suitable Bat Habitat
- Waters and Wetlands
- # Photo Number and Direction

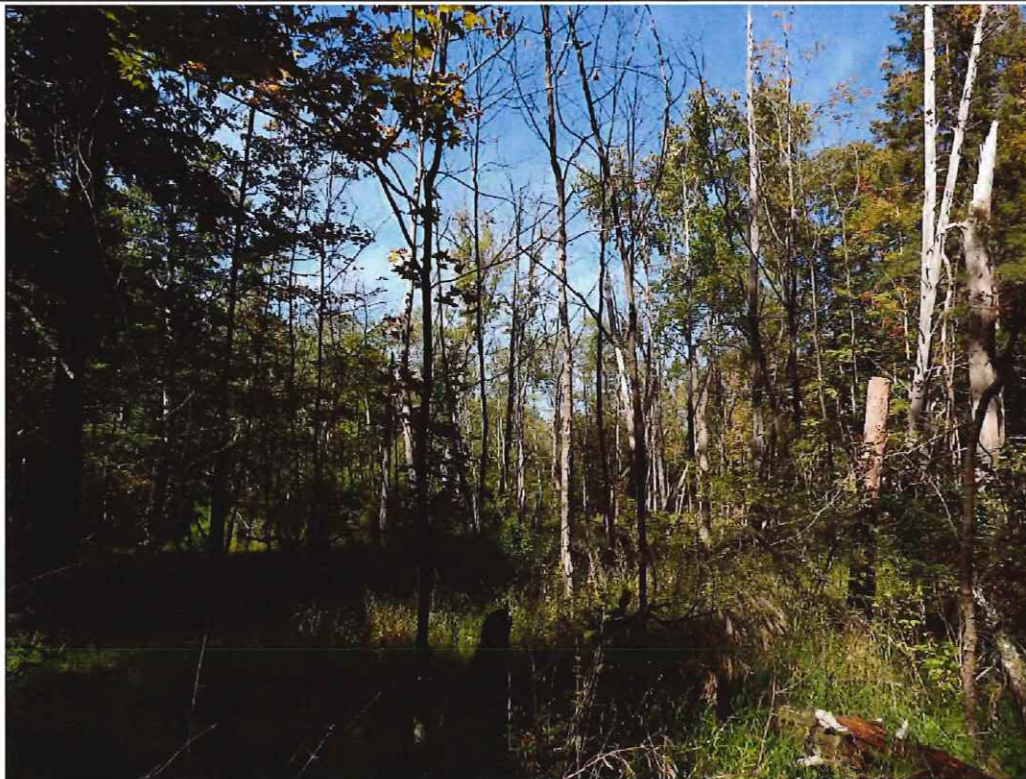
Photograph: 1

View of wetland at proposed Site entrance from Saugerties-Woodstock Road. Open understory and snags provide potential roost and foraging habitat.

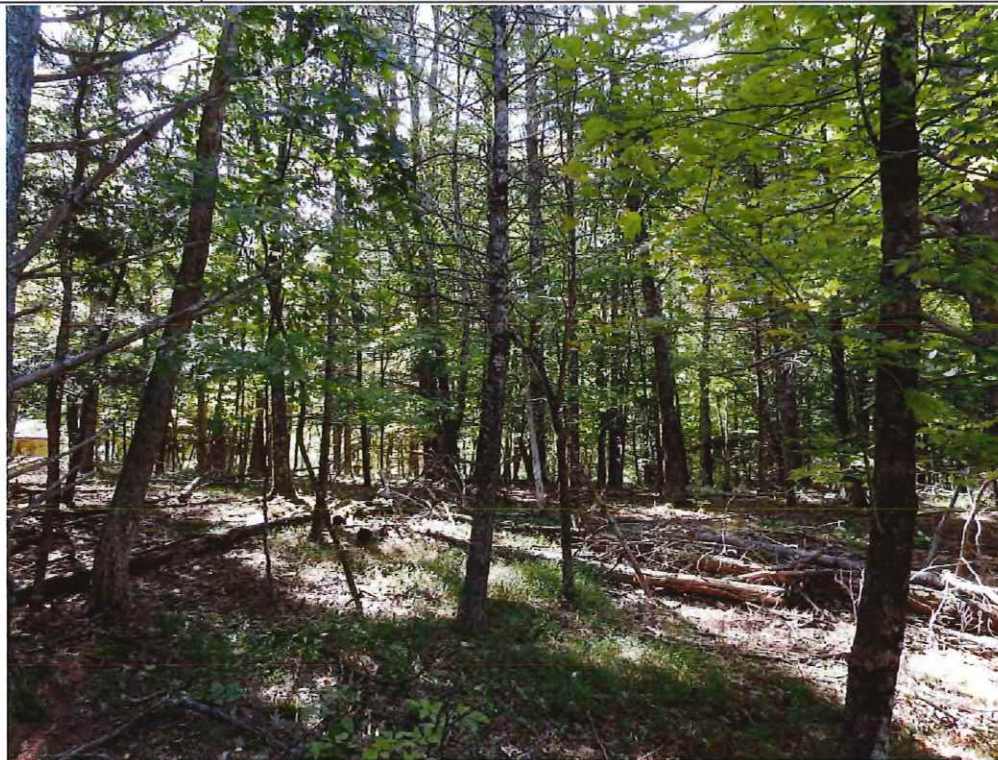
Photograph: 2

Rich mesic forest with open understory, but young growth. Passage habitat, but no potential roosts.

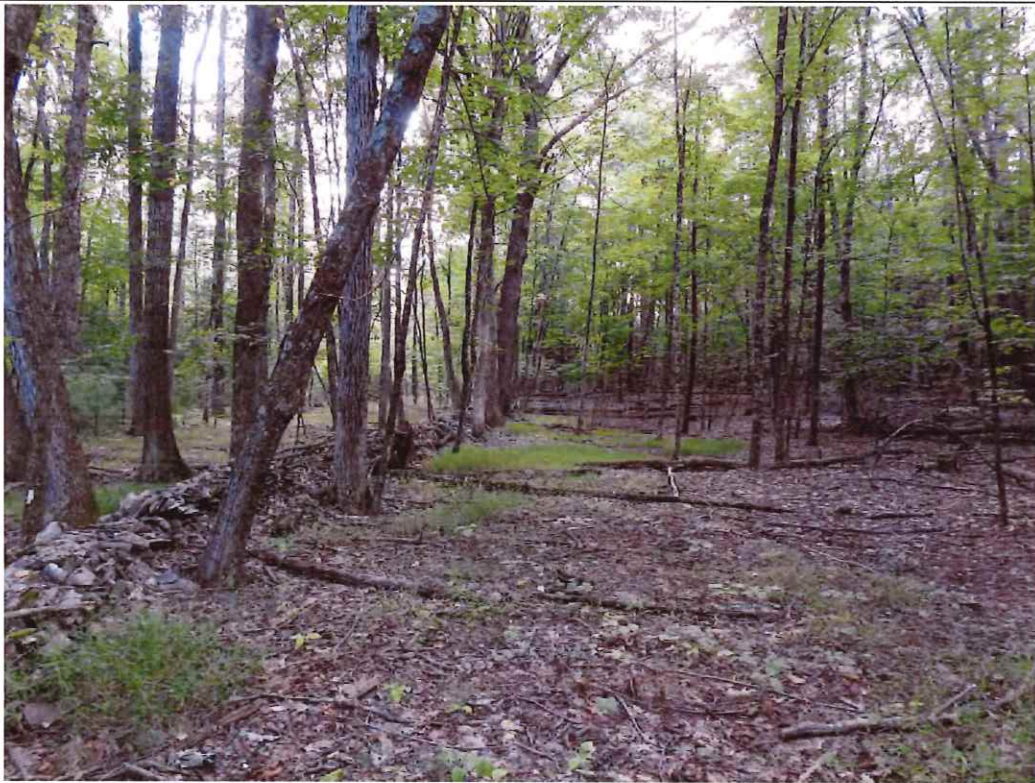
Photograph: 3 Successional northern hardwoods (mature). Open understory and mature hardwoods provide foraging, transit, and potential roost habitat.

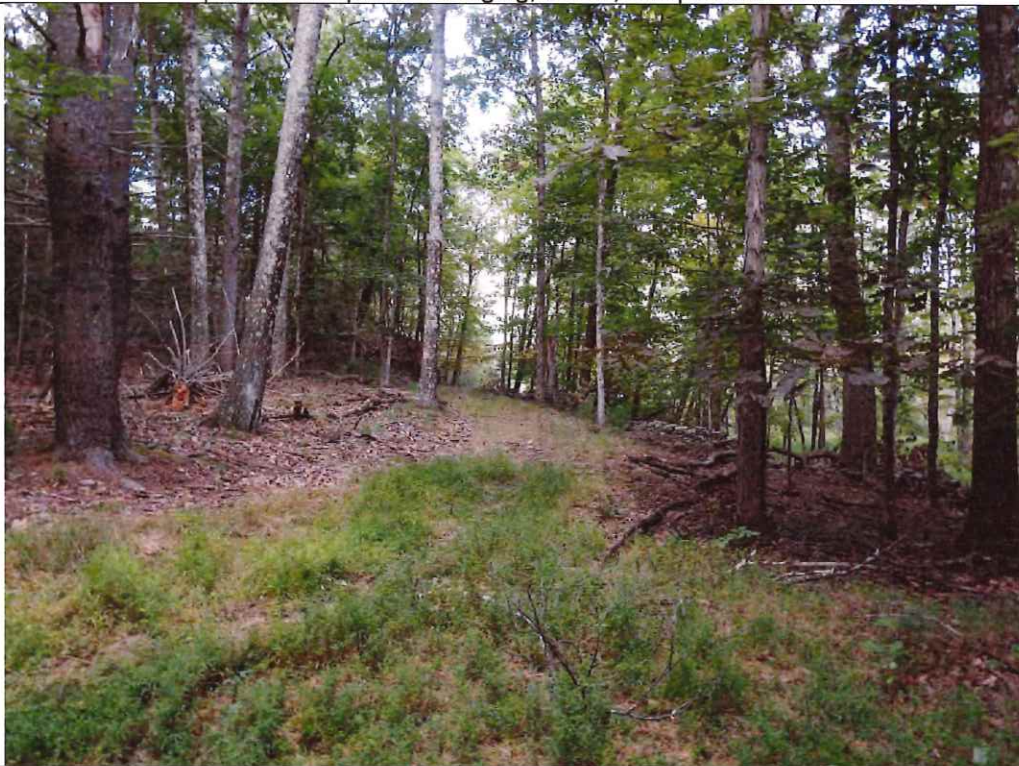
Photograph: 4 Unpaved road between Hemlock-Northern Hardwood (left) and Successional Northern Hardwood (right). Road provides flyway and hardwoods provide roosts; dense evergreens to left are not suitable habitat.

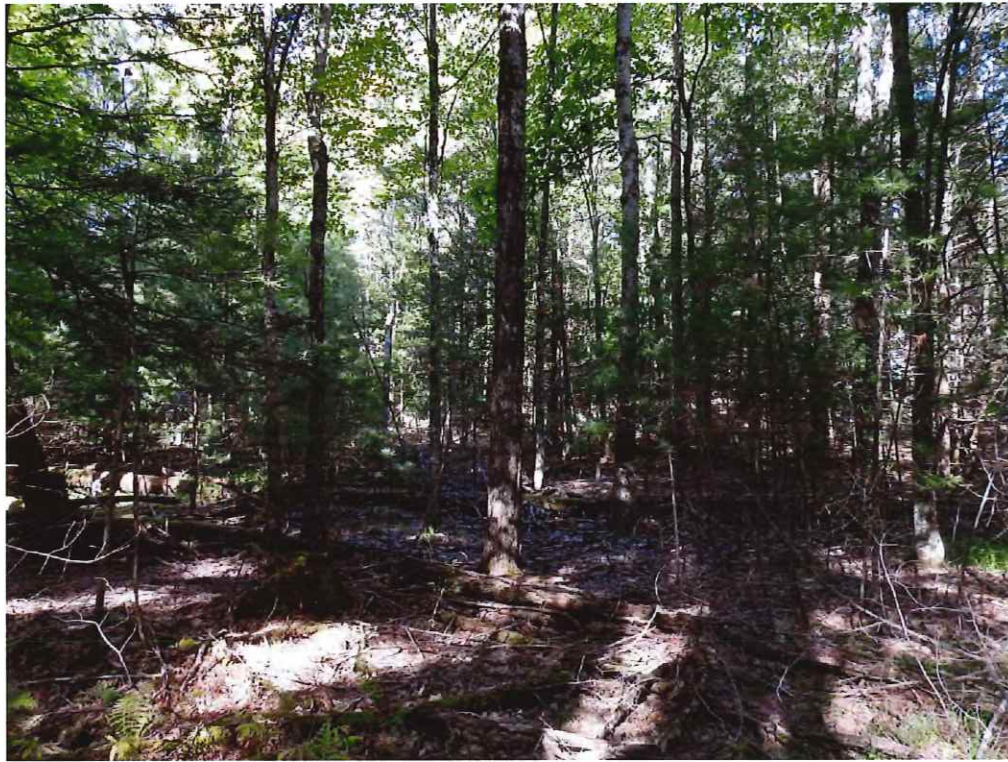
Photograph: 5 Hemlock-northern hardwoods with dense understory and few if any snags. No open flyways and no roost structure – not suitable potential bat habitat.

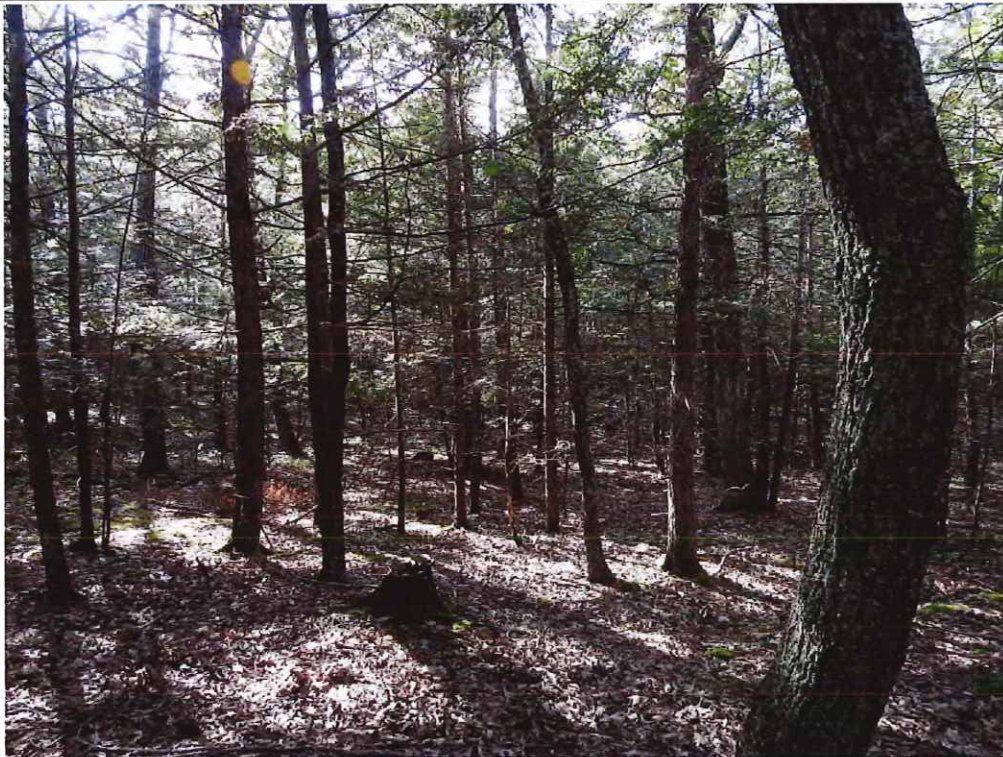
Photograph: 6 Hemlock-northern hardwoods – young growth. Dense understory and young/small trees provide no flyways and no potential roost structure.

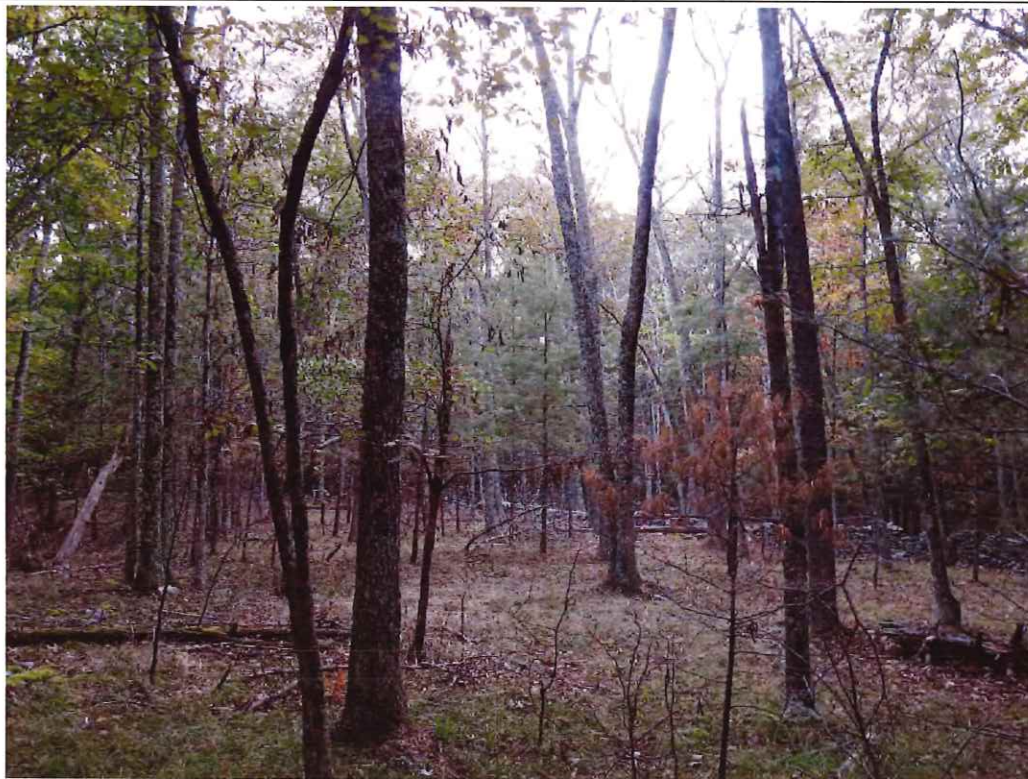
Photograph: 7

Patch of dying ash trees in Successional Northern Hardwoods. Open understory provides flyway and snags provide potential roosts.

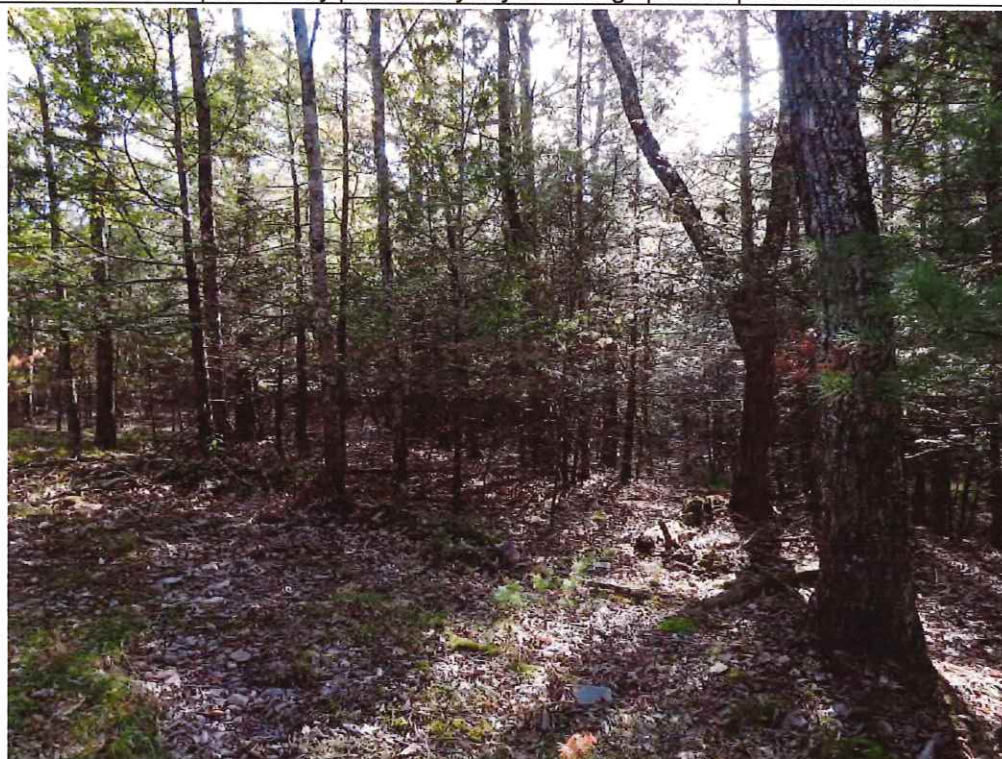
Photograph: 8

Young Hemlock-Northern Hardwoods with dense understory; no flyways and no potential roost structure.

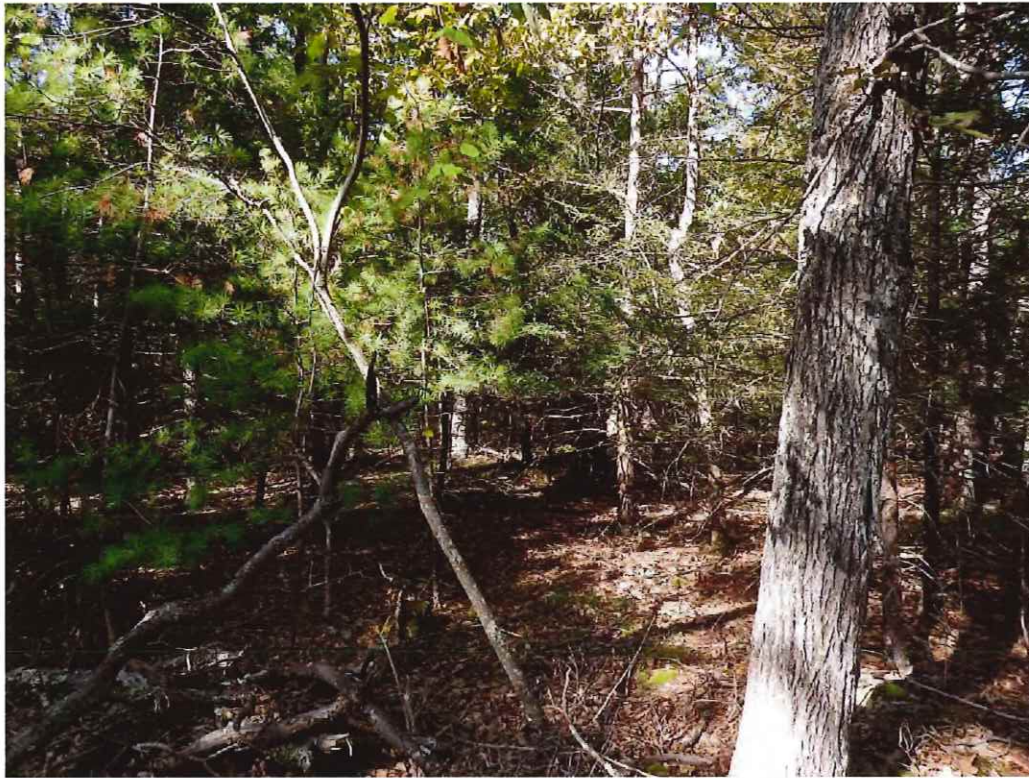
Photograph: 9

Young Hemlock-Northern Hardwoods (with some White Pine mixed in) with dense understory; no flyways and no potential roost structure.

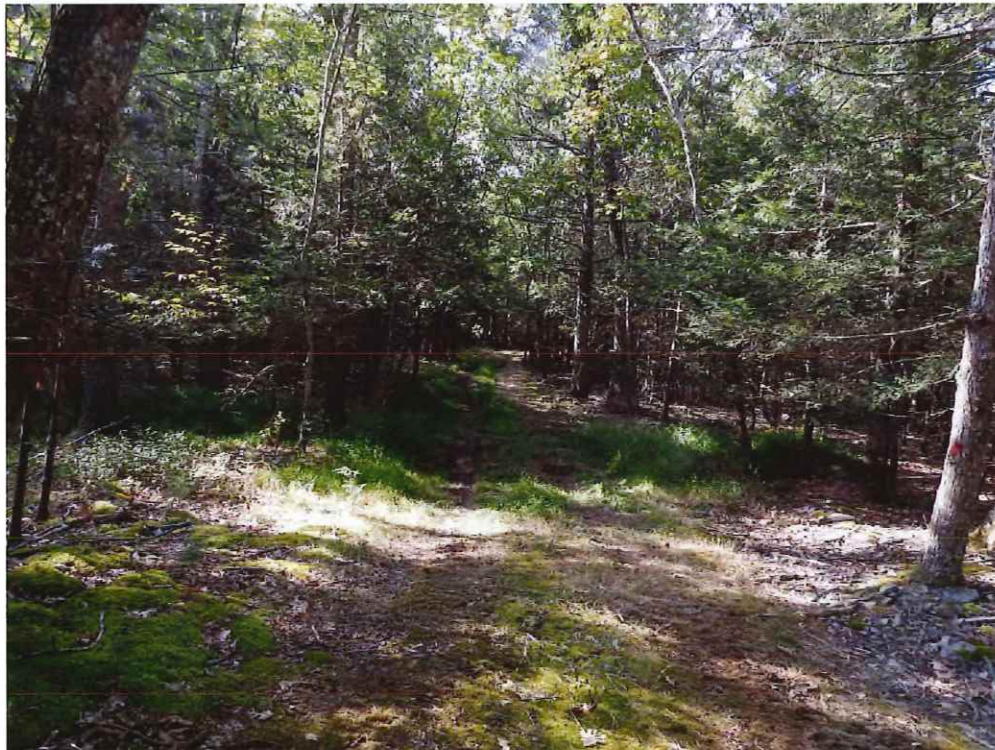
Photograph: 10

Unpaved Road through dense, young Hemlock-Northern Hardwoods provides only flyway through this habitat. No mature trees or snags for potential roost structure.

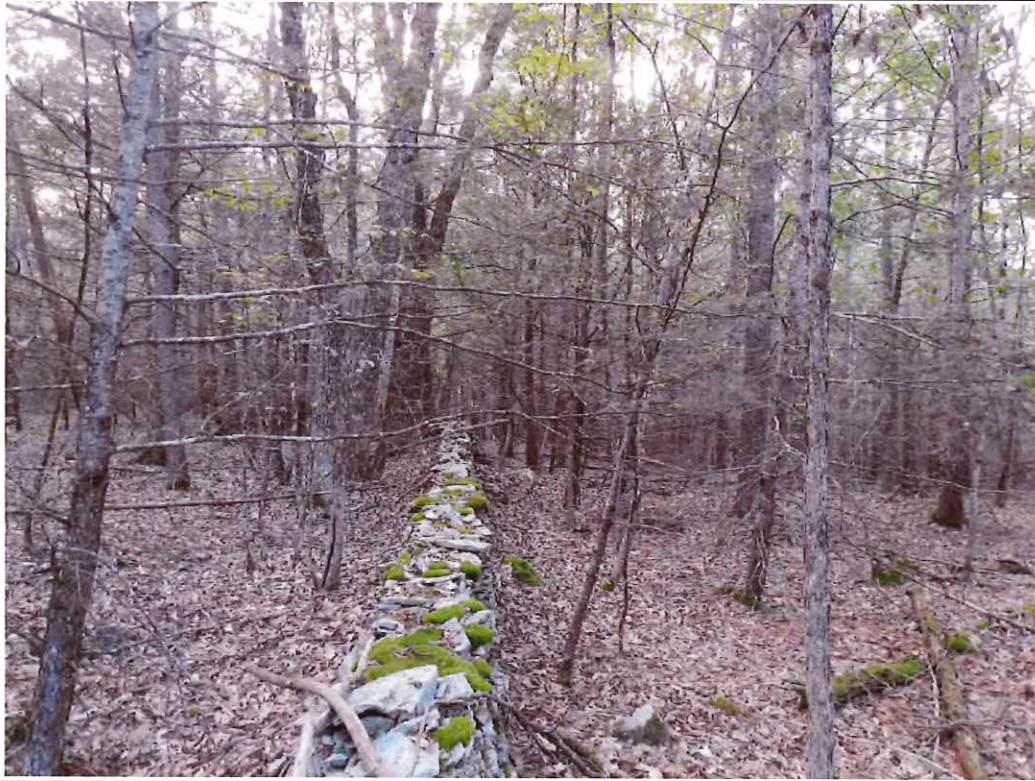
Photograph: 11 Dense young Hemlock-Northern Hardwoods provide no flyways or roost structure.

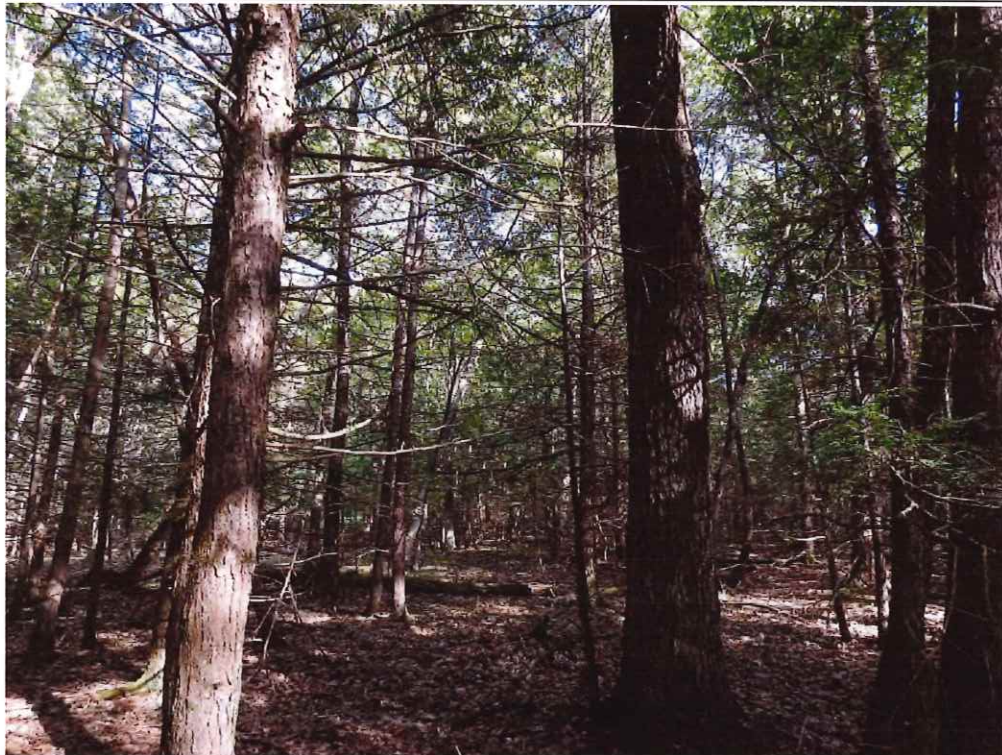
Photograph: 12 Mature Hemlock-Northern Hardwood stand still has dense understory of dead minor limbs; no open flyways and no potential roost structure.

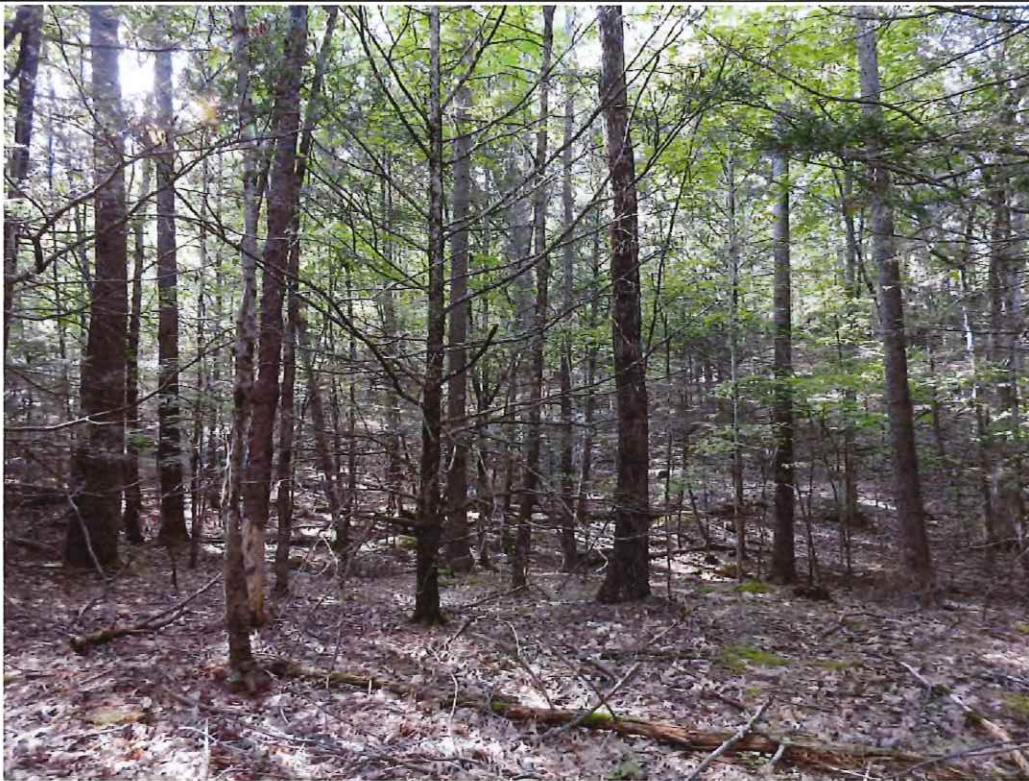
Photograph: 13 Mature Hemlock-Northern Hardwood stand still has dense understory of dead minor limbs; no open flyways. Snag (right) is not accessible to flying/foraging bats.

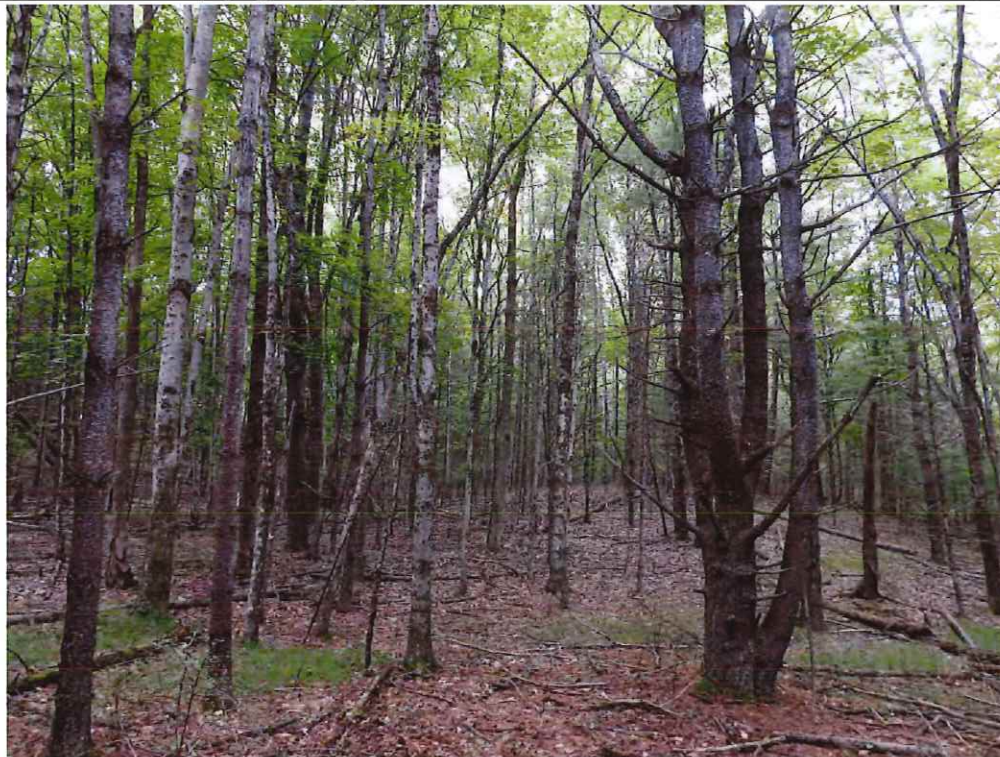
Photograph: 14 Successional Northern Hardwood patch with open understory: provides potential foraging and transit flyways and larger trees may provide potential bat roosts.

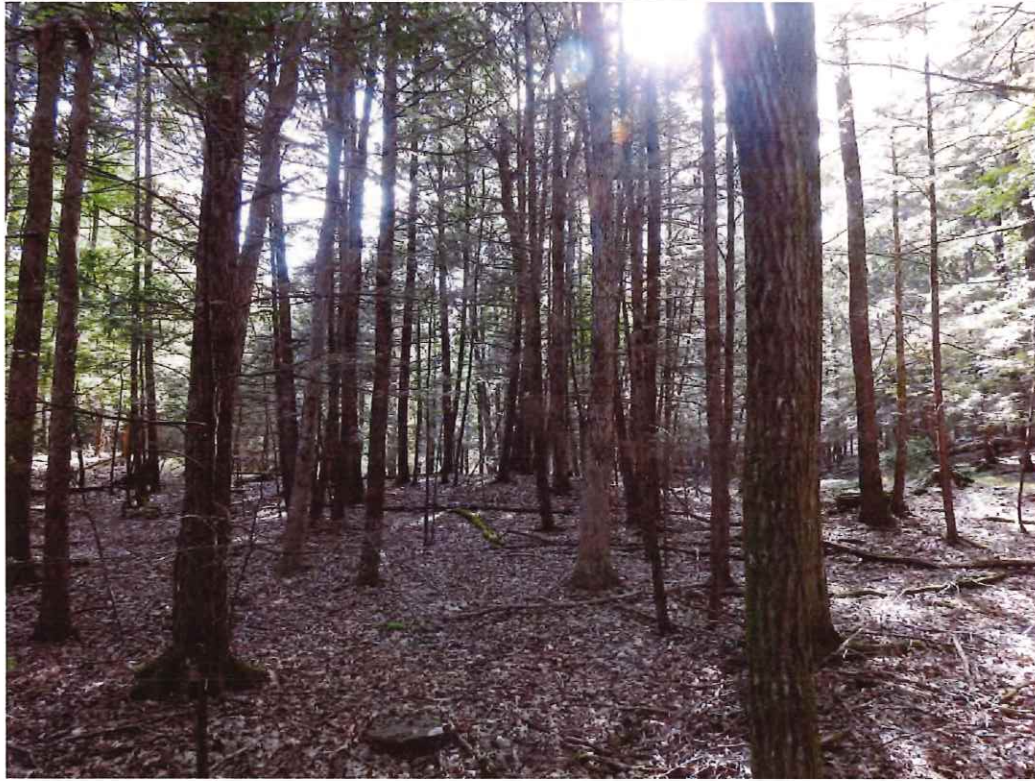
Photograph: 15 Successional Northern Hardwood patch with open understory for open flyways and mature hardwoods for potential roosts.
