Terramor Outdoor Luxury Campground

Expanded EAF Narrative

Town of Saugerties, New York

December 6, 2022

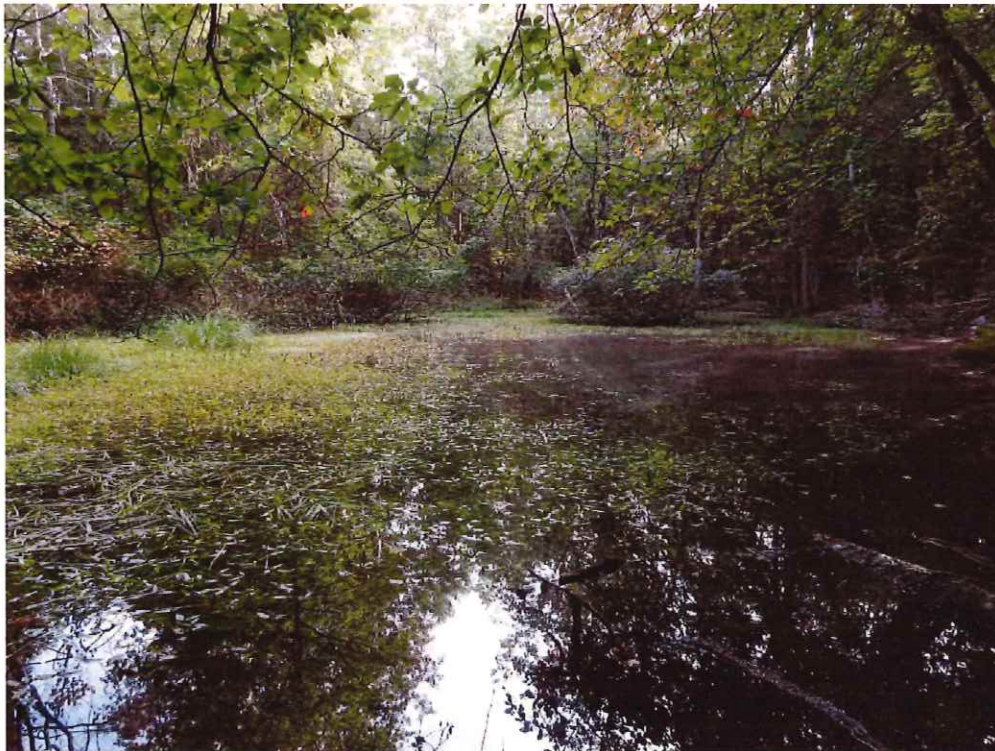
Photograph: 16 Woodland pool surrounded by dense Hemlock-Northern Hardwood forest. Potential for water resource, but not easily accessible to bats from below the forest canopy.

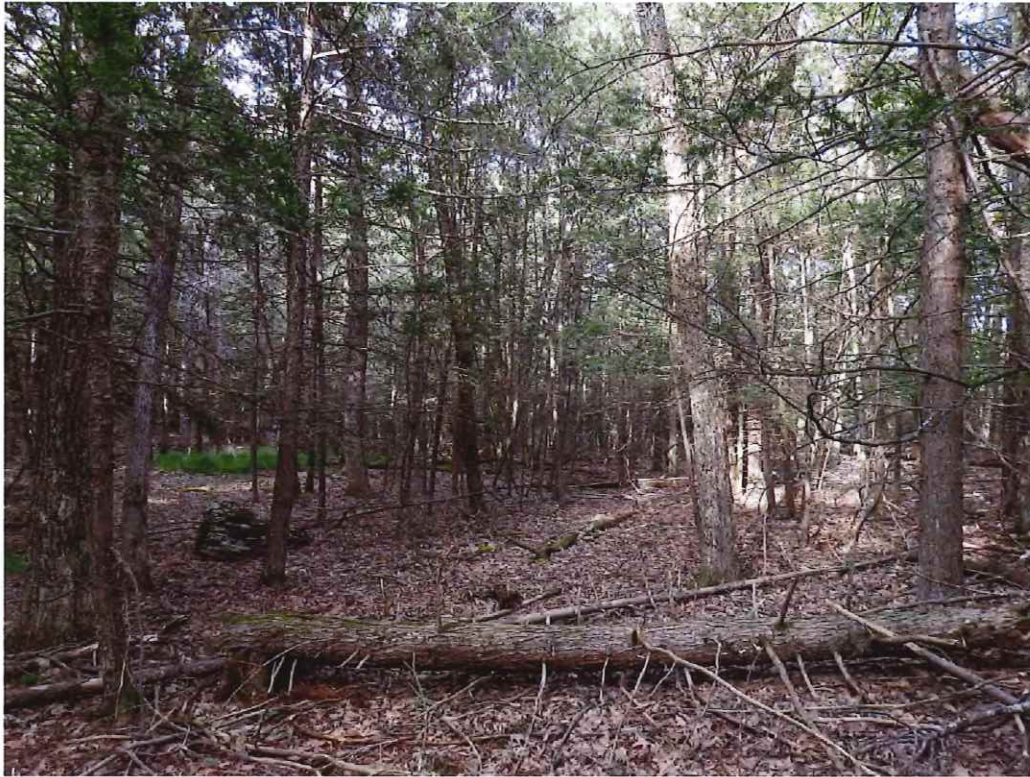
Photograph: 17 Dense Hemlock-Northern Hardwood forest with no open flyways; only gaps are in small blowdowns, or along Unpaved Roads.

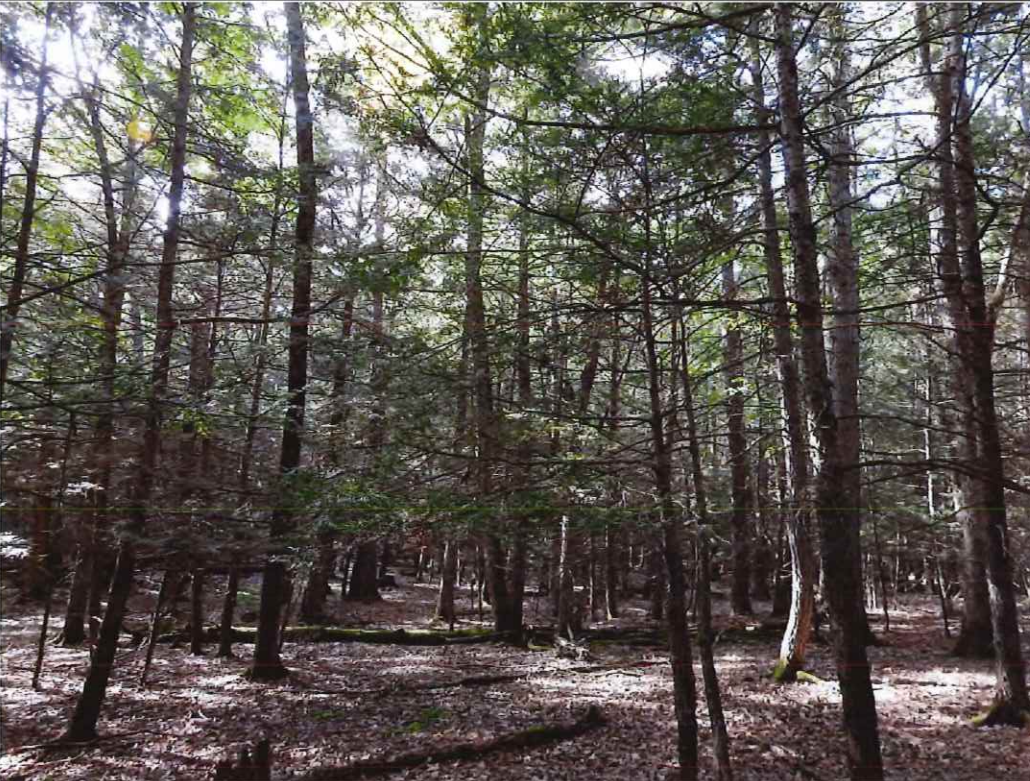
Photograph: 18 Dense Hemlock-Northern Hardwood forest; no open flyways or potential roost structure.

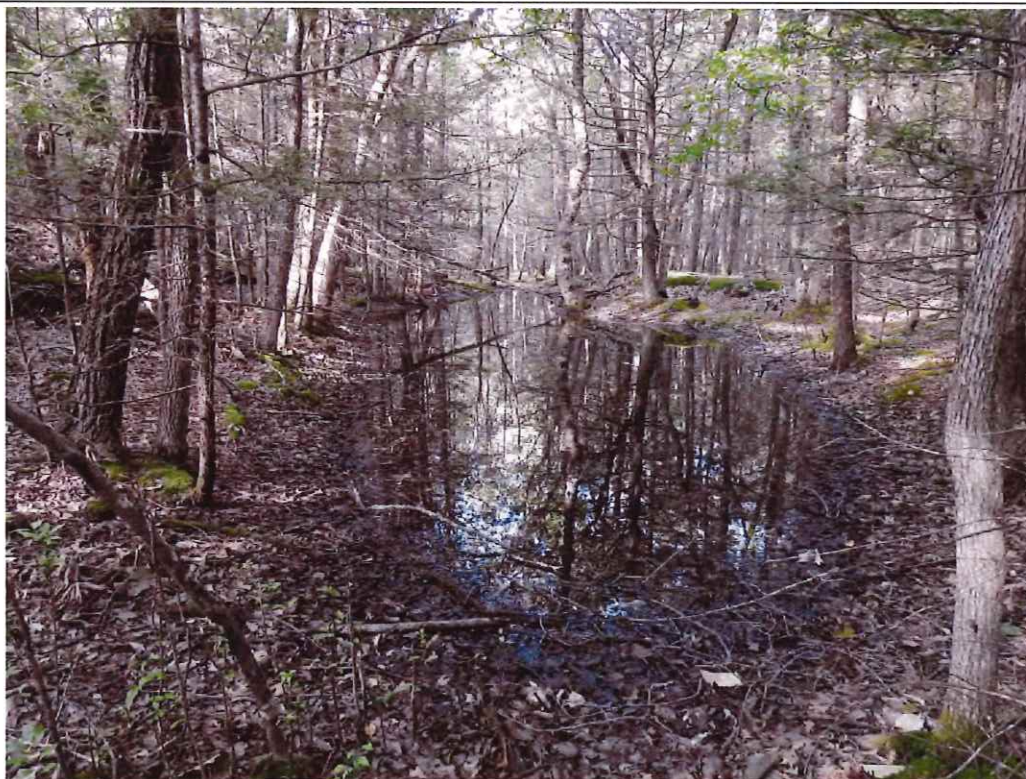
Photograph: 19 Woodland pool surrounded by dense Hemlock-Northern Hardwood forest. Potential for water resource, but not easily accessible to bats from below the forest canopy.

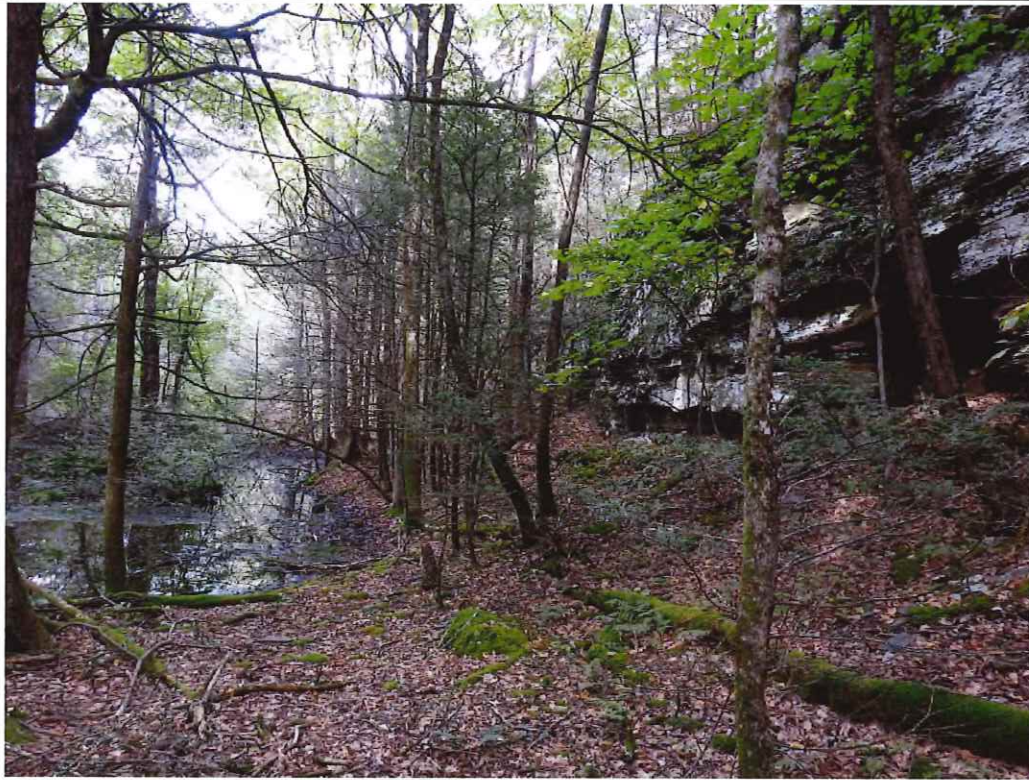
Photograph: 21 Hemlock/Hardwood Swamp/Red Maple-Hardwood Swamp provides potential habitat (water resource, open flyway for foraging; snags for roosting)

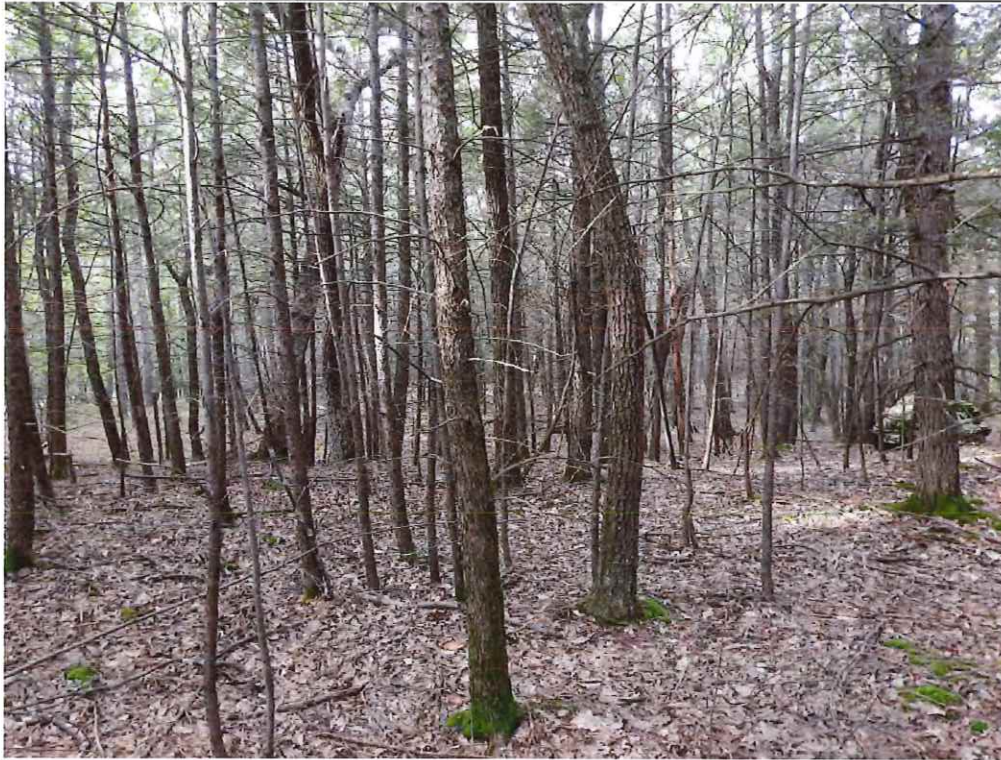
Photograph: 22 Dense Hemlock-Northern Hardwoods along western side of Site: too dense in understory for flyways and trees are too small and no snags for roost structure.

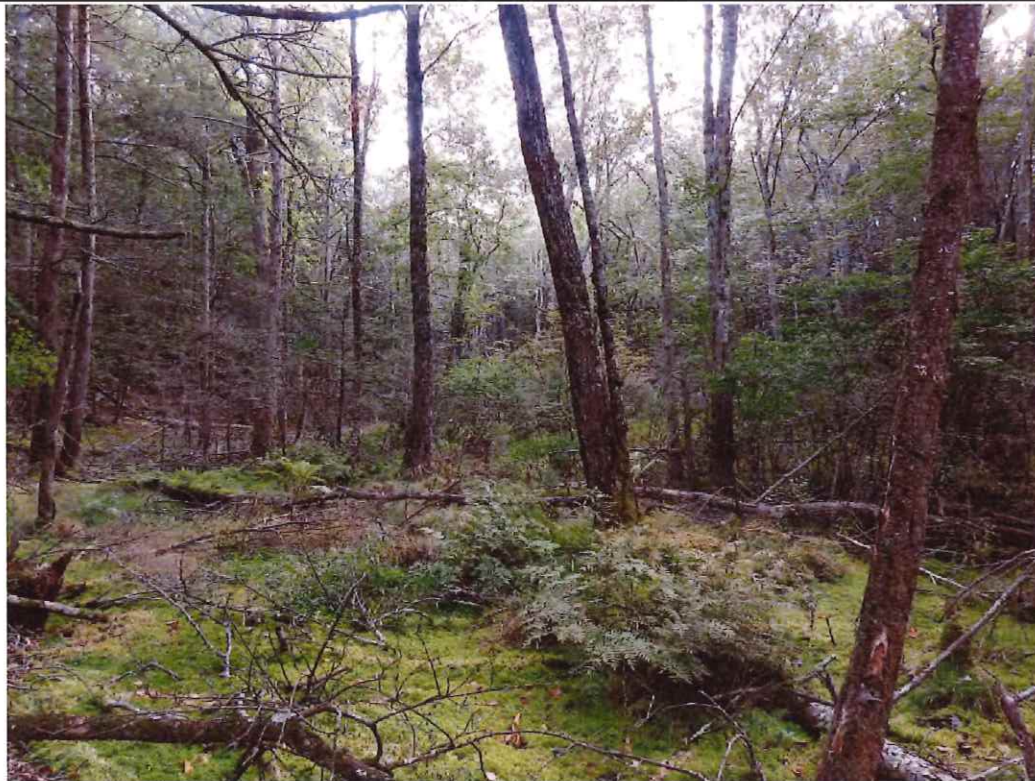
Photograph: 23 Hemlock-Hardwood Swamp (distant) transitions to Red Maple-Hardwood Swamp (foreground); open understory is open flyway and snags provide potential bat roosts.

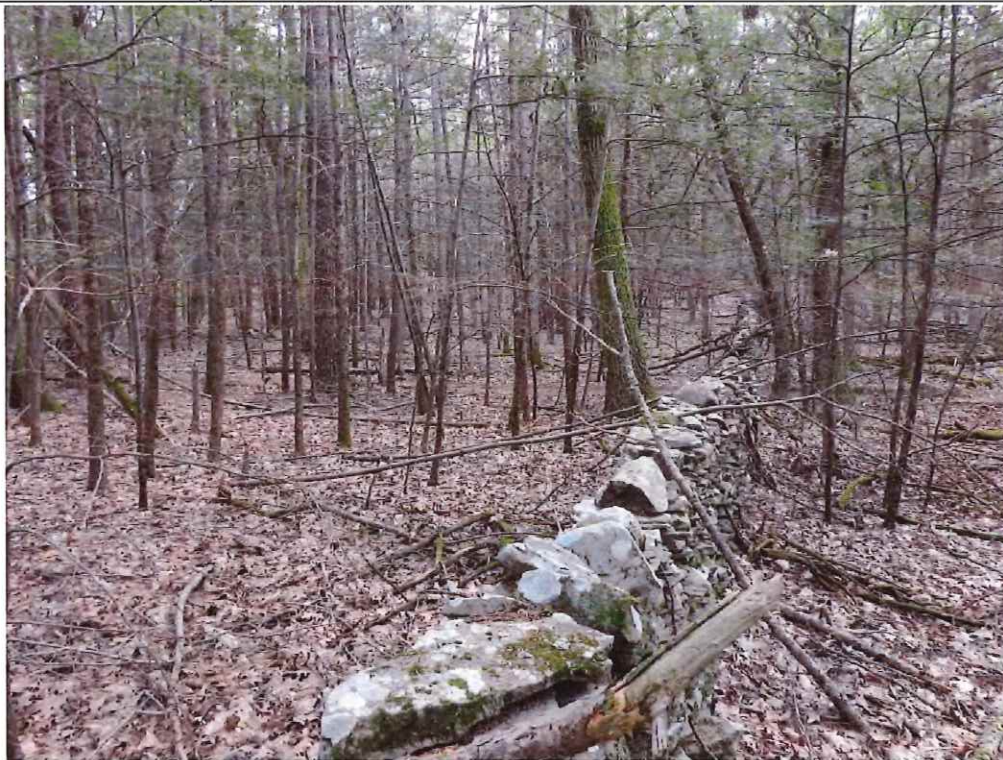
Photograph: 24 Dense young growth Hemlock-Northern Hardwood forest; no open flyways and no potential roost structure.

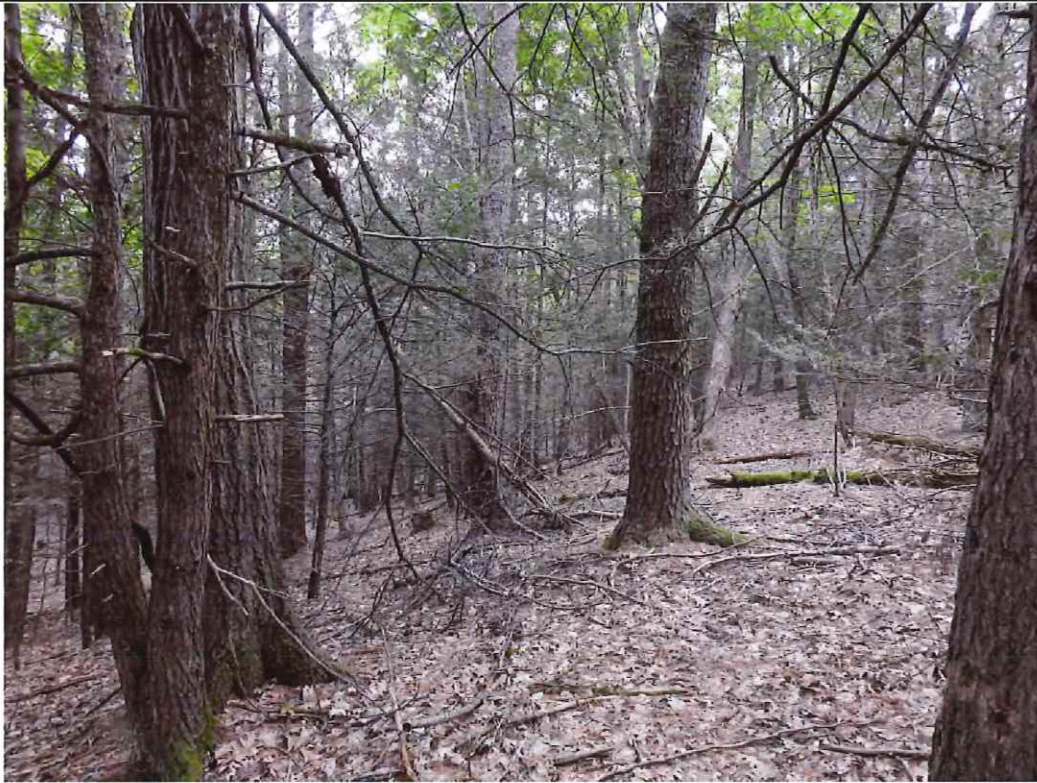
Photograph: 25 Mature Hemlock-Northern Hardwood forest; dense understory provides no open flyways; bats can't access mature trees for potential roosts.

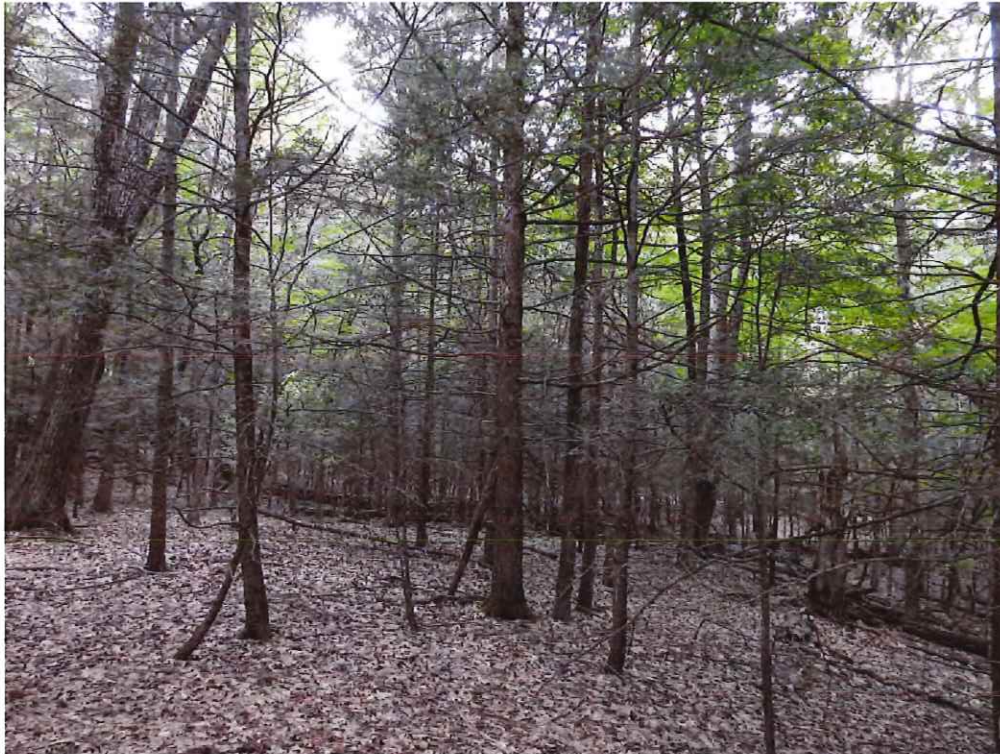
Photograph: 26 Mostly young Hemlock-Northern Hardwood forest with scattered larger trees. Young hemlocks are too dense to provide open flyways.

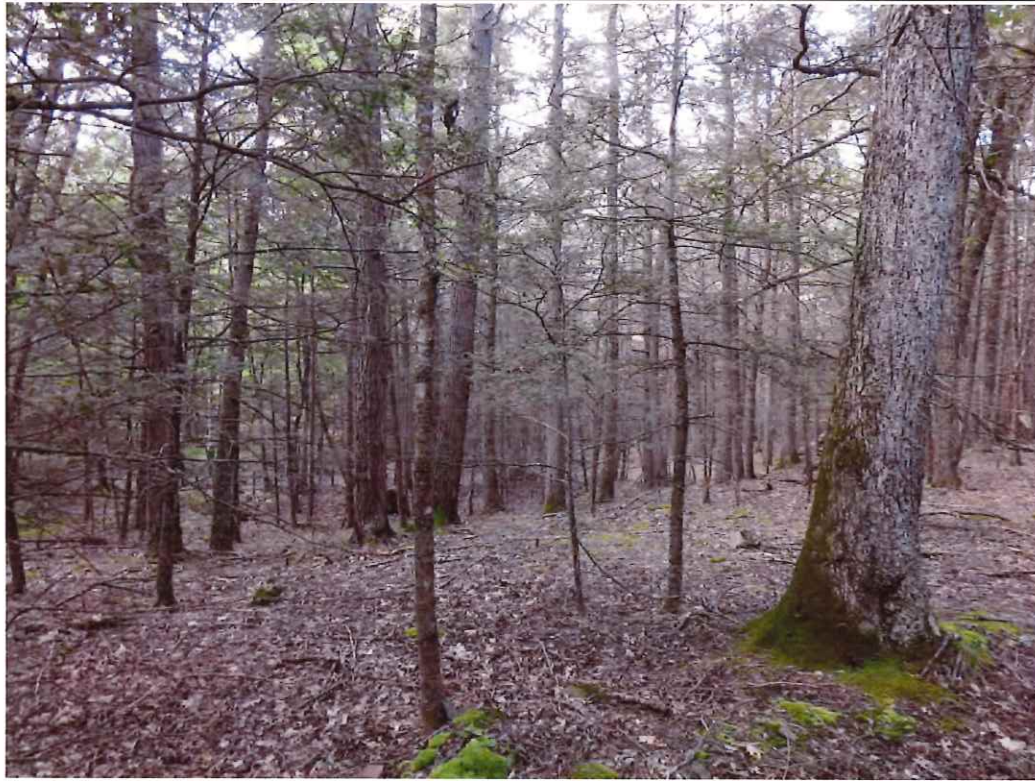
Photograph: 27 Mixed age Hemlock-Northern Hardwoods; understory is too dense for open flyways. Scattered larger trees are not accessible to bats from beneath the canopy.

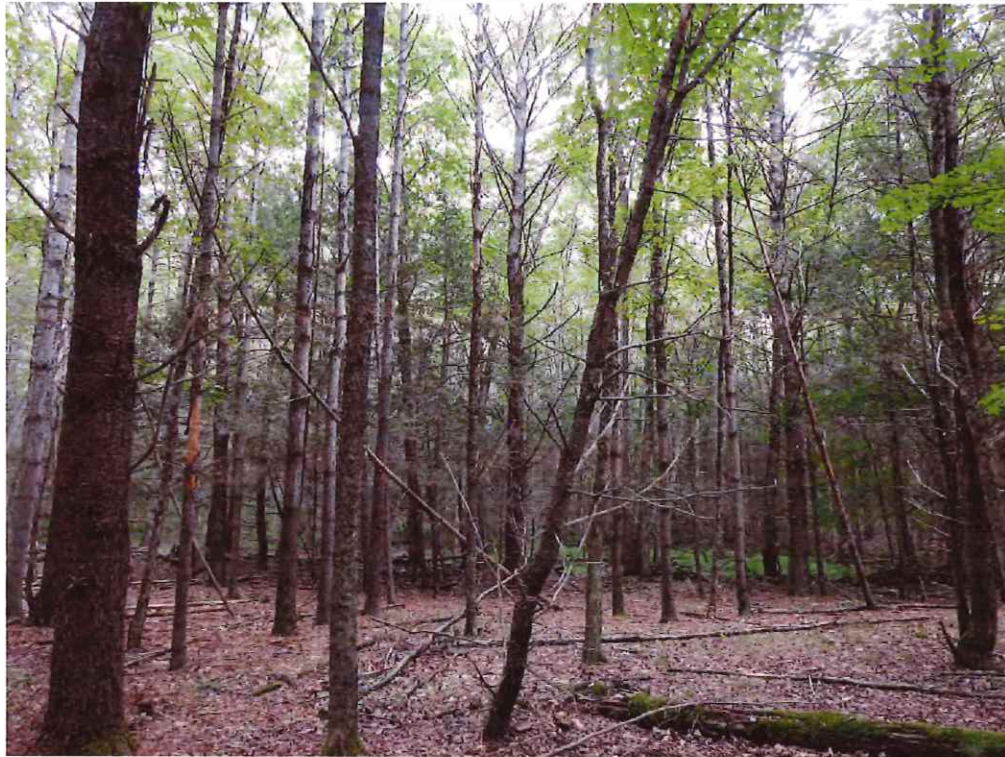
Photograph: 28 Very dense subcanopy of young Hemlock-Northern Hardwood forest; no open flyways or potential roost structure.

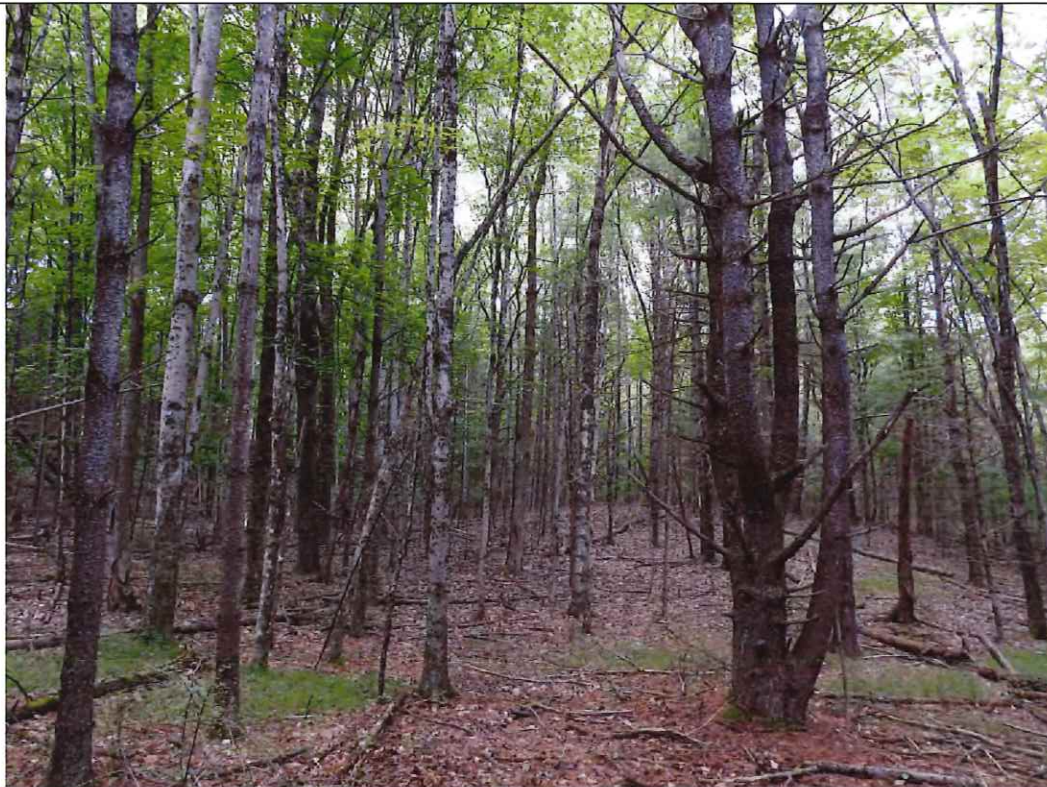
Photograph: 29 Young Hemlock-Northern Hardwood forest with dense understory; no flyways for bat transit or foraging and no snags for potential roosts.

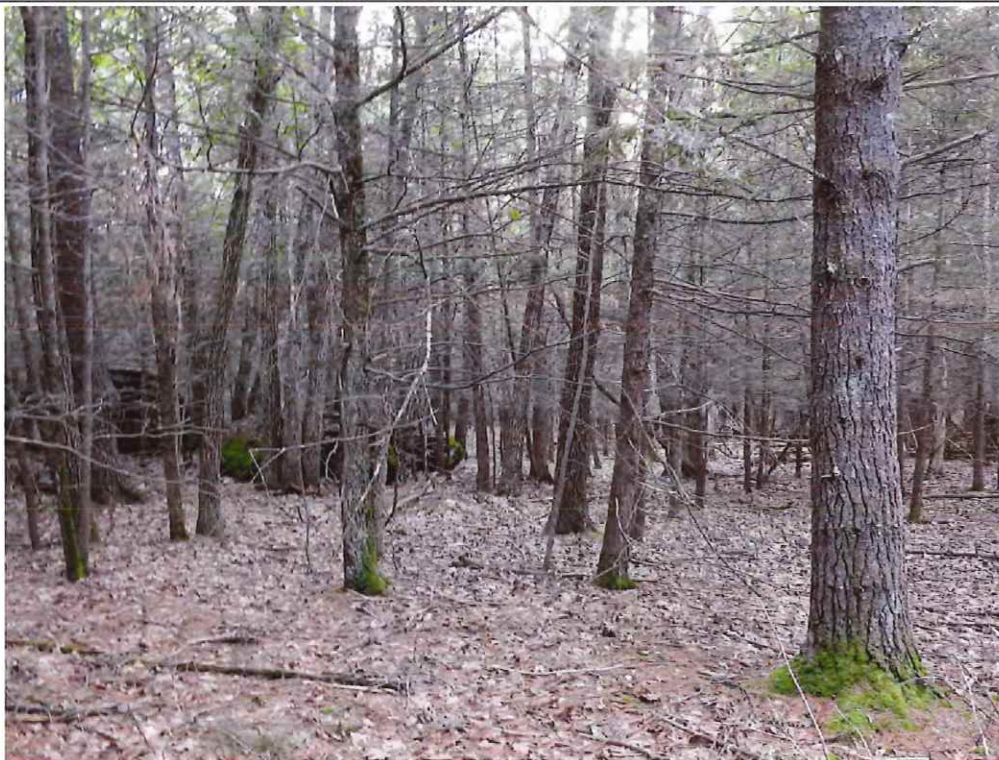
Photograph: 30 Young Hemlock-Northern Hardwood forest; too dense to provide sub-canopy flyways or access to potential roost trees, of which there are few.

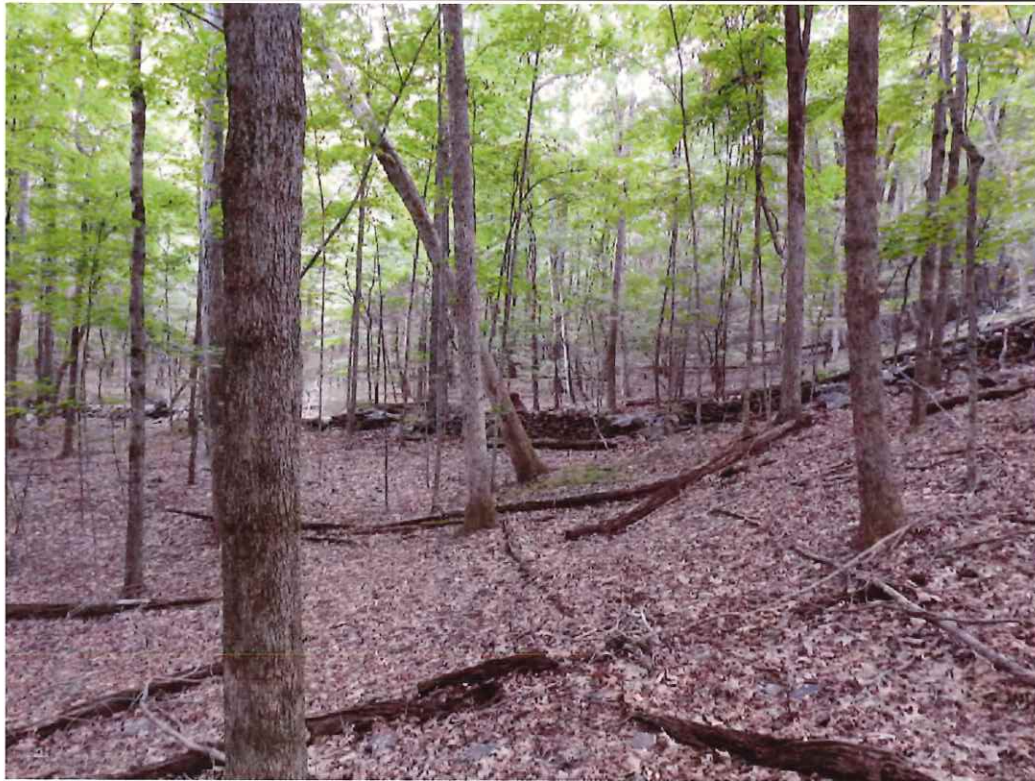
Photograph: 31 Mature Successional Northern Hardwoods in the northwestern corner of the Site with a wide-open understory for flyways, and mature trees and snags for potential roost trees.

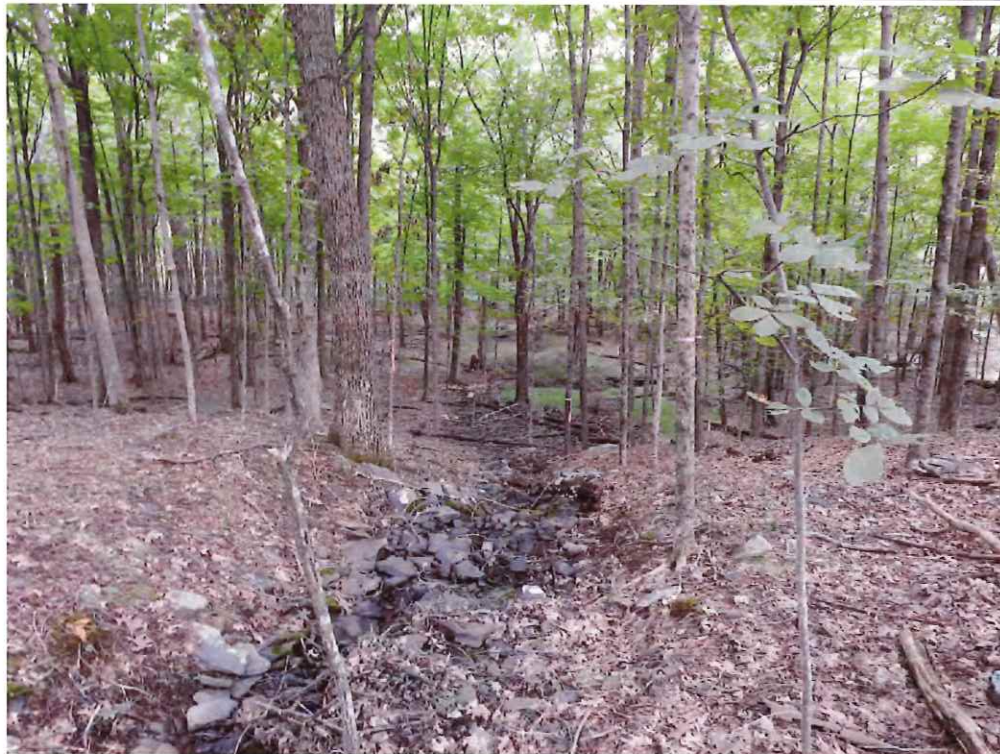
Photograph: 32 Mature Successional Northern Hardwood forest with intermittent drainage channel flowing downhill toward Red Maple-Hardwood Swamp. Open understory provides flyways, and mature trees and snags provide potential roosts.

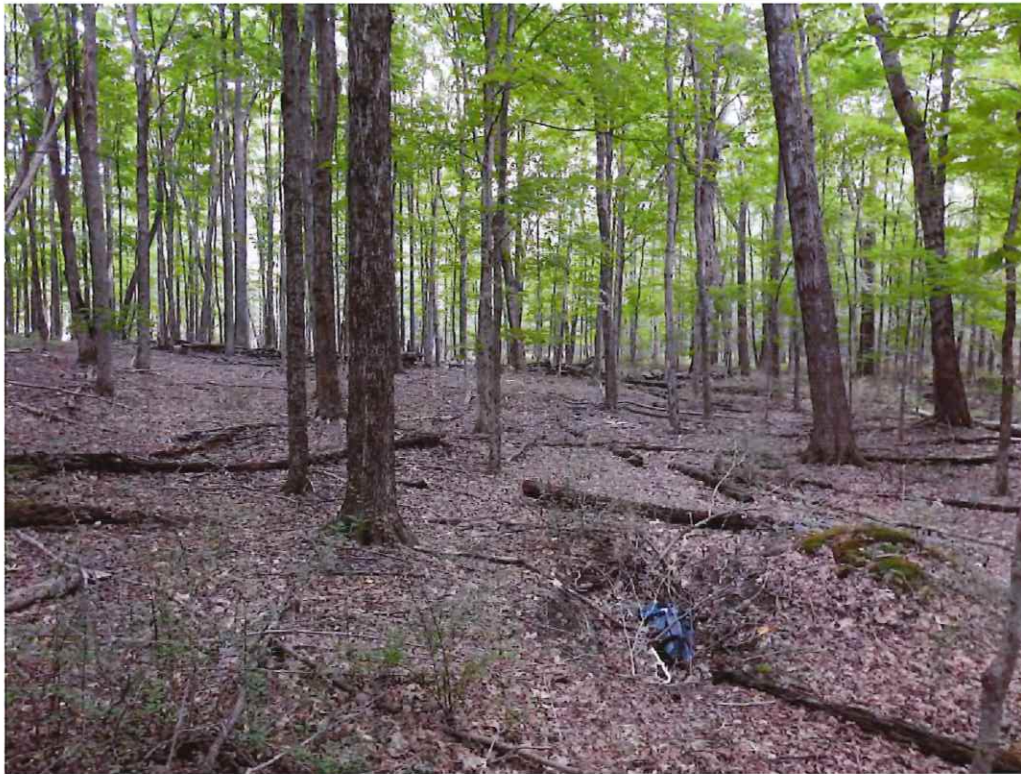
Photograph: 33 Open understory of mature Successional Northern Hardwoods provide open flyways for foraging and transit, and large trees and snags provide potential roost trees.

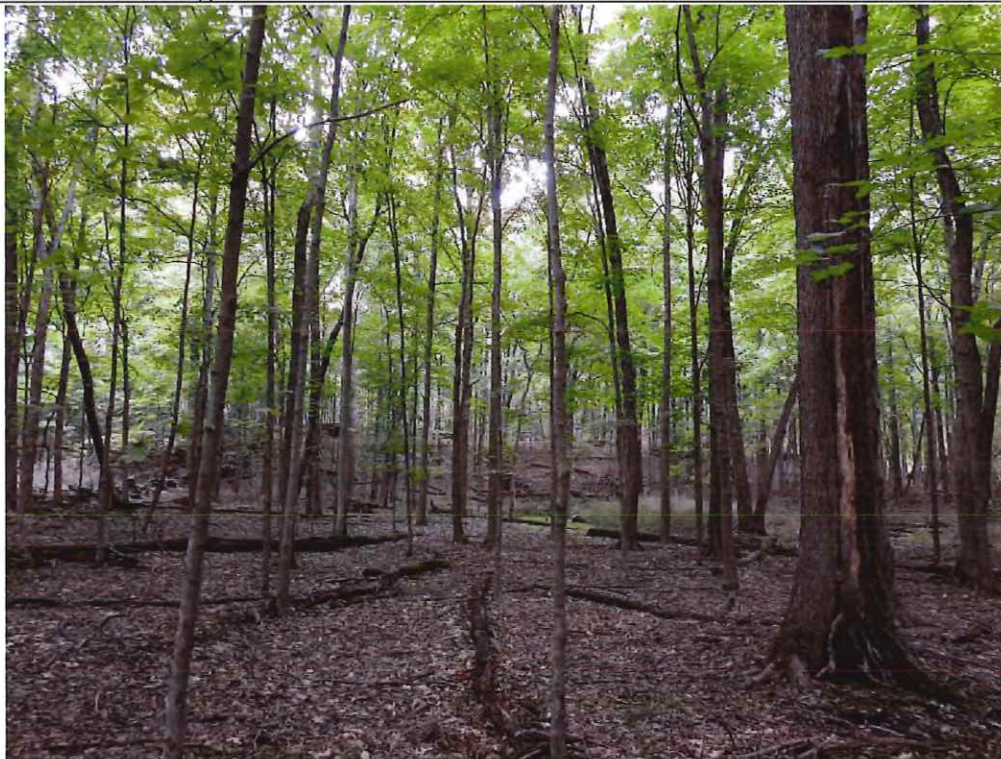
Photograph: 34 Younger Successional Northern Hardwoods provide an open understory for flyways, and scattered large trees and snags for potential roost trees.

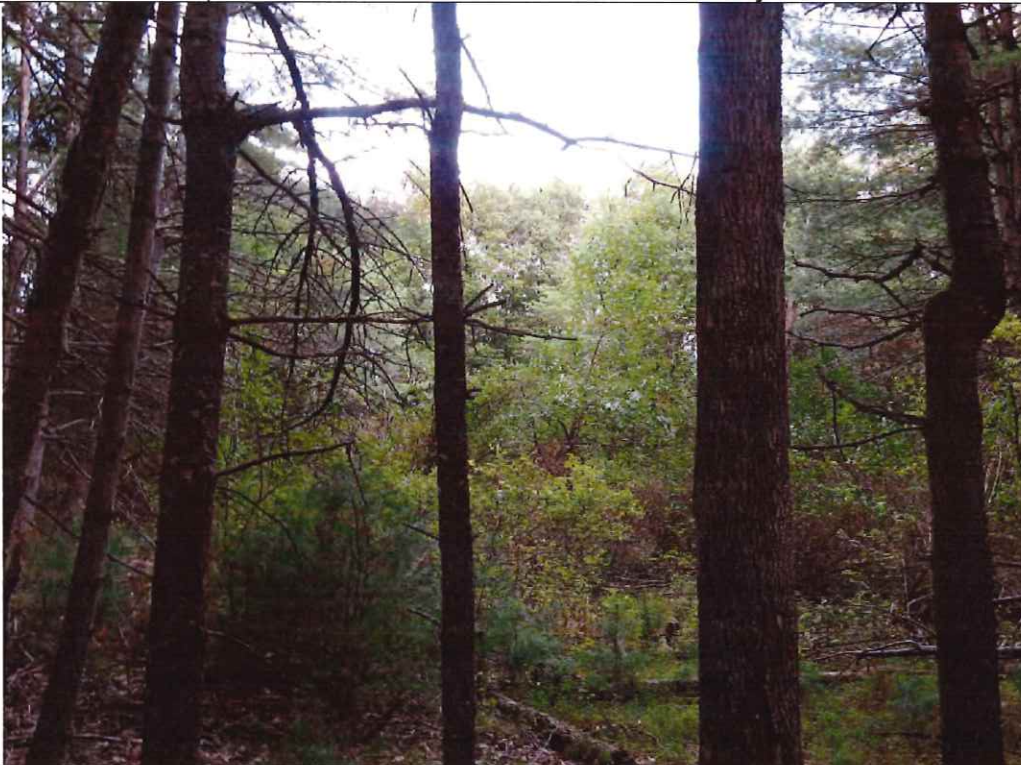
Photograph: 36 A small patch of open canopy Successional Northern Hardwoods in the northeast corner of the Site provides potential foraging area and access to potential roost trees at edges.

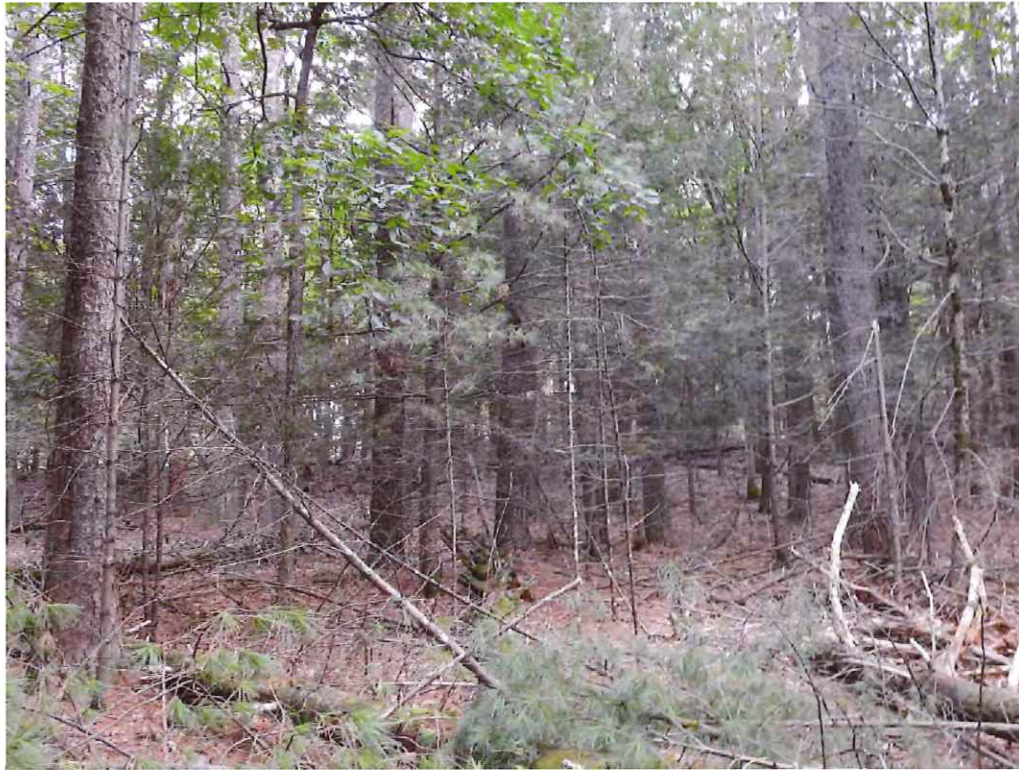
Photograph: 37 Young Hemlock-Northern Hardwood forest; no open flyways or roosts.

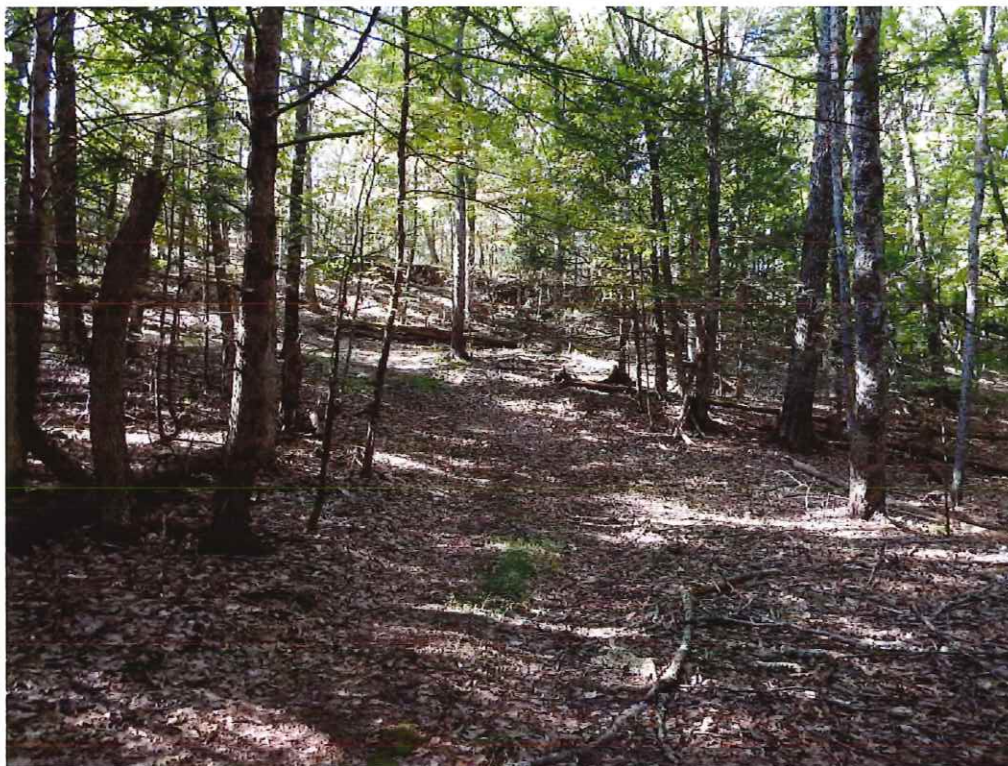
Photograph: 38 Narrow band of Successional Northern Hardwoods provides subcanopy flyways and potential roost trees.

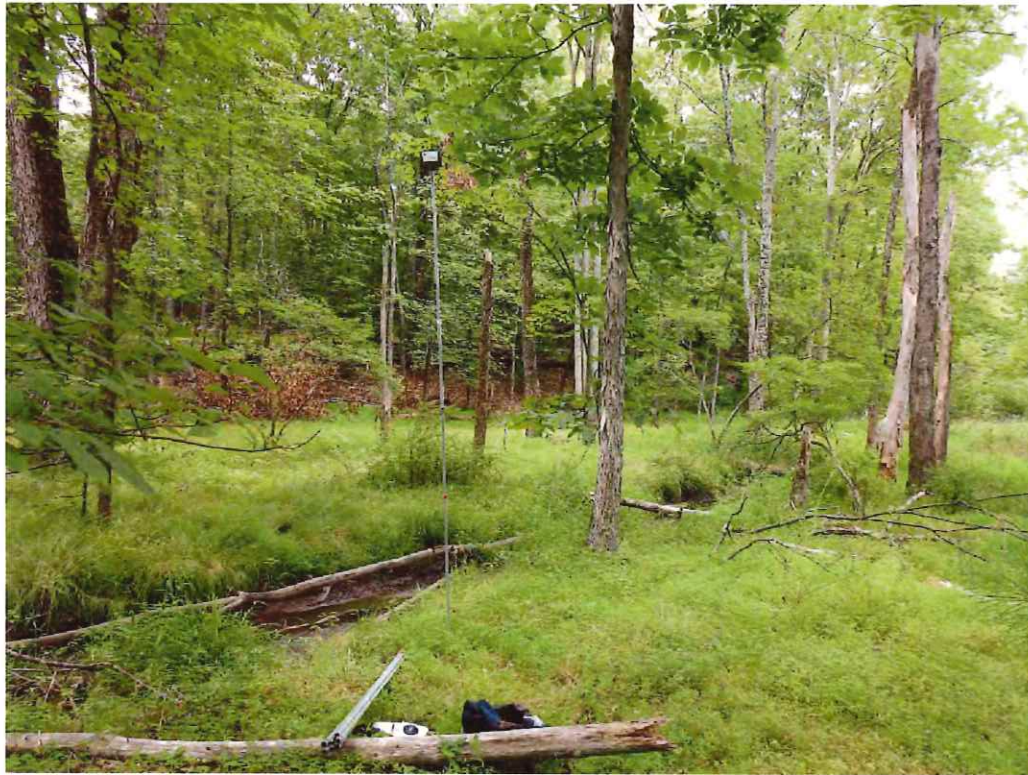
Photograph: 1 Bat Detector 1 Deployment in Red Maple Hardwood Swamp along a narrow stream.

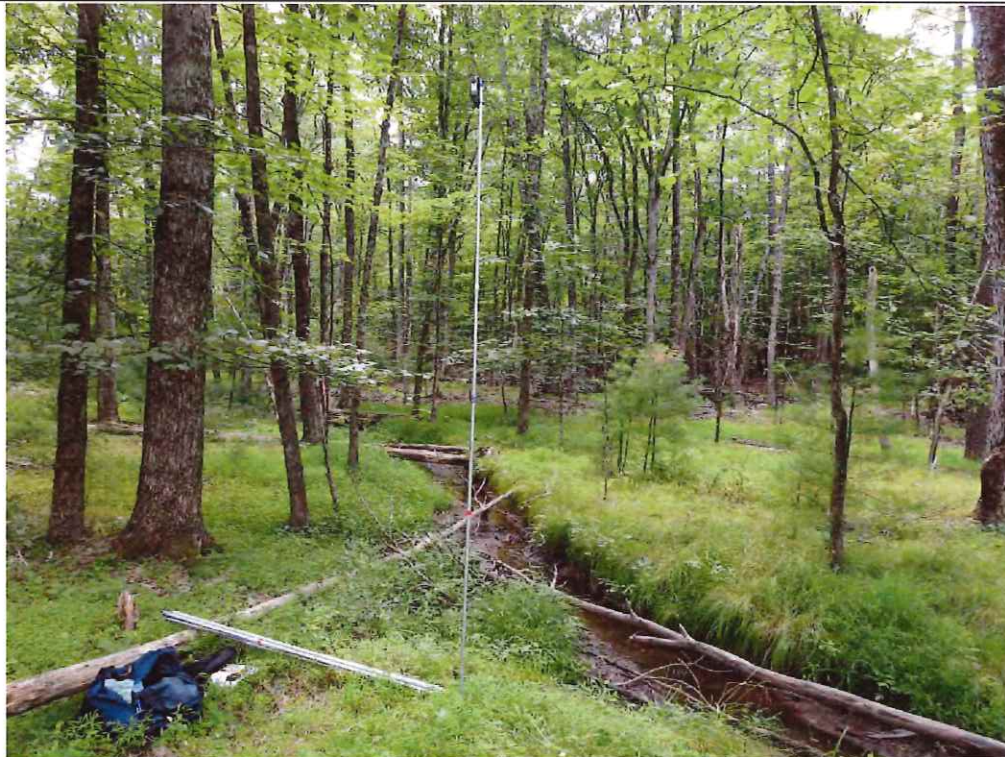
Photograph: 2 Bat Detector 1 Reception Cone

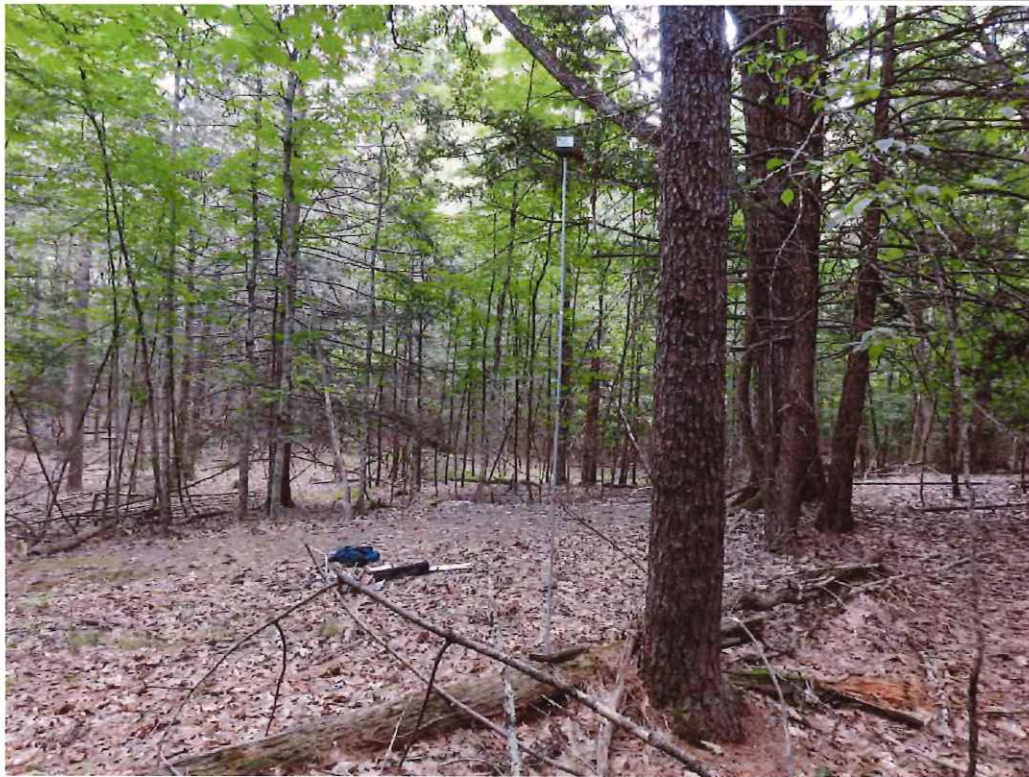
Photograph: 5

Bat Detector 2 Deployment along a logging road at the edge between mature Successional Northern Hardwoods and Hemlock Hardwood forests.

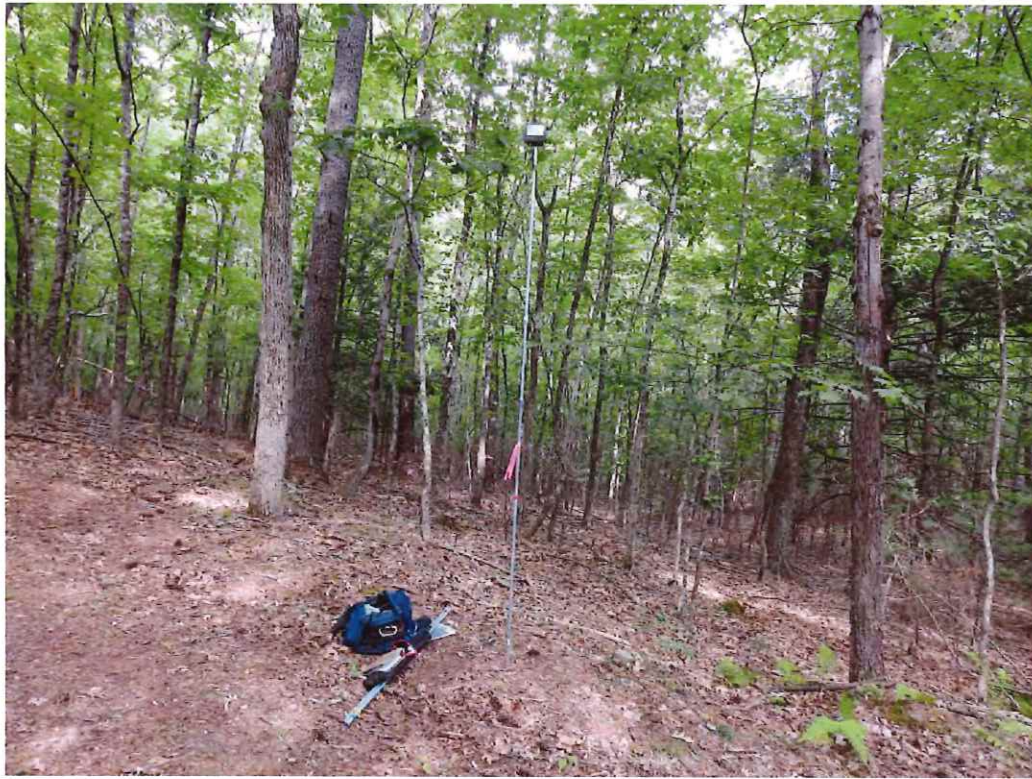
Photograph: 9 Bat Detector 3 Deployment along side of logging road through dense Hemlock Northern Hardwood Forest.

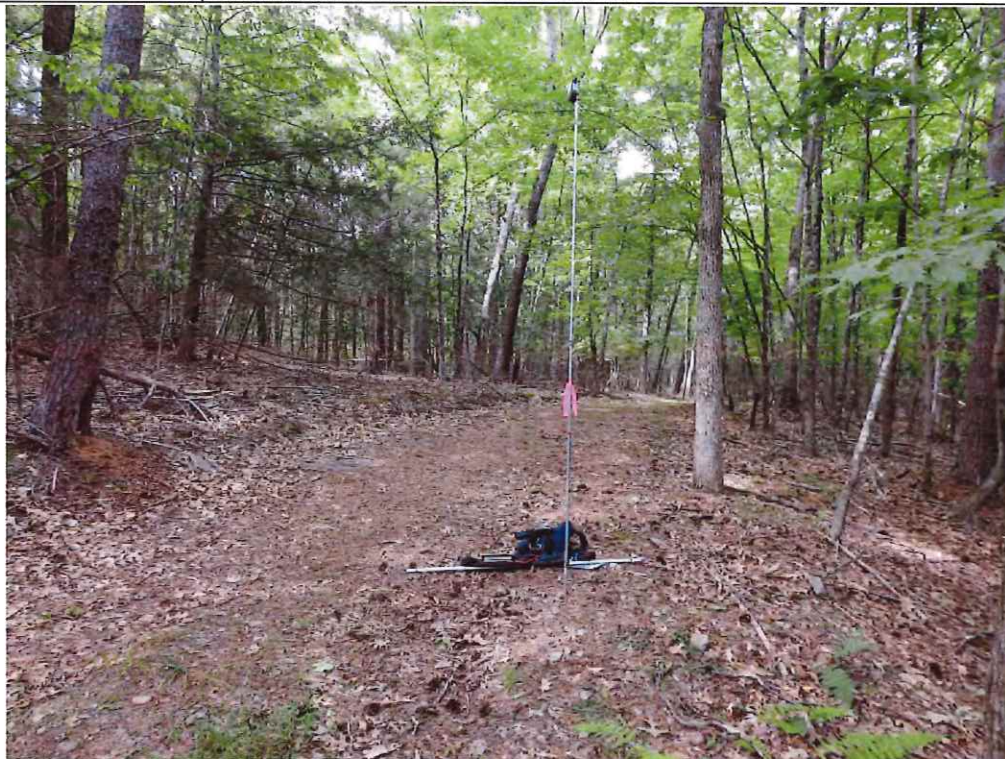
Photograph: 10 Bat Detector 3 Reception Cone

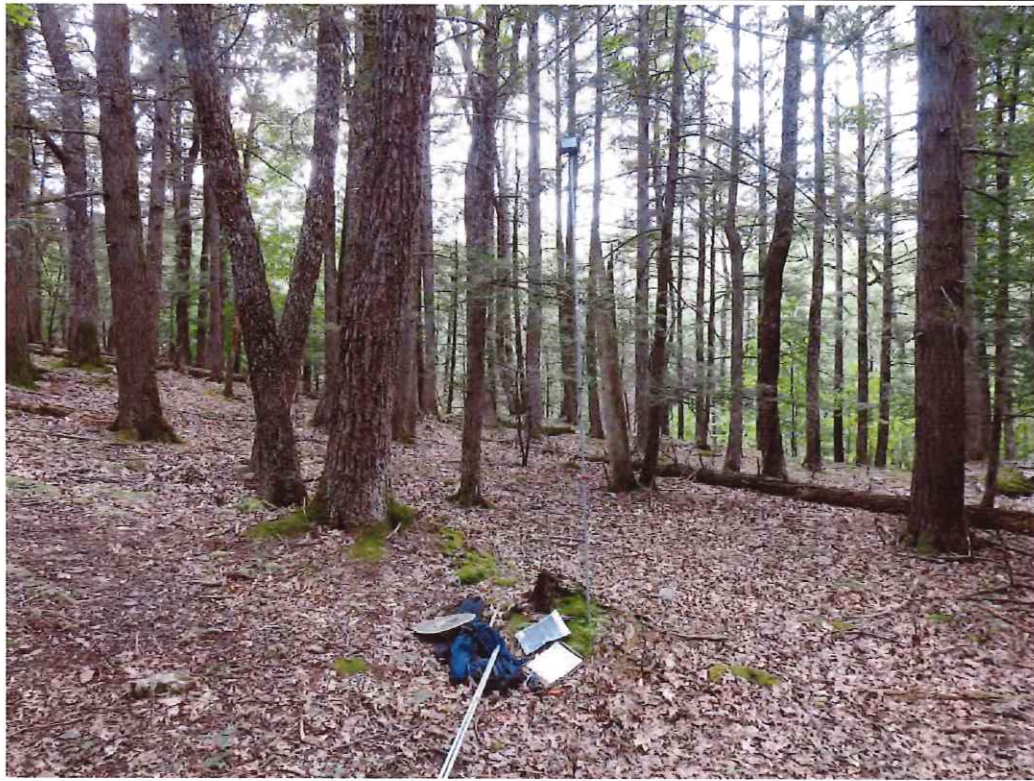
Photograph: 13 Bat Detector 4 Deployment along logging road through Hemlock-Hardwood Forest.

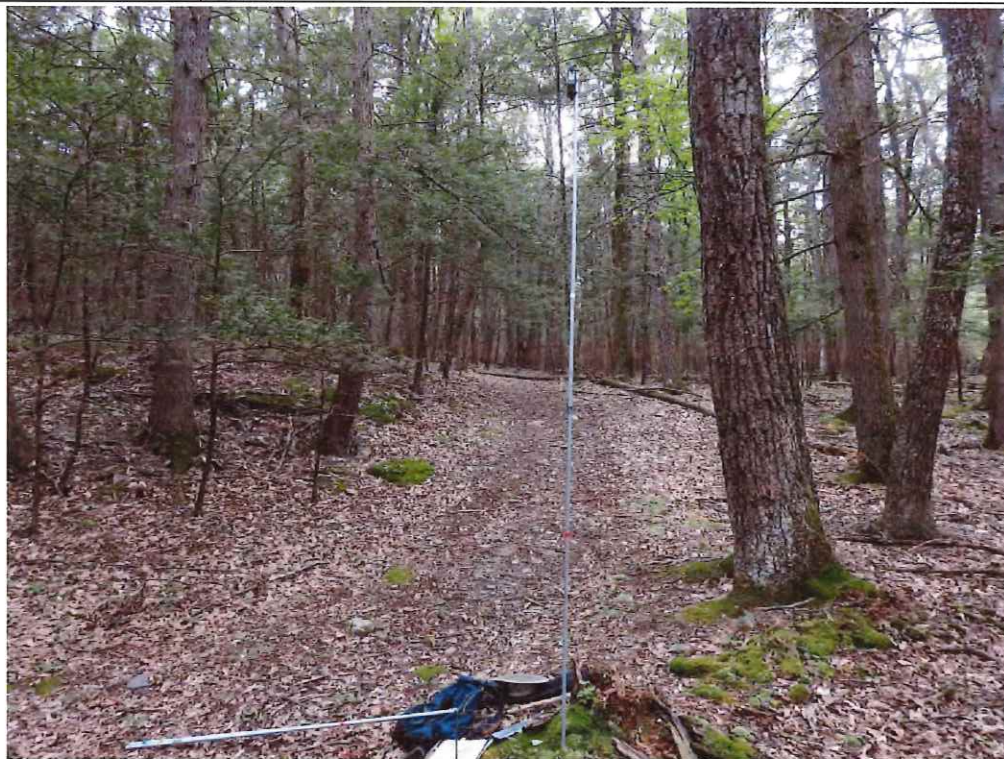
Photograph: 14 Bat Detector 4 Reception Cone
