Terramor Outdoor Luxury Campground

Expanded EAF Narrative

Town of Saugerties, New York

December 6, 2022

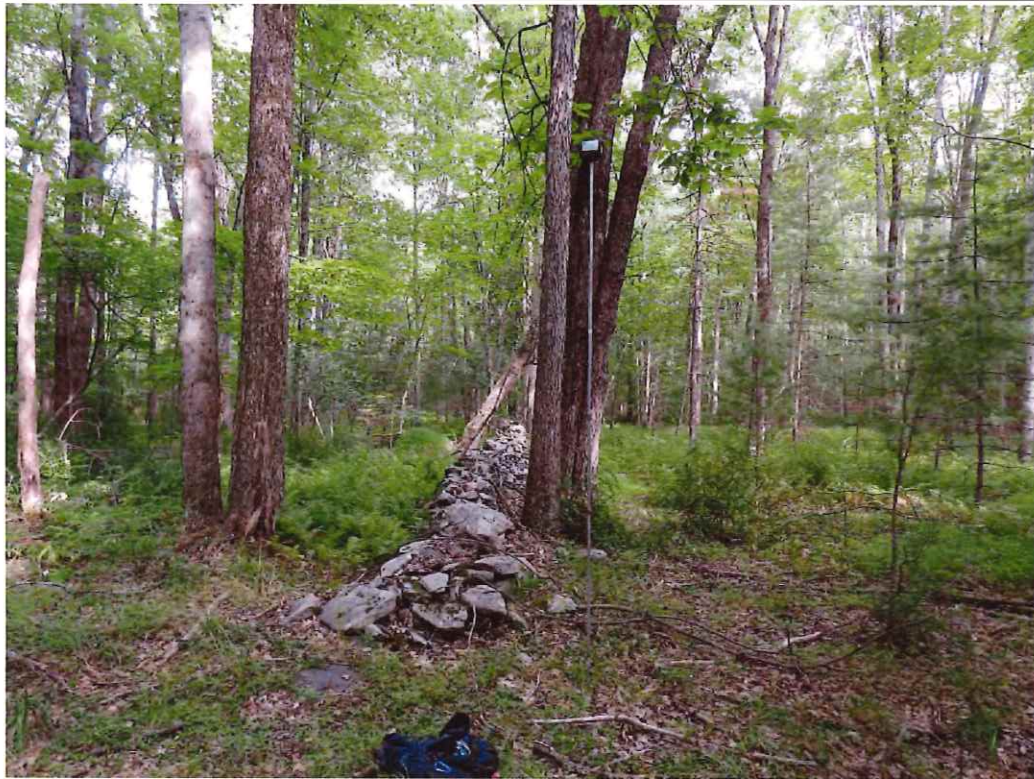
Photograph: 17 Bat Detector 5 Deployment in open understory of Red Maple-Hardwood Swamp near edge of mature Successional Northern Hardwood forest.

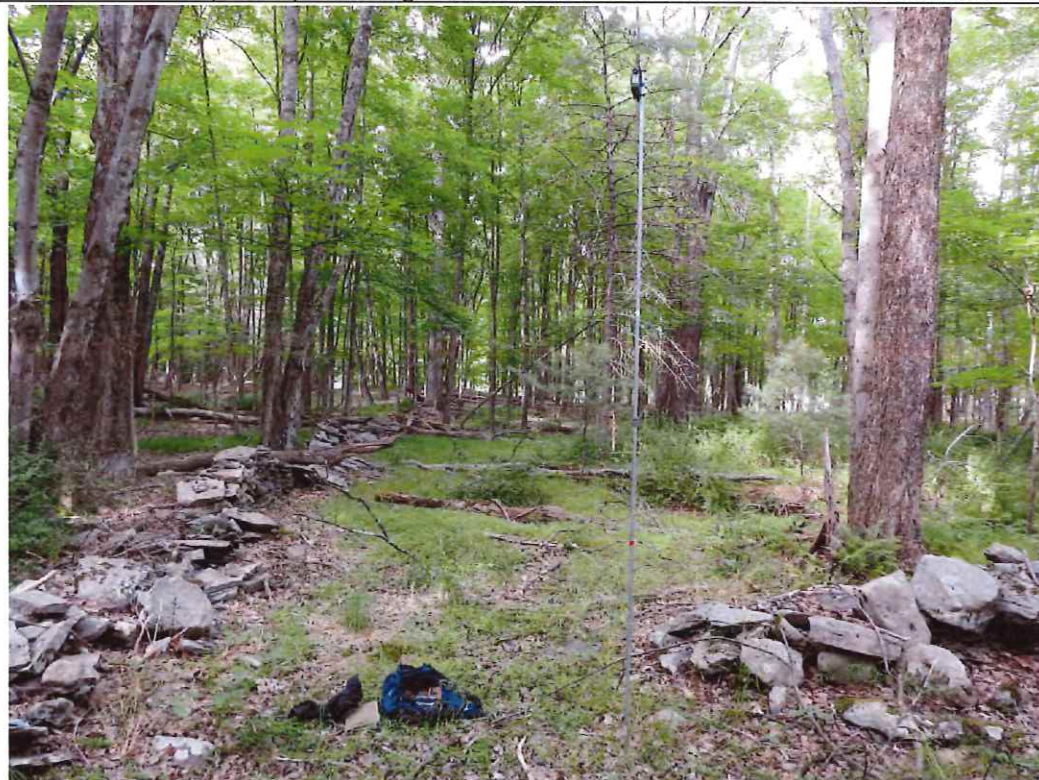
Photograph: 18 Bat Detector 5 Reception Cone

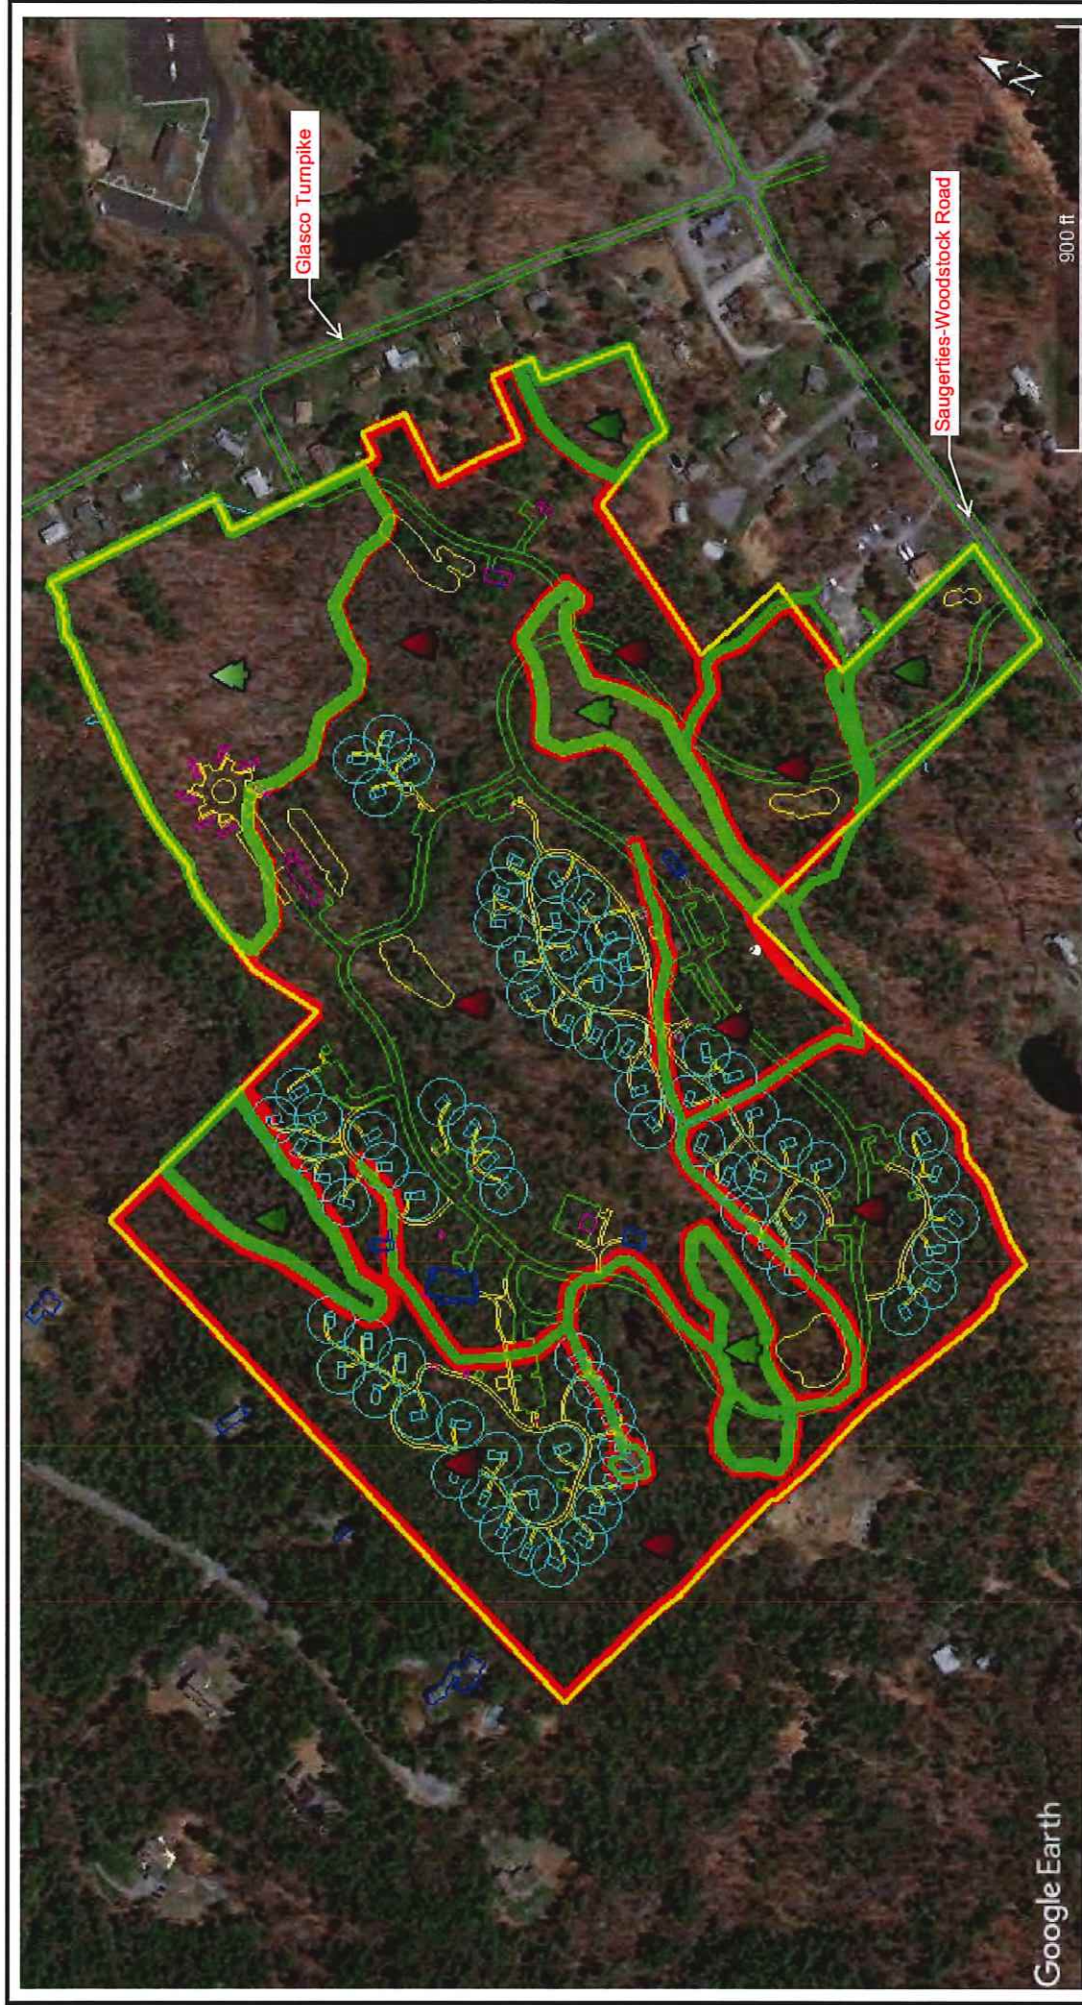
Bat Habitat Map with Proposed Site Plan Overlay

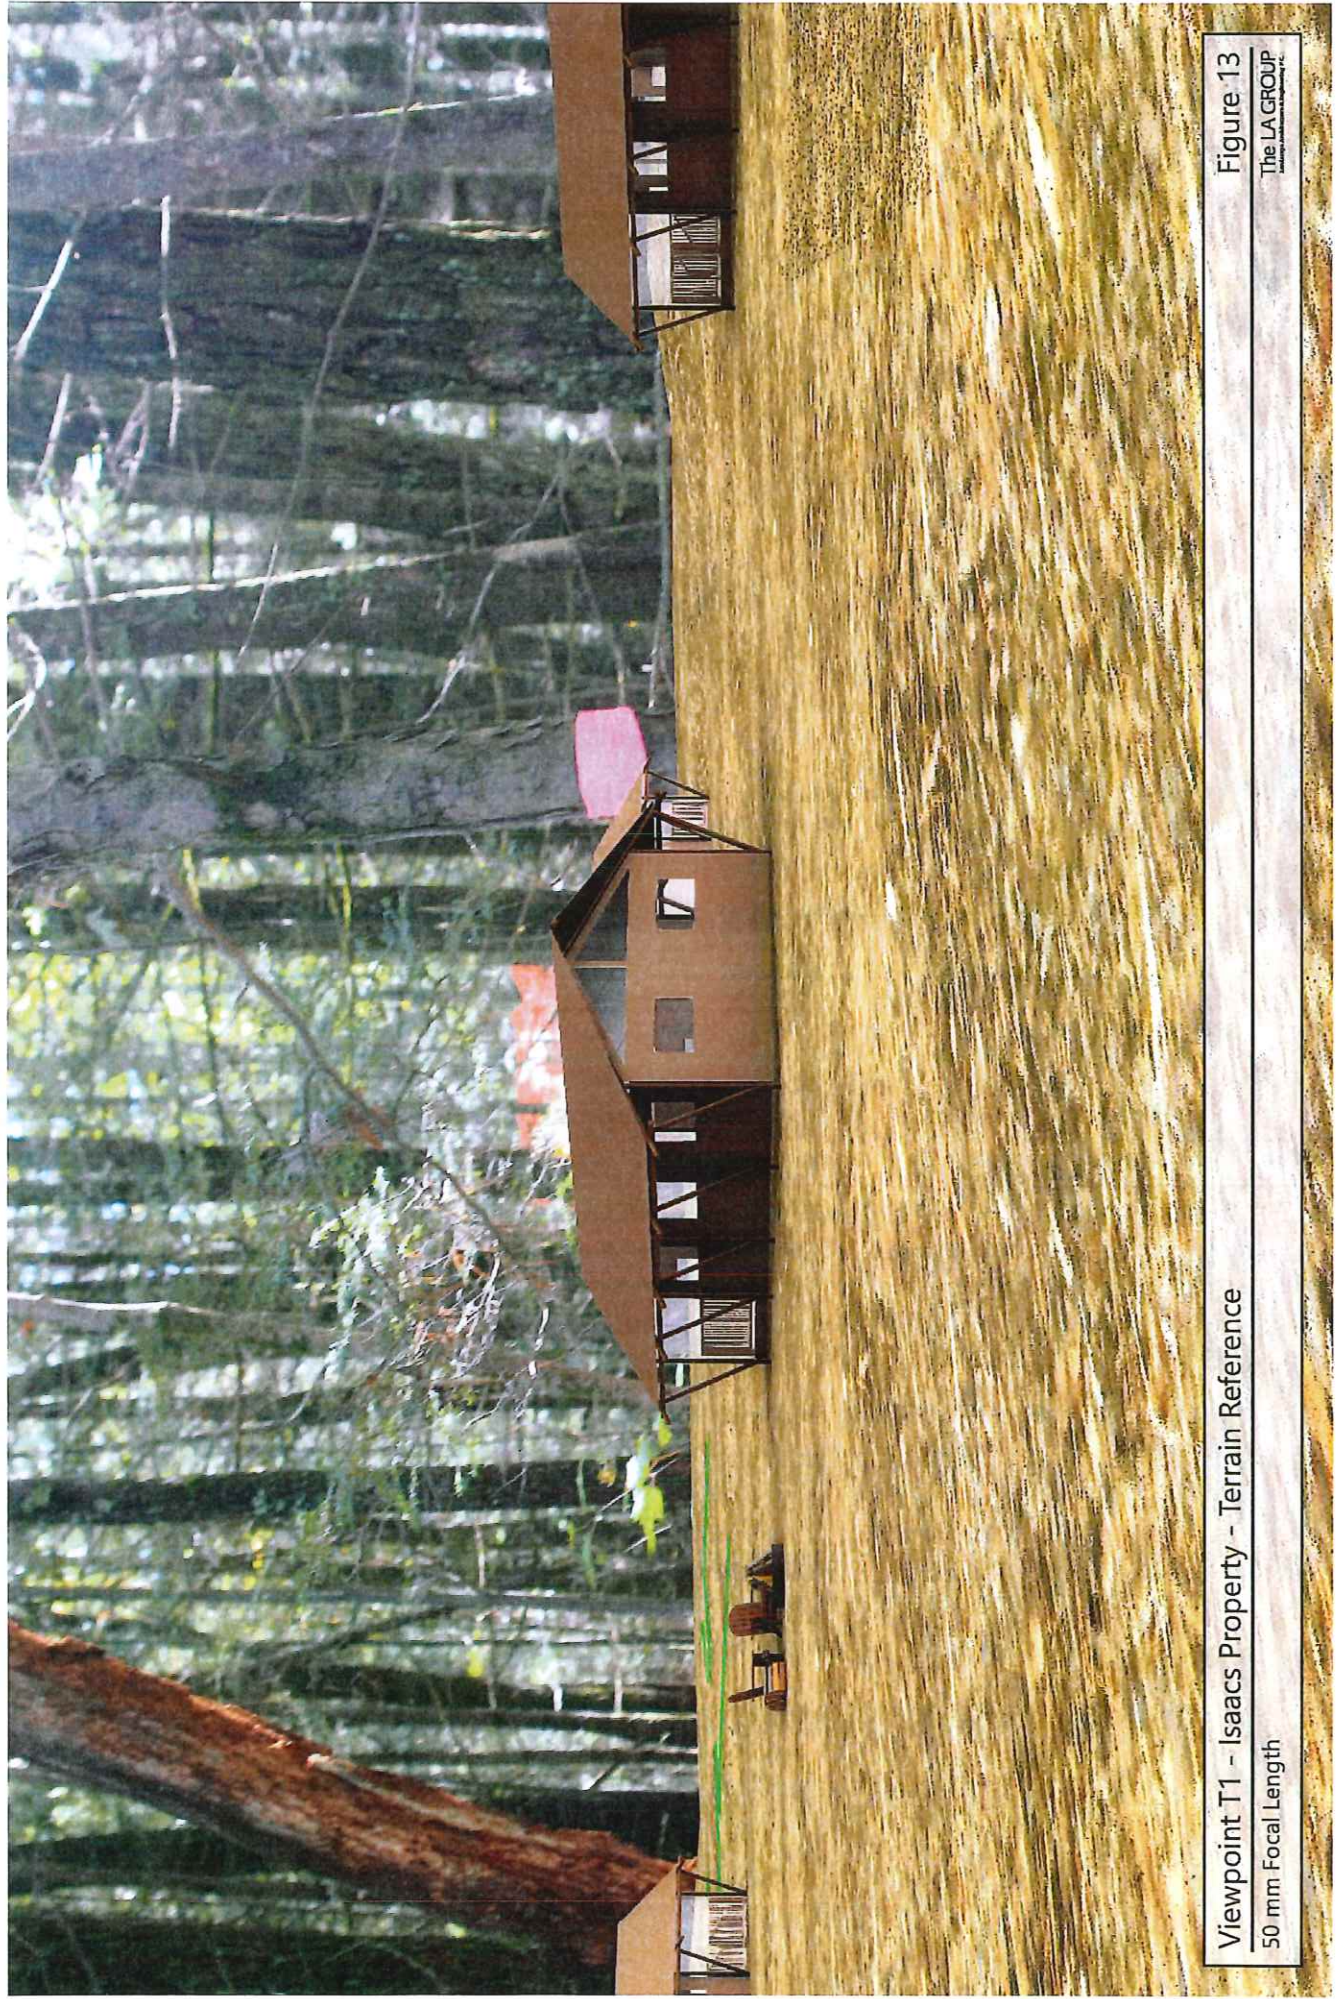
Figure 13

Viewpoint T1 - Isaacs Property - Terrain Reference

50 mm Focal Length

A 3-dimensional model of the study area was built by bringing the site plan, 3D models of the proposed tents, and the same DEM used to produce the Zone of Potential Visibility – No Tree Cover Map (See **Figure 5**) into the modeling program Rhino 3D. The DEM was used to create a 3D terrain surface. The 3D tents were then placed onto the terrain surface in the appropriate locations. Proposed project features from the site plan (buildings, roads, clearing limits, proposed plantings, and other miscellaneous features (campfires, light poles, signage, etc.)) were then projected onto the terrain surface to sit at the correct X, Y, Z positions in space.

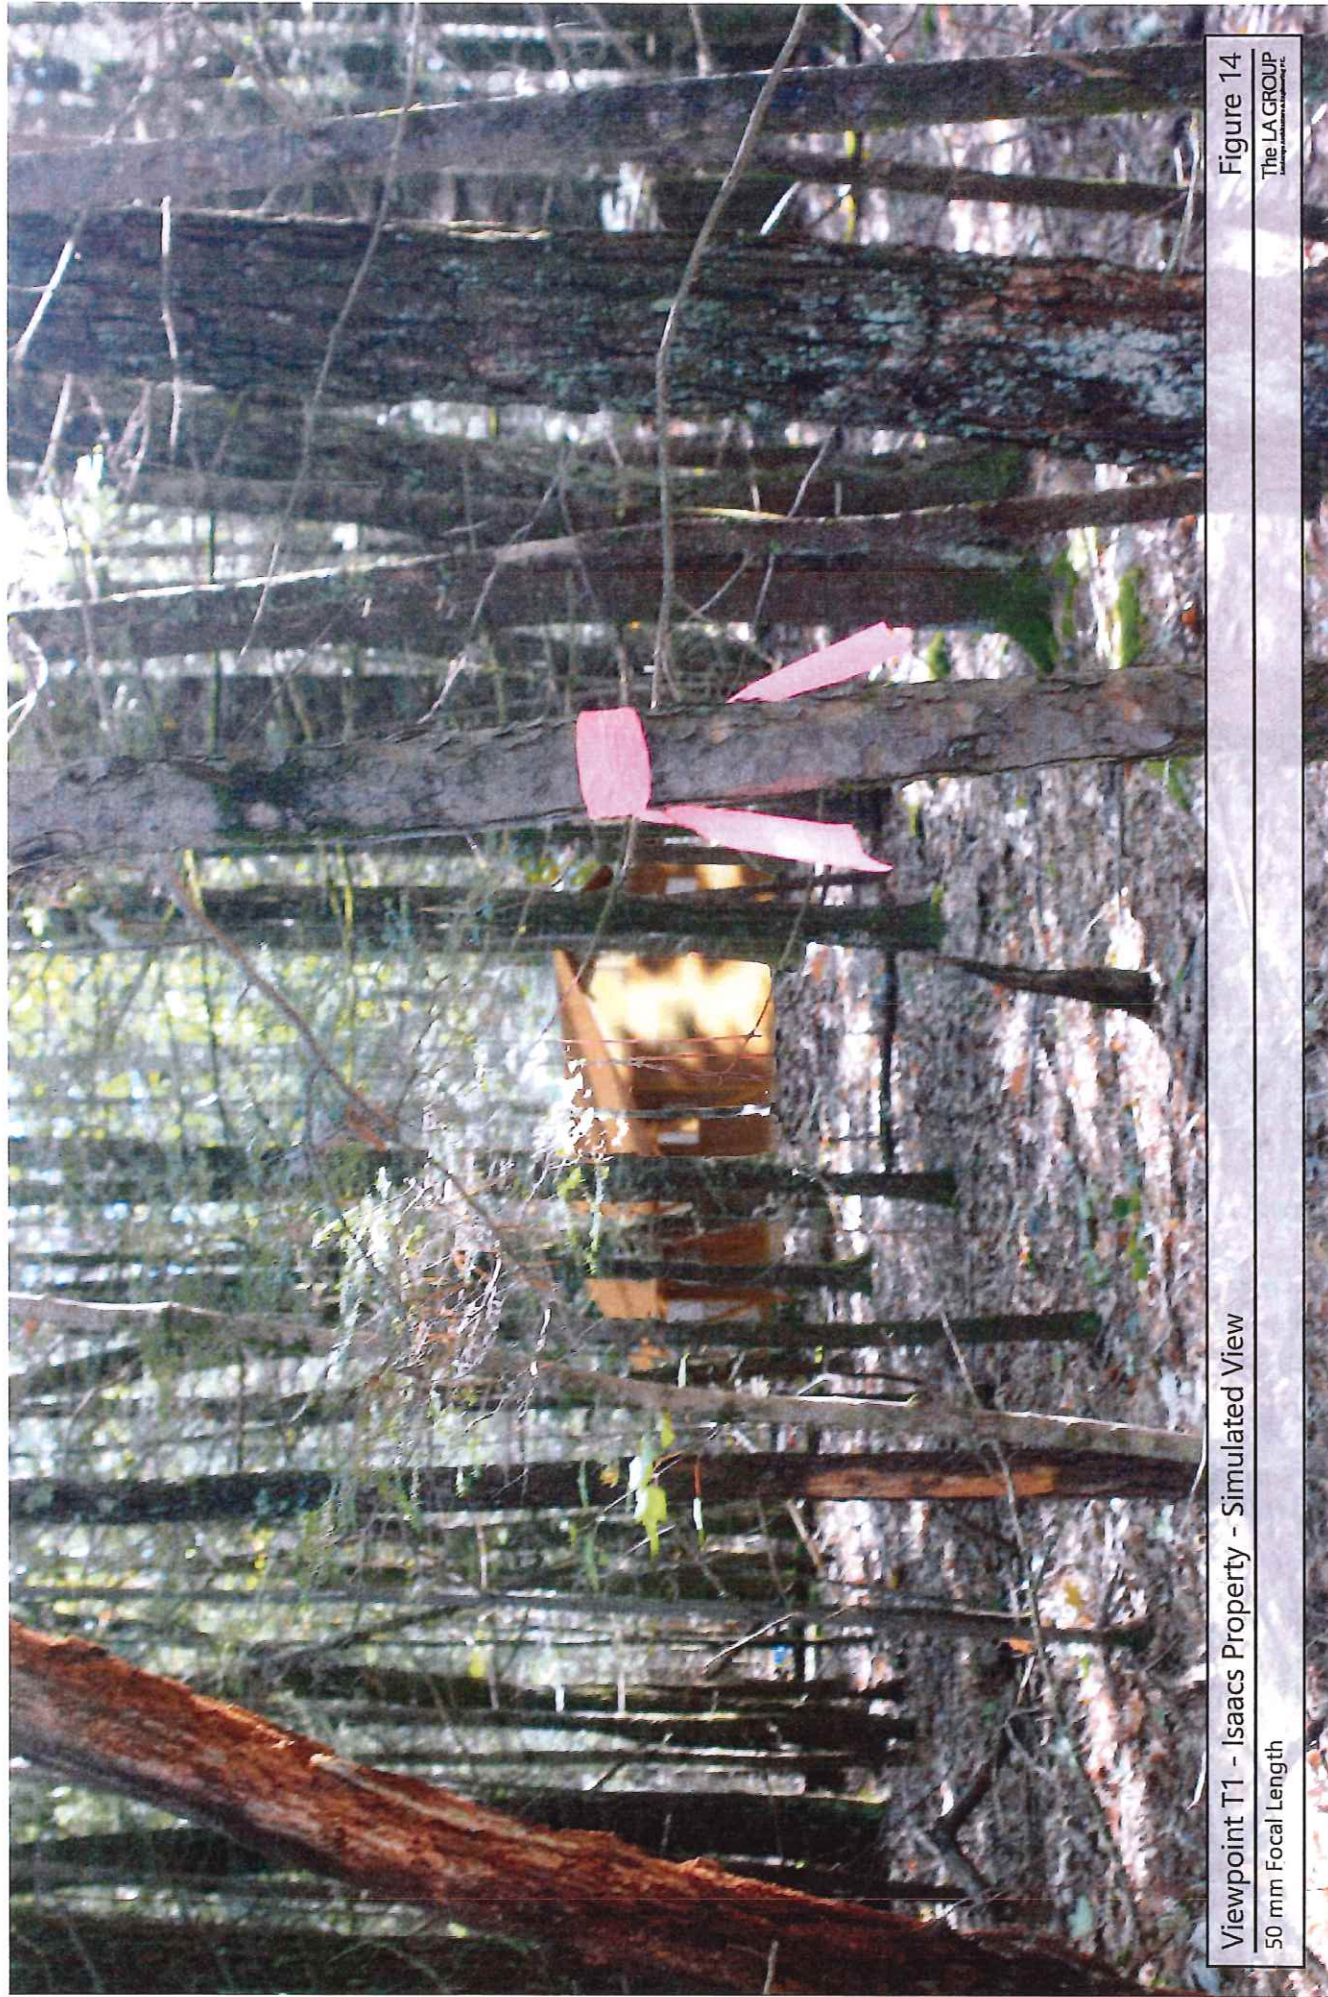
Figure 14

Viewpoint T1 - Isaacs Property - Simulated View
50 mm Focal Length

The Visual Impact Assessment explicitly investigates the potential impact of the Project on all sensitive receptors (including scenic, aesthetic, historic, recreational, residences and natural resources) identified as having potential views into the Project Site. Visual Impact Assessment demonstrates that the Project will not cause a significant undue adverse visual impact.

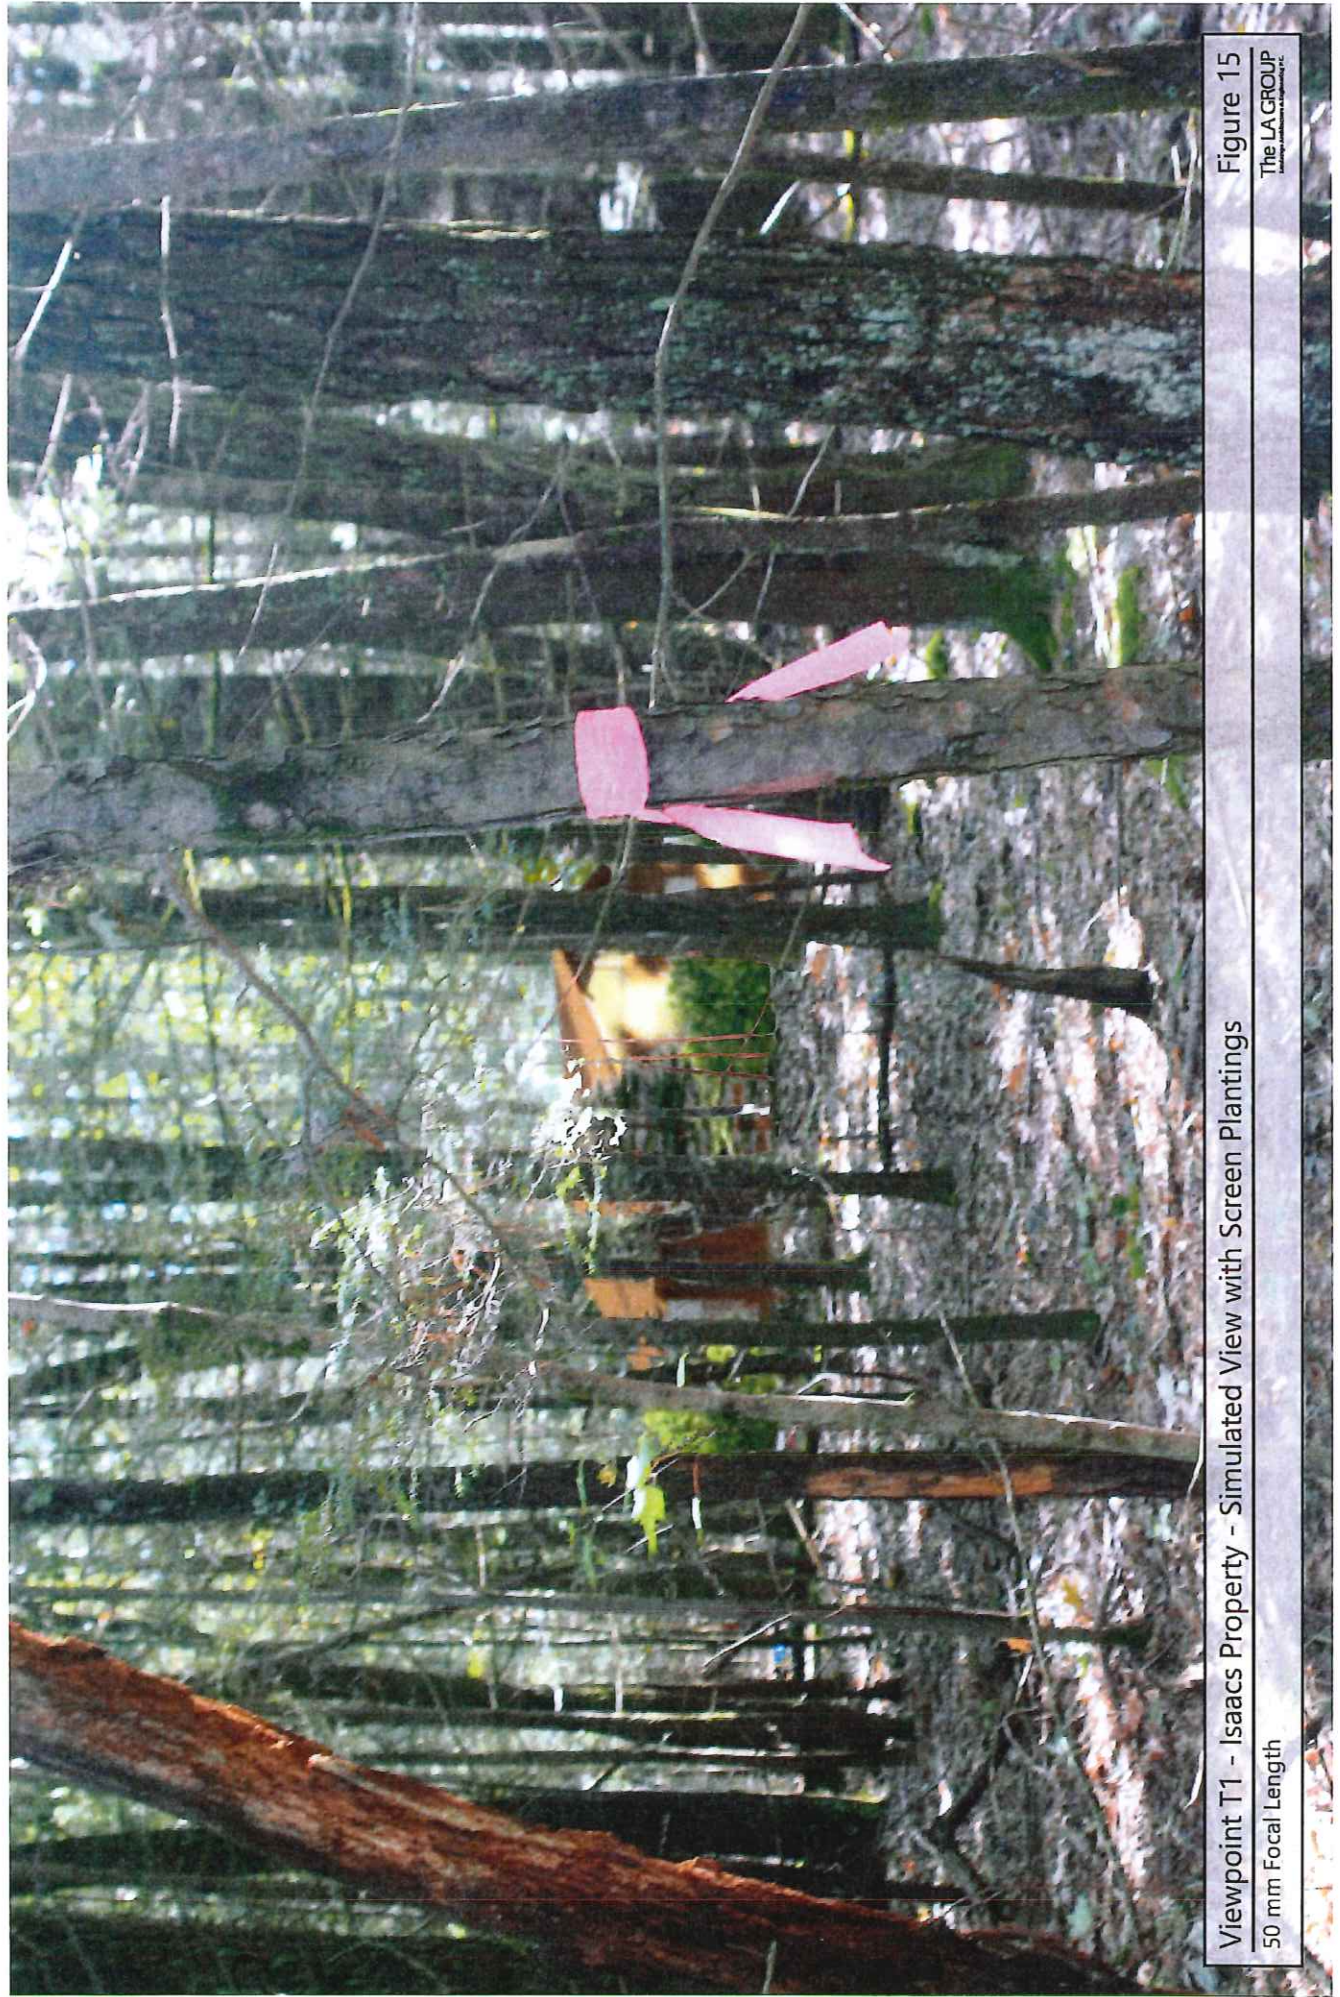
Figure 15

Viewpoint T1 - Isaacs Property - Simulated View with Screen Plantings

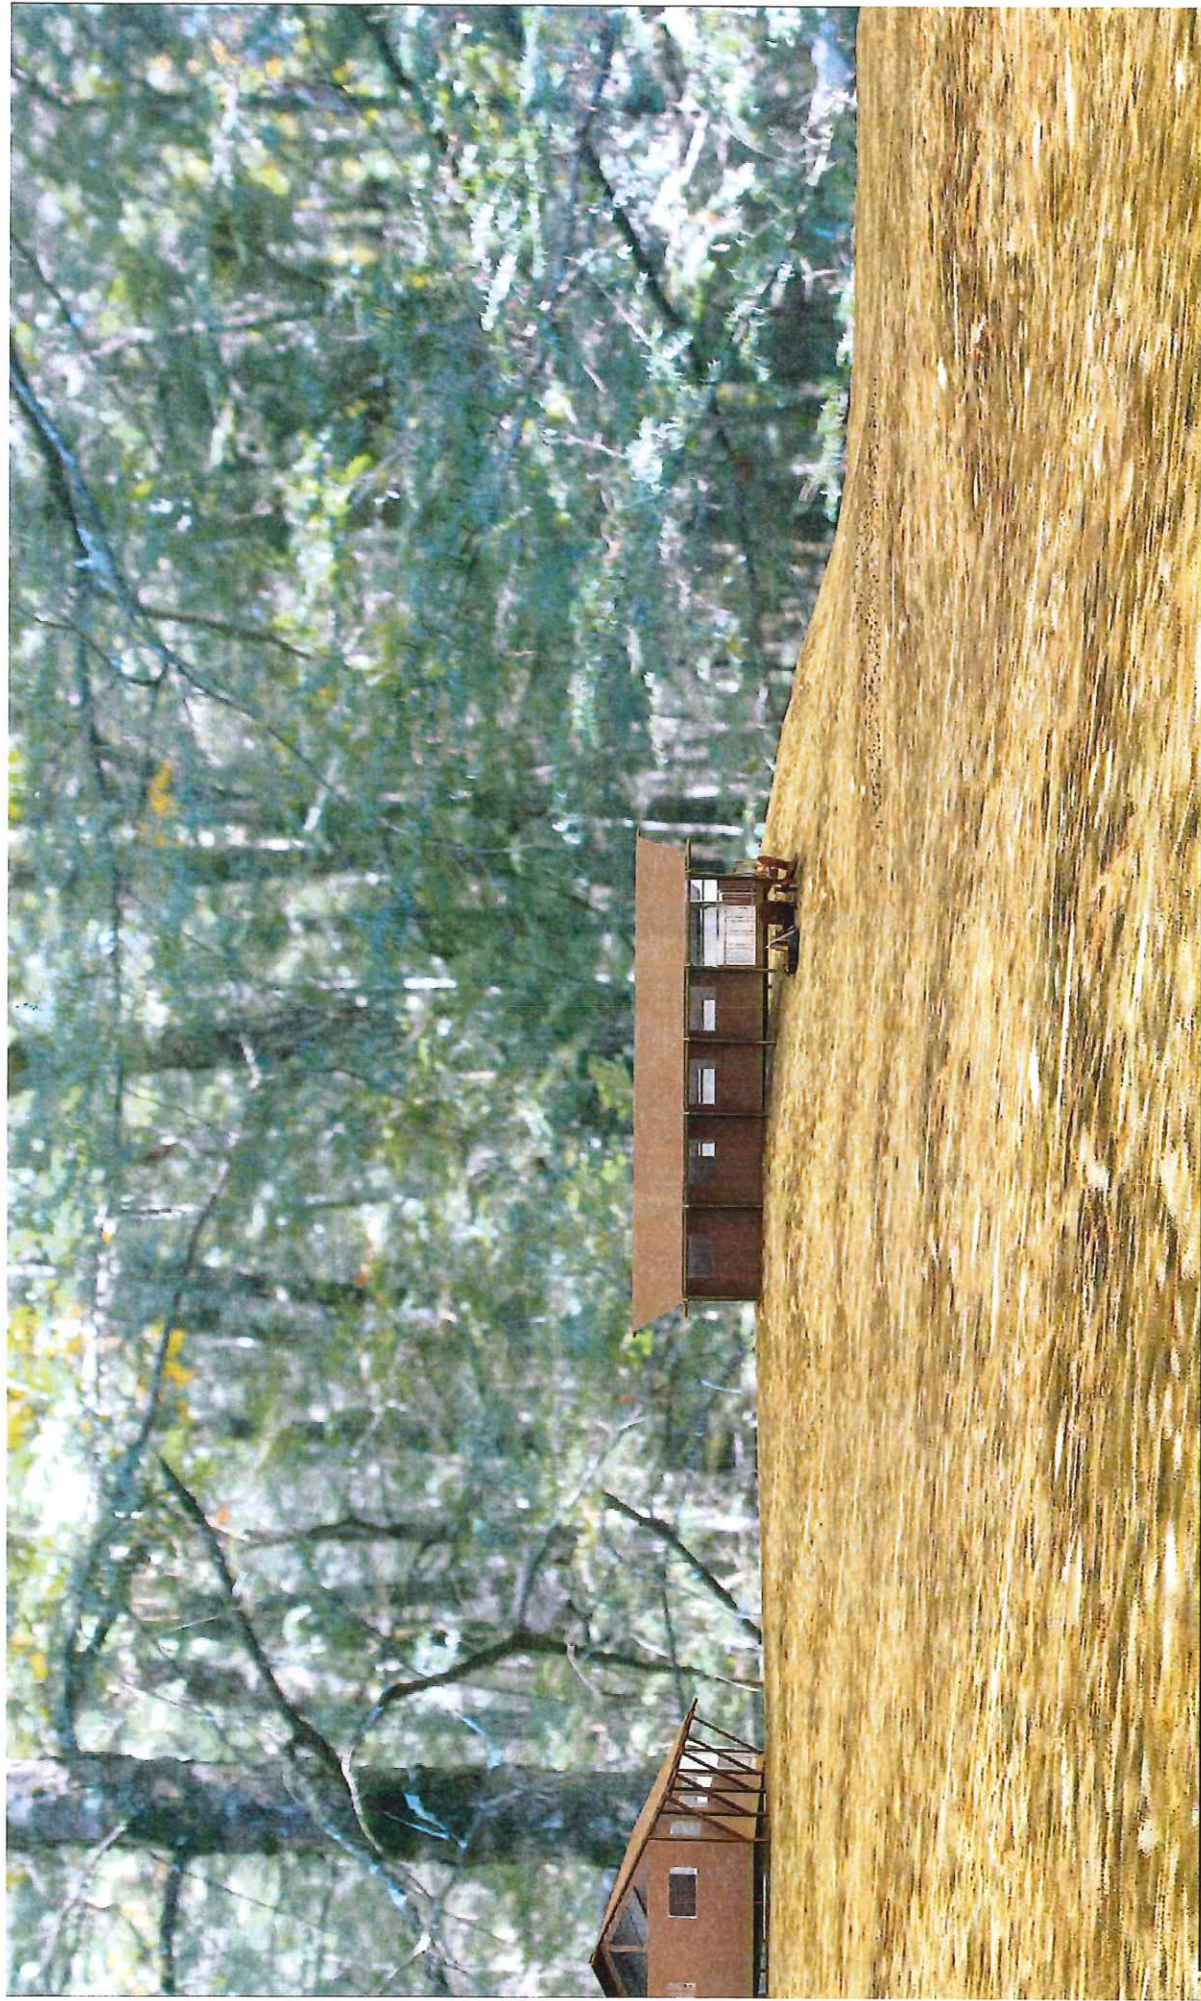
Figure 17

Viewpoint T2 - Buck Property - Terrain Reference

50 mm Focal Length

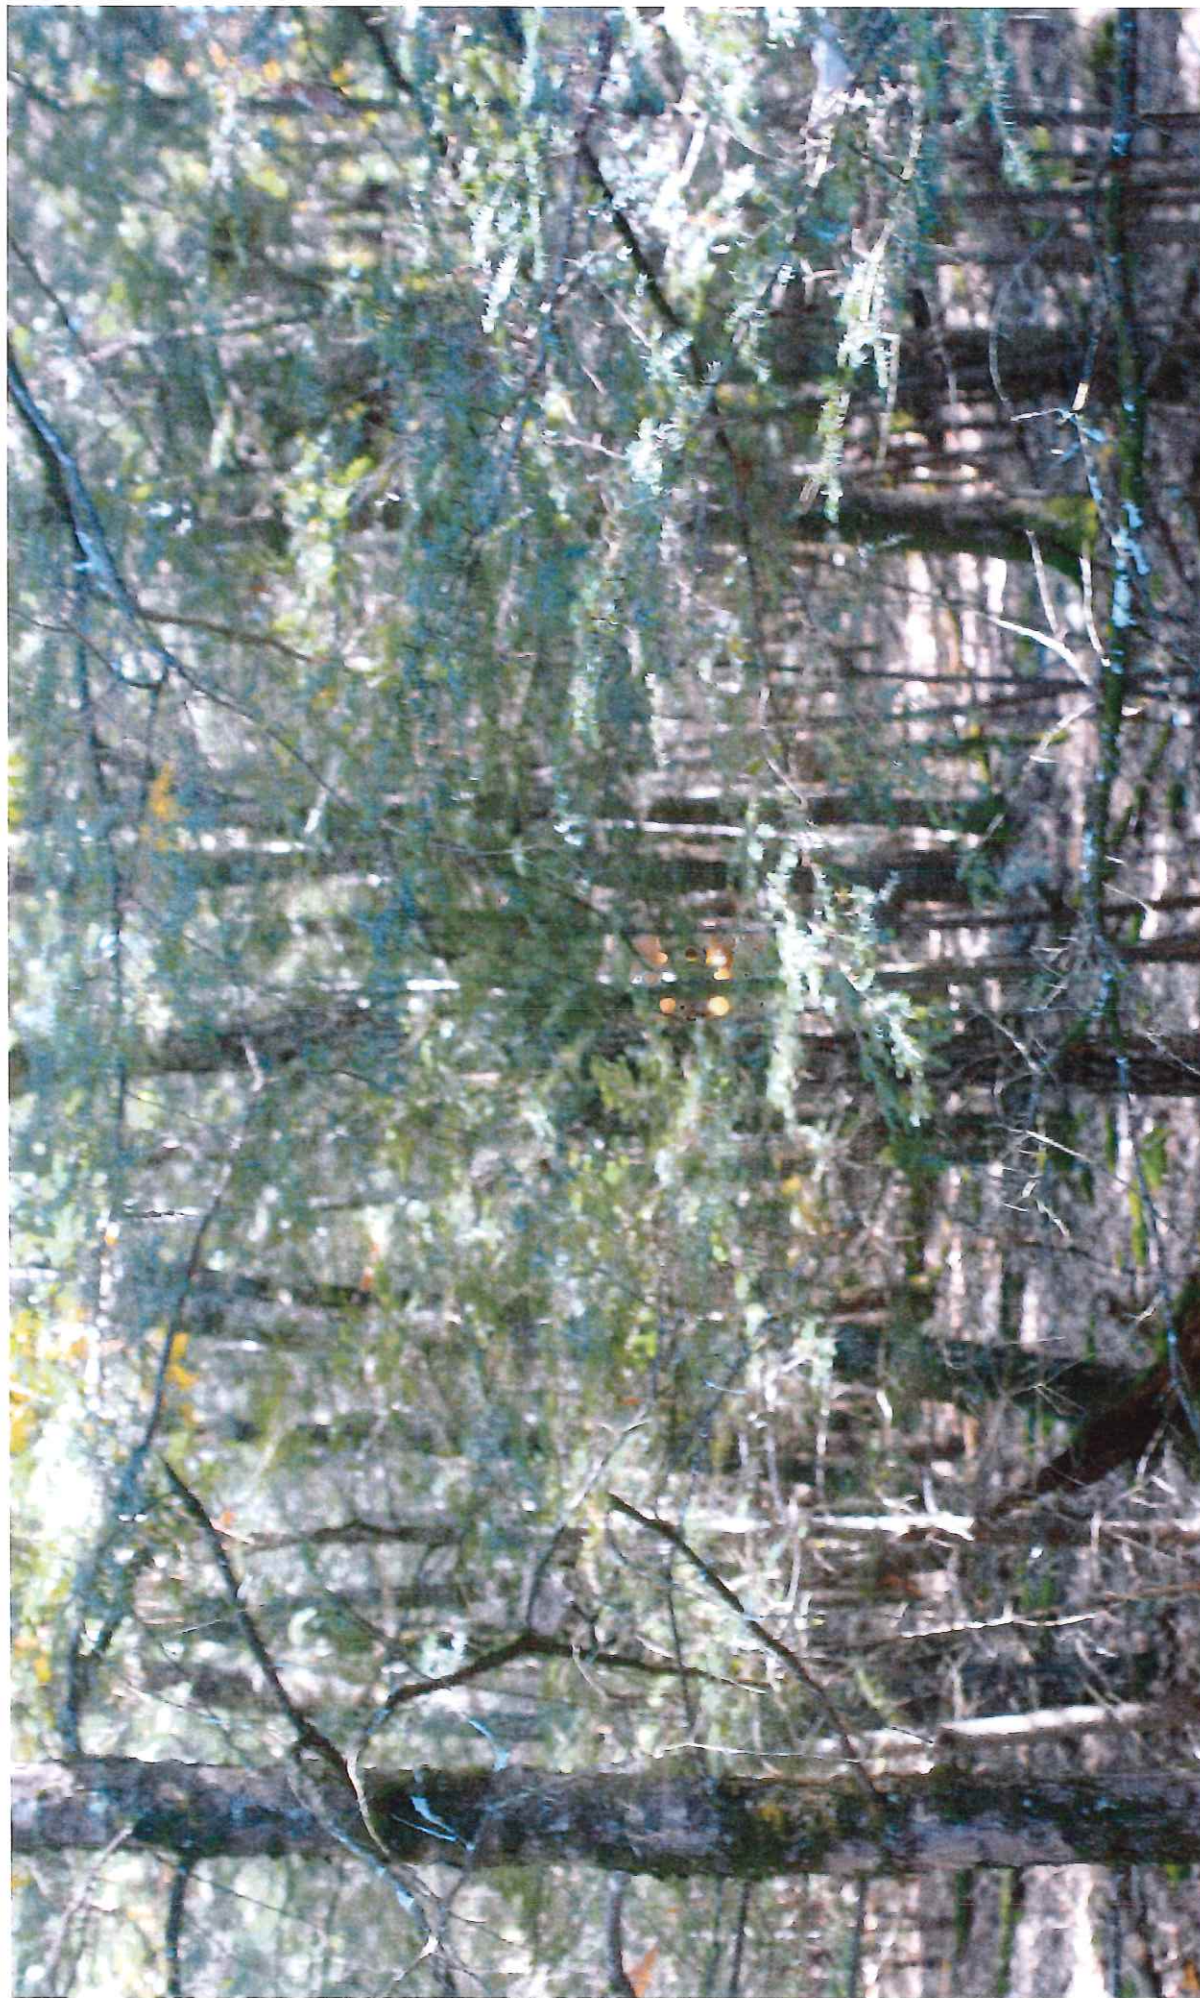
Figure 18

Viewpoint T2 - Buck Property - Simulated View

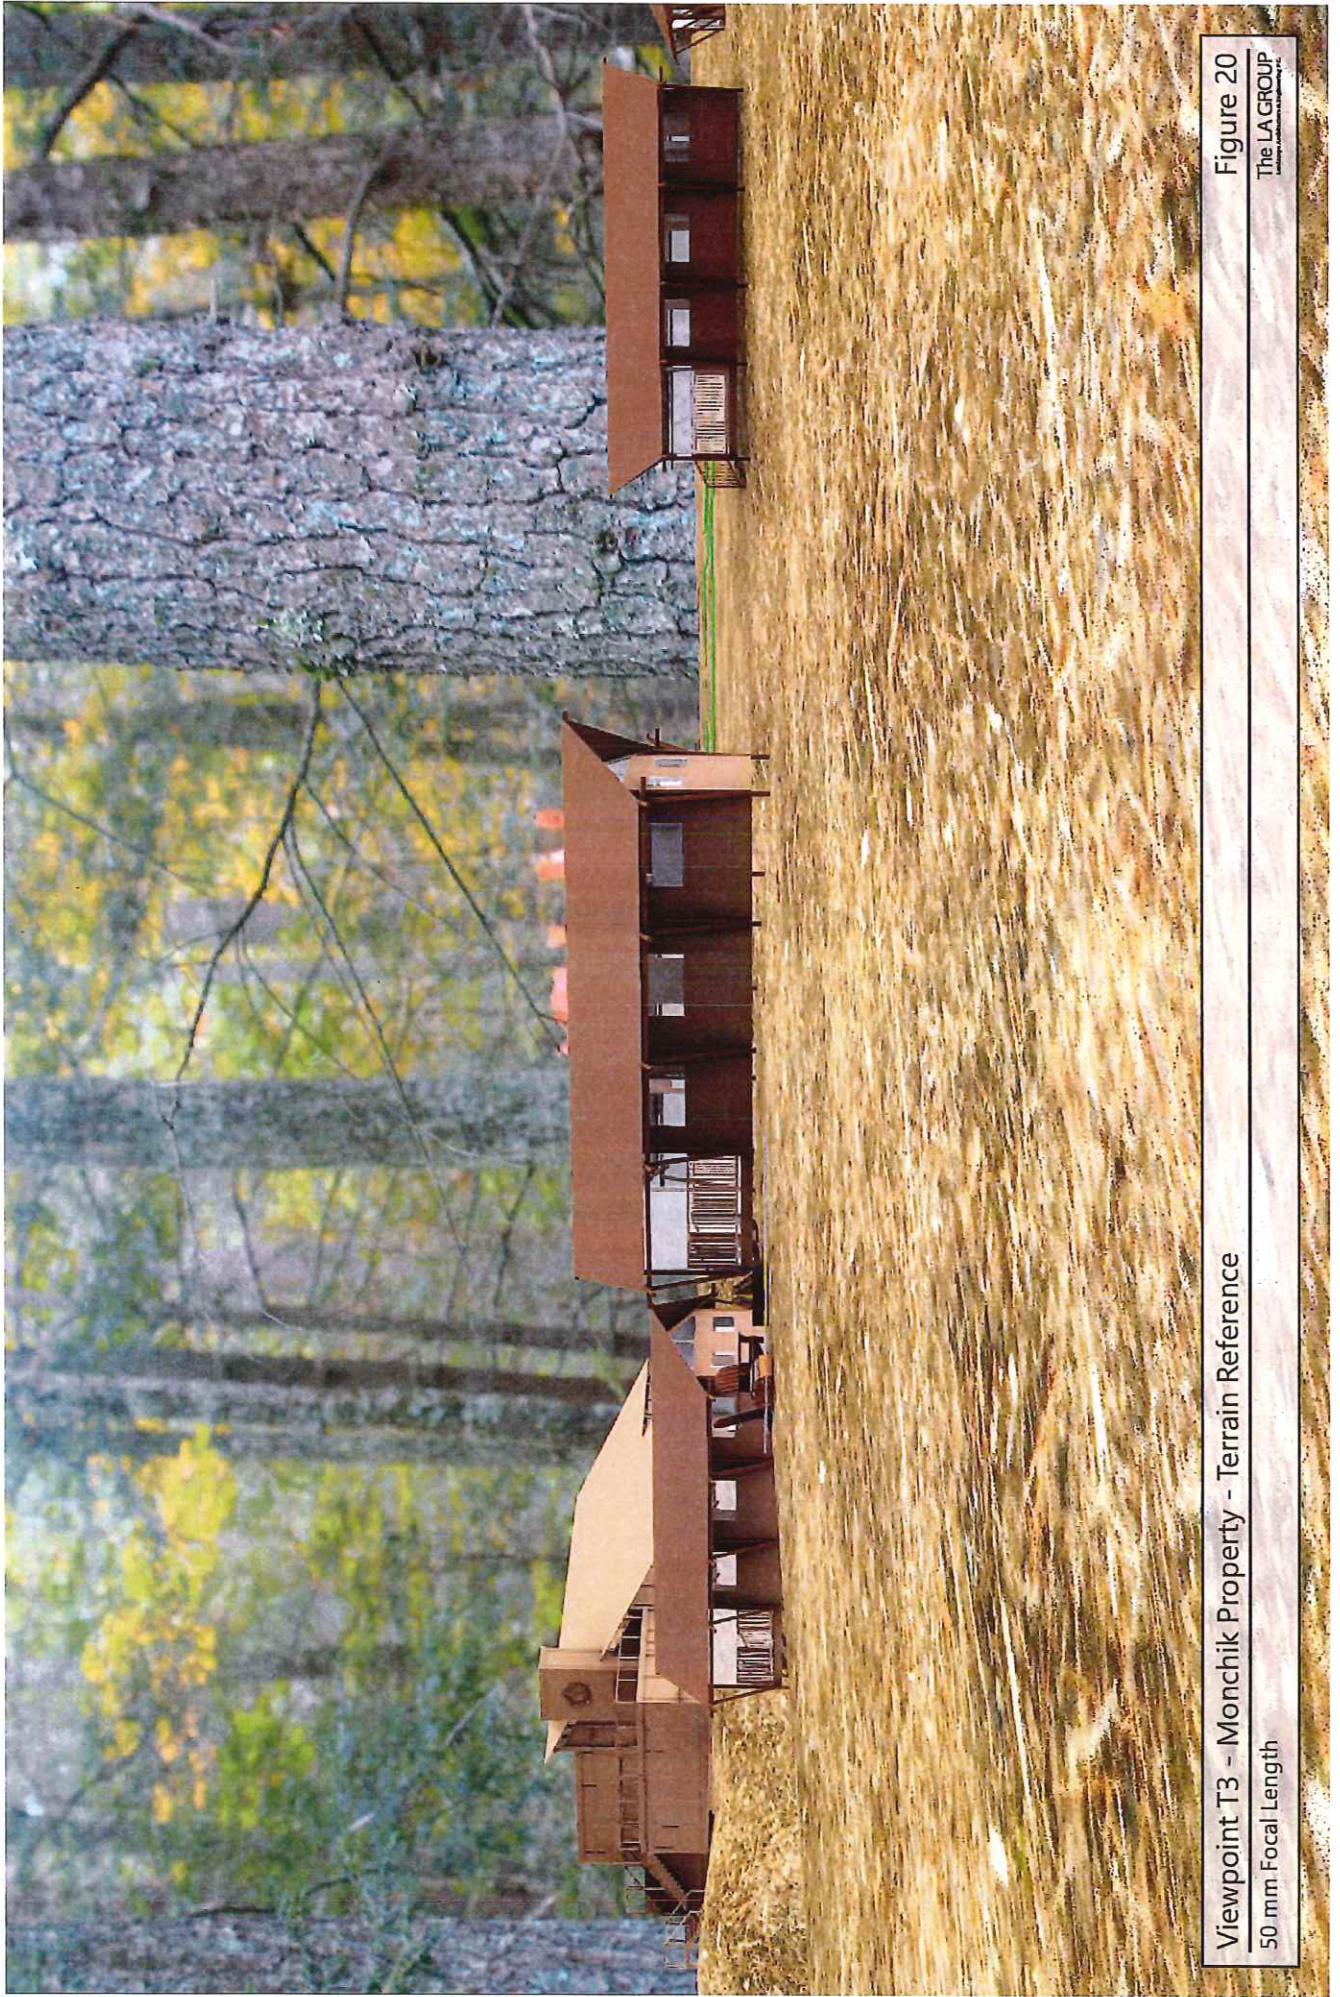
Viewpoint T3 - Monchik Property - Terrain Reference

50 mm Focal Length

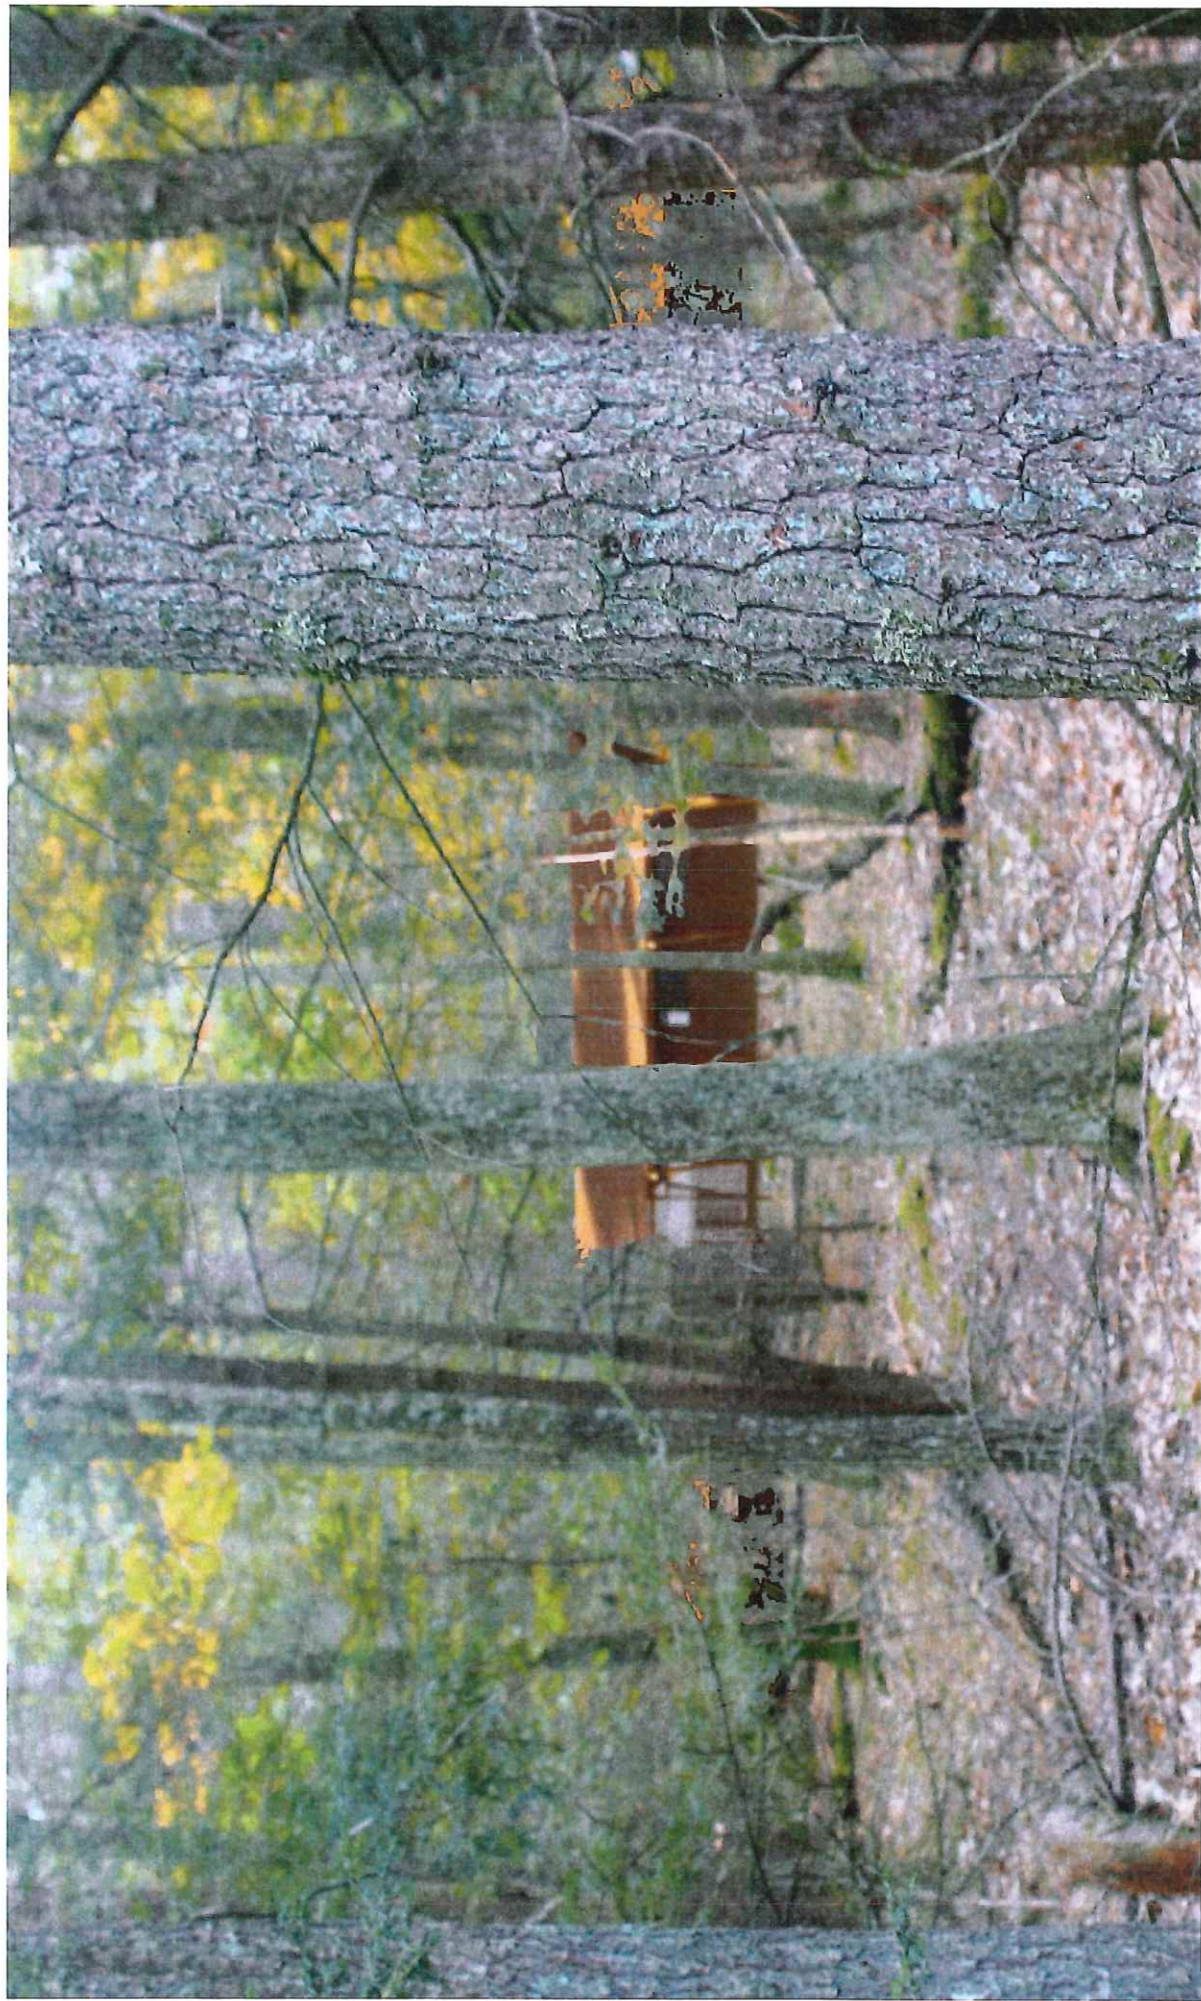
Figure 21
The LA GROUP
Landmark Architecture & Engineering, P.C.

Viewpoint T3 - Monchik Property - Simulated View
50 mm Focal Length
