Terramor Outdoor Luxury Campground

Expanded EAF Narrative

Town of Saugerties, New York

December 6, 2022

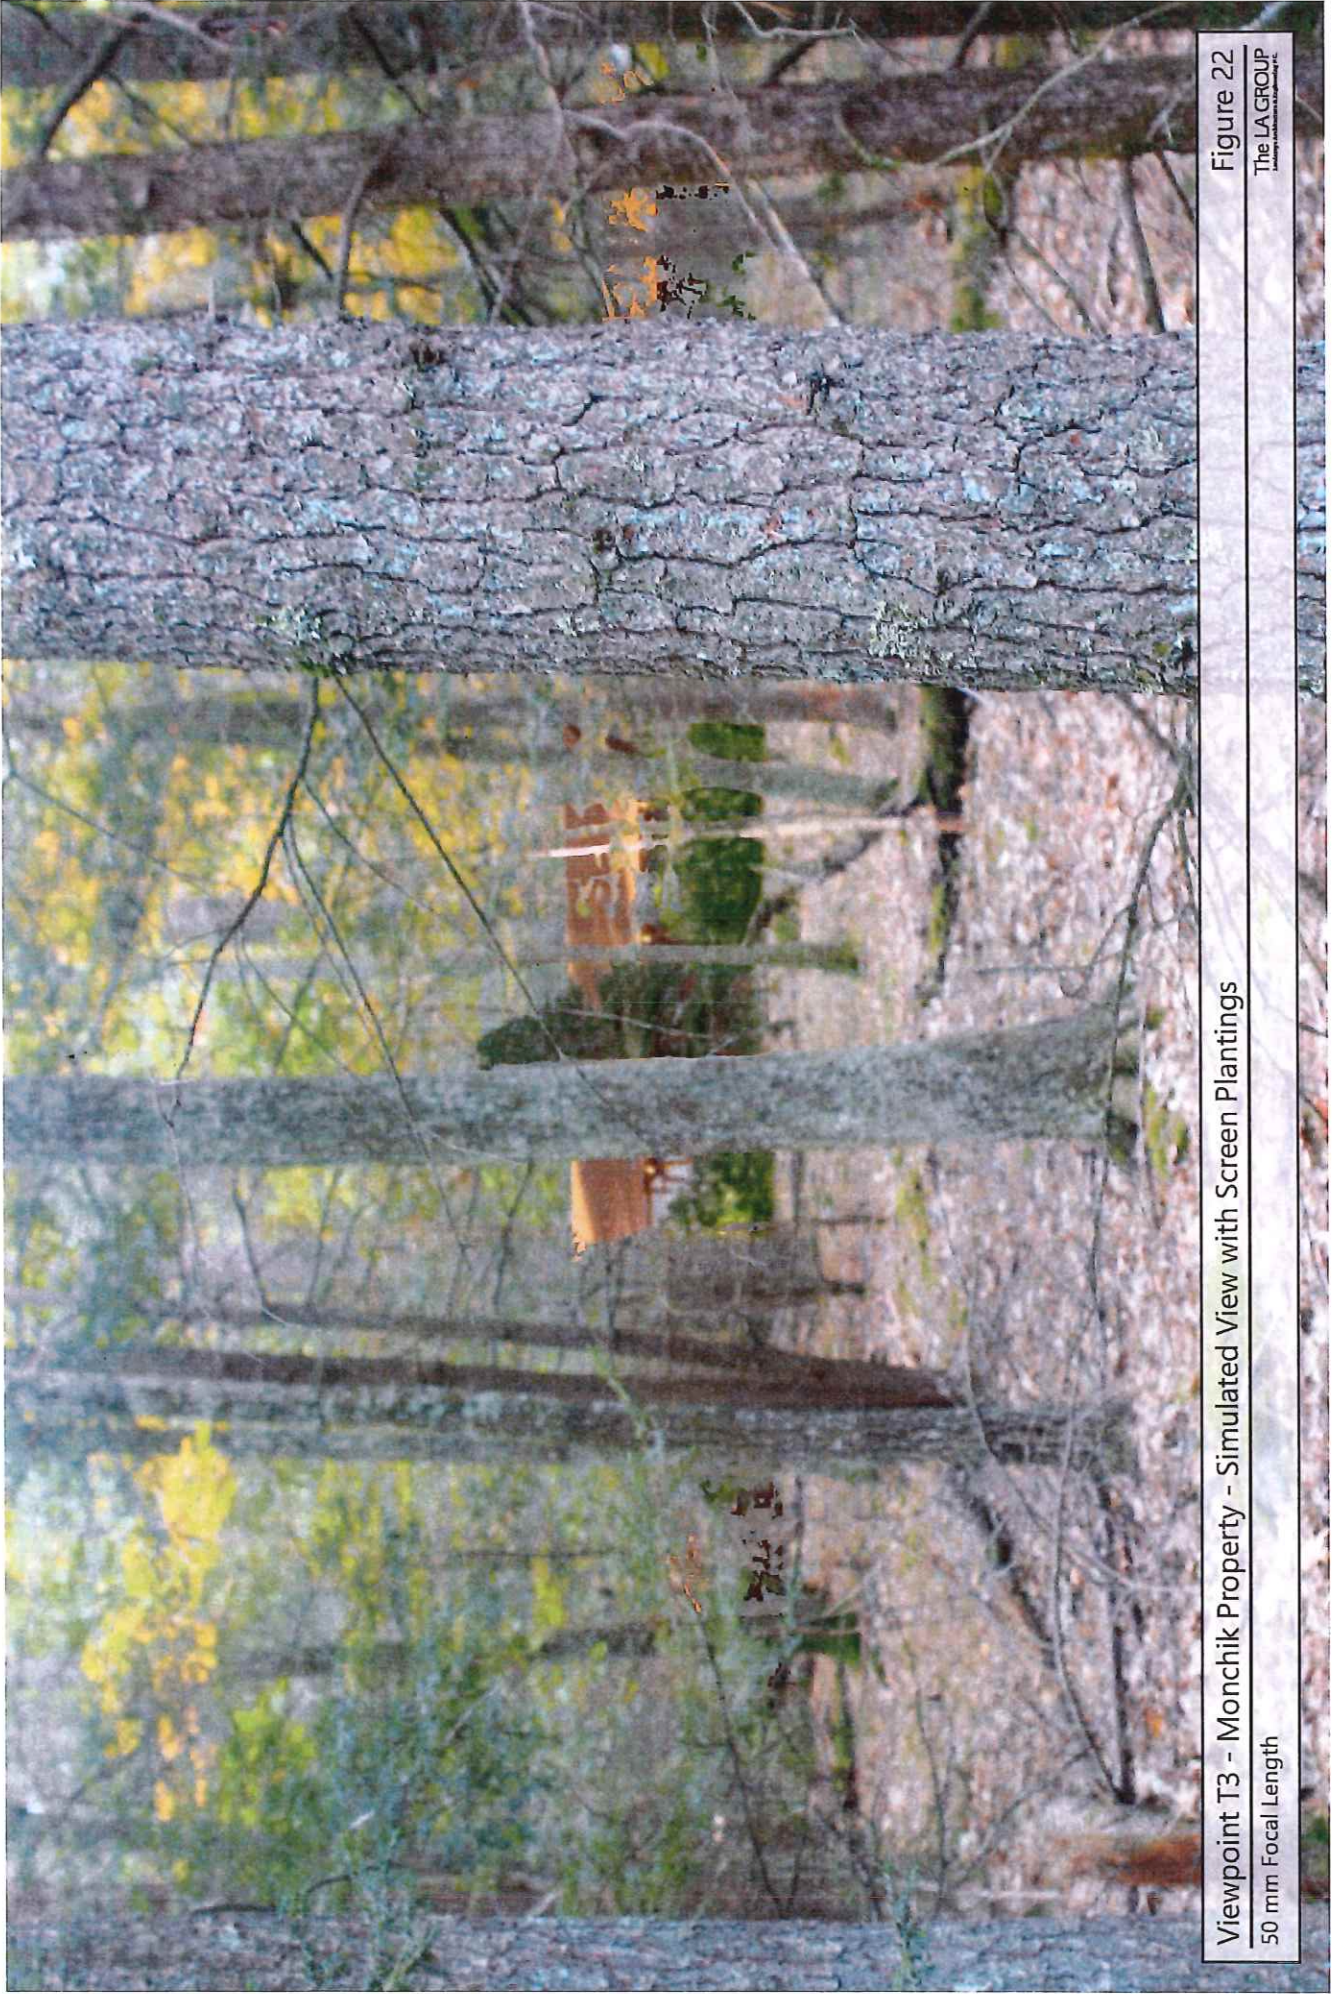
Figure 22

Viewpoint T3 - Monchik Property - Simulated View with Screen Plantings

50 mm Focal Length

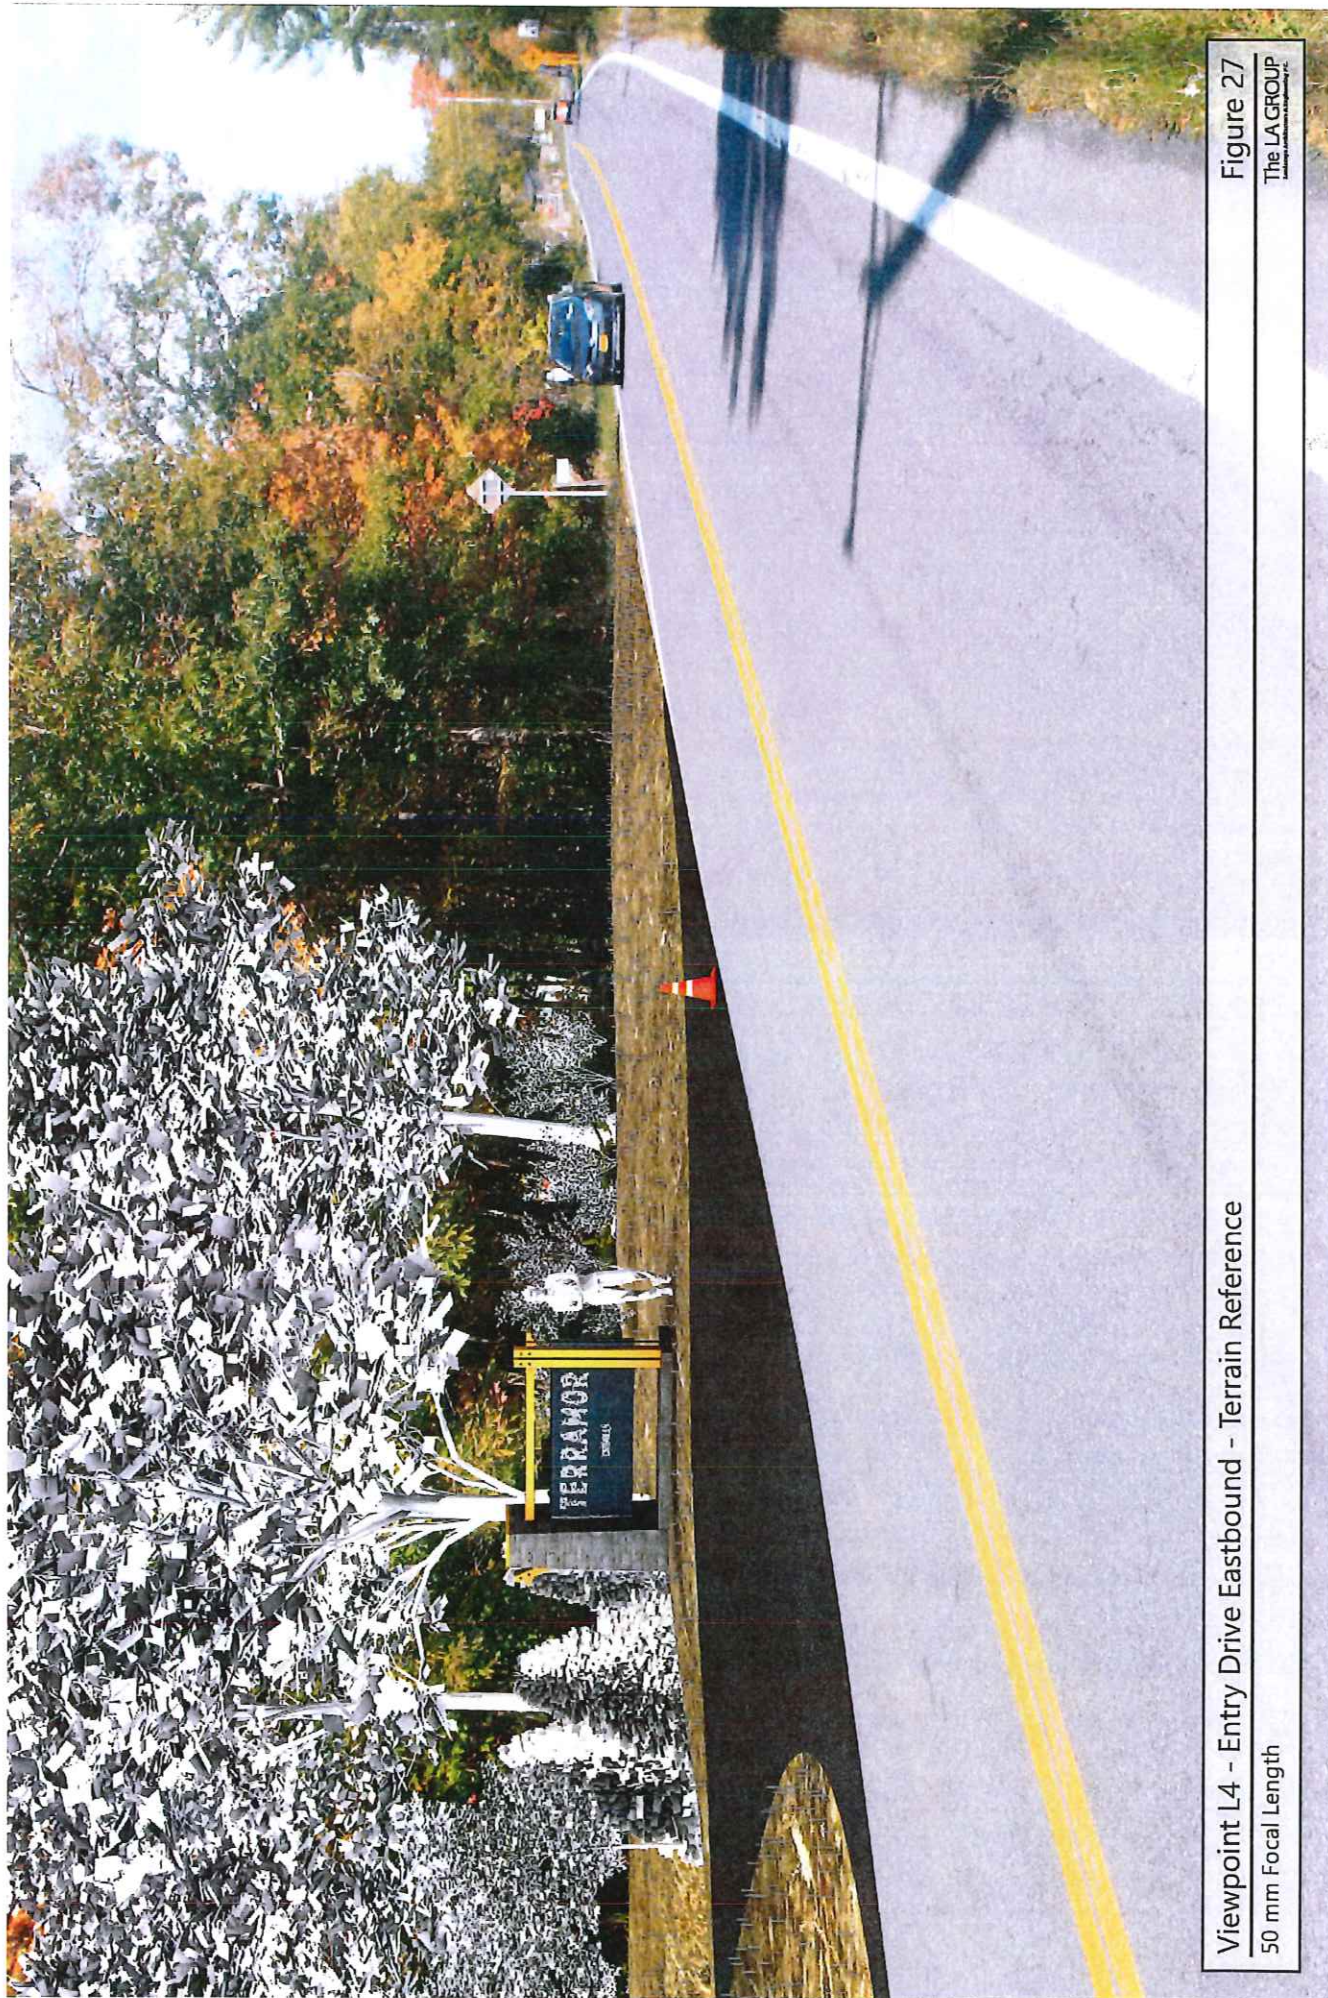
Viewpoint L4 - Entry Drive Eastbound - Terrain Reference

50 mm Focal Length

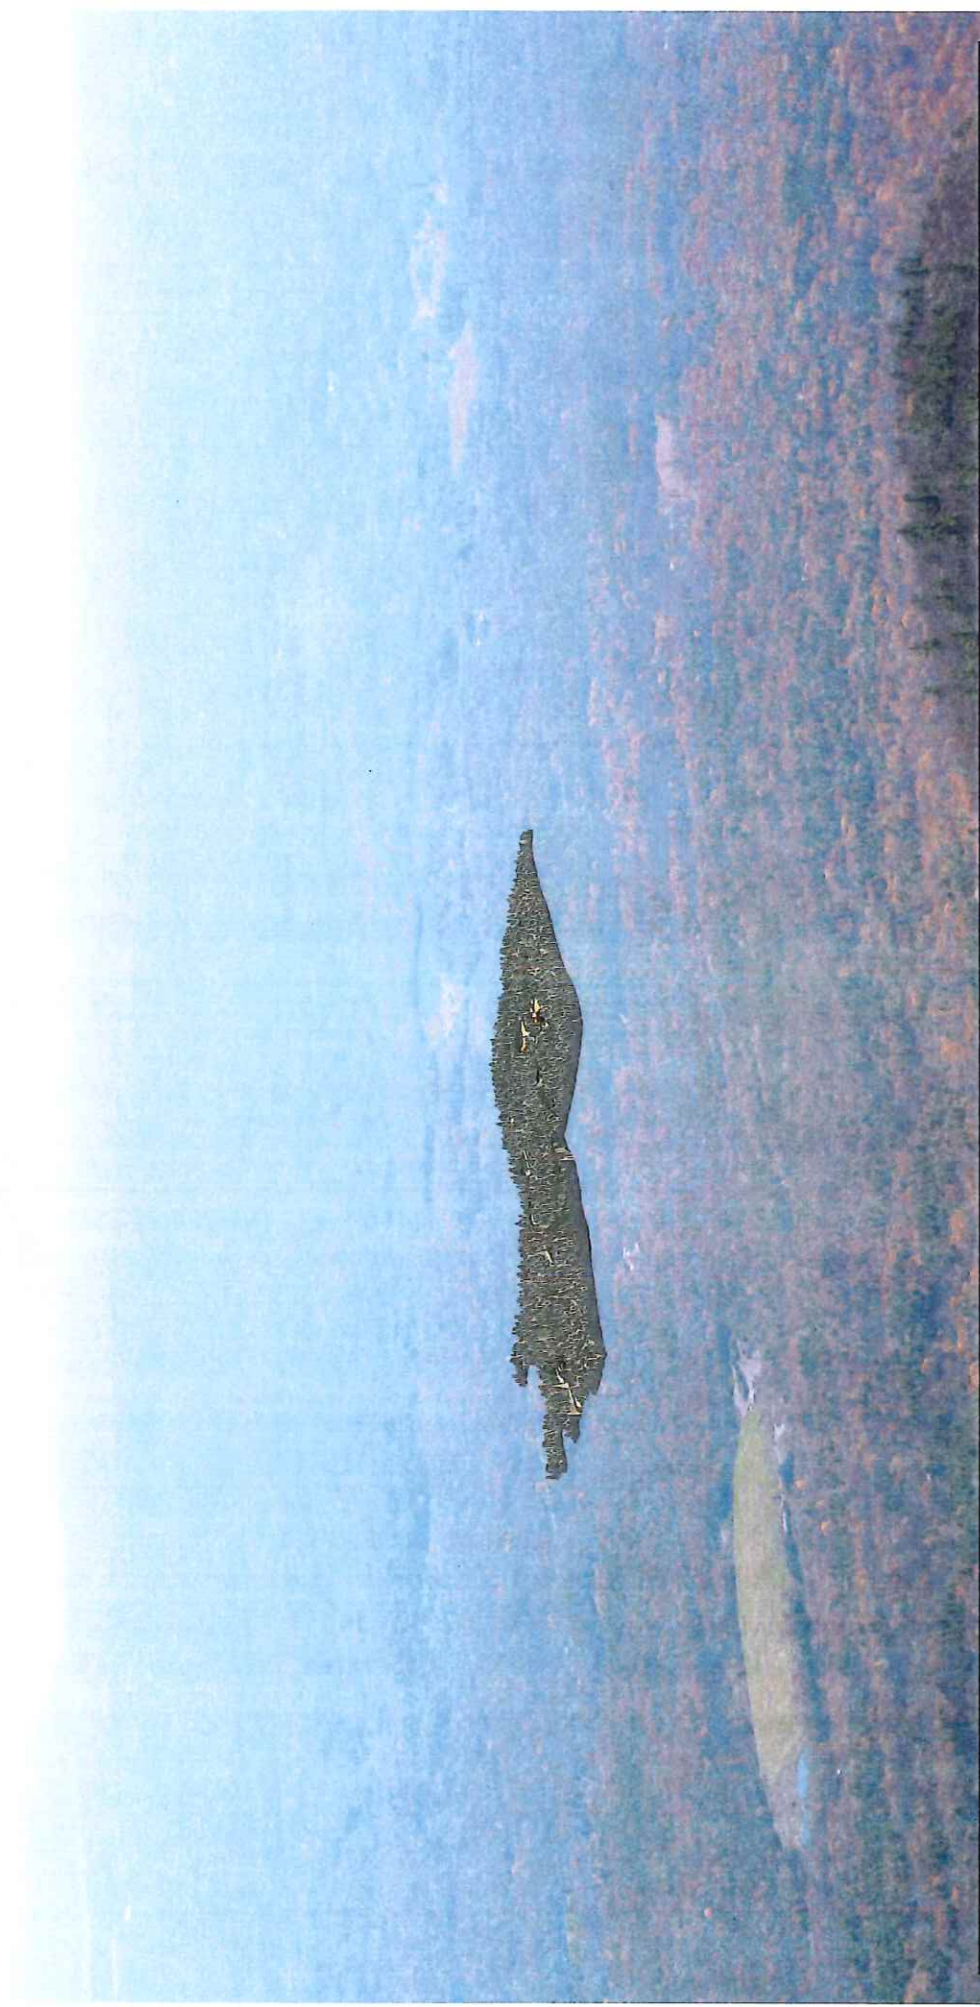
Figure 31

Viewpoint OM1 - Overlook Mountain Fire Tower - DSM Reference

50 mm Focal Length

A second visibility analysis was then conducted using the DSM surface to determine each 1 ft x 1 ft raster cell within the reduced buffer area around the project site from which the campground facility may be visible based on existing topographic conditions and vegetative cover. Due to the high computational requirements for manipulating LiDAR data, the DSM zone of potential visibility analysis was only conducted for the reduced buffer area covering potential sensitive receptors identified in the more conservative DEM analysis. The height of the “viewer” was once again assumed to be 5’6”, and the target point was set at the highest point on the roofline of the Lodge building. In this analysis, vegetation is assumed to be sufficiently dense to block views when it is an intervening feature between the viewer and the Project. A second **Zone of Potential Visibility** map was prepared to aid in visual assessment (See **Figure 6**). **Figure 6** shows the location of the project site and areas from which views into the Project might be visible when both topography and vegetative cover are considered (areas of potential visibility are denoted by the color orange).

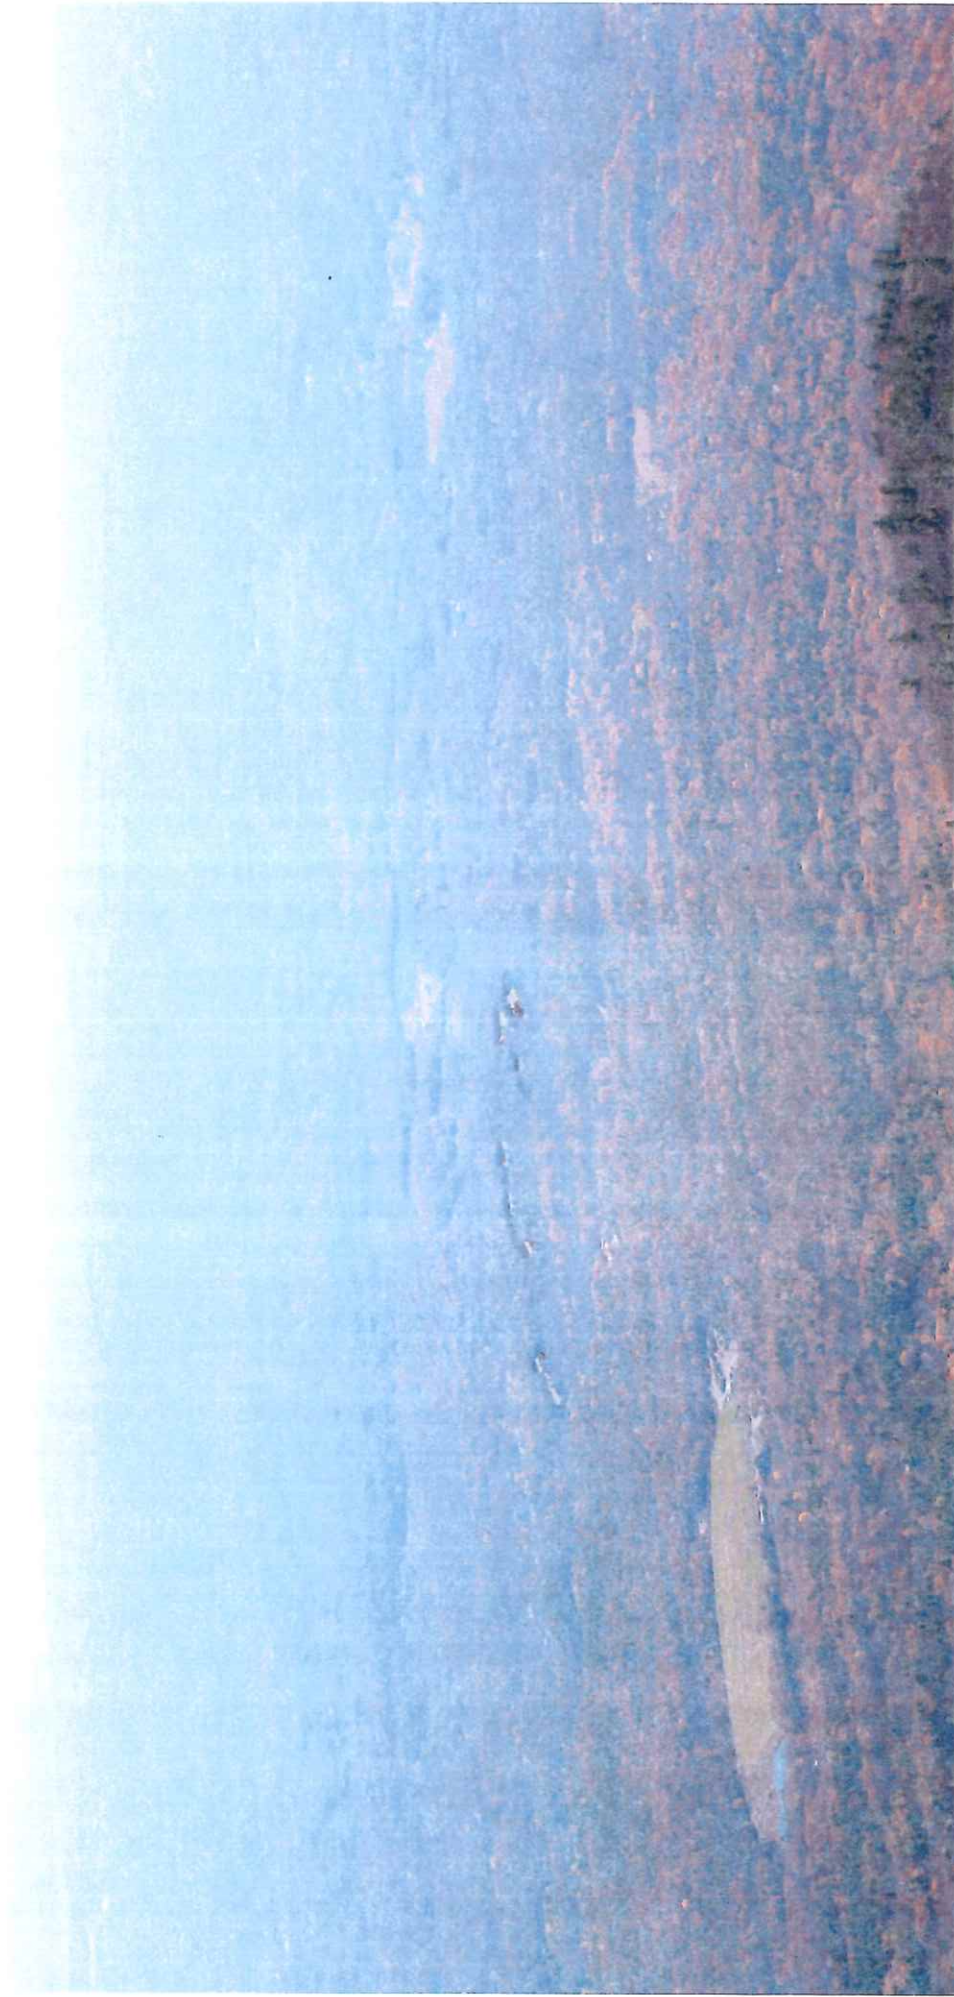
Figure 32

Viewpoint OM1 - Overlook Mountain Fire Tower - Simulated View

50 mm Focal Length

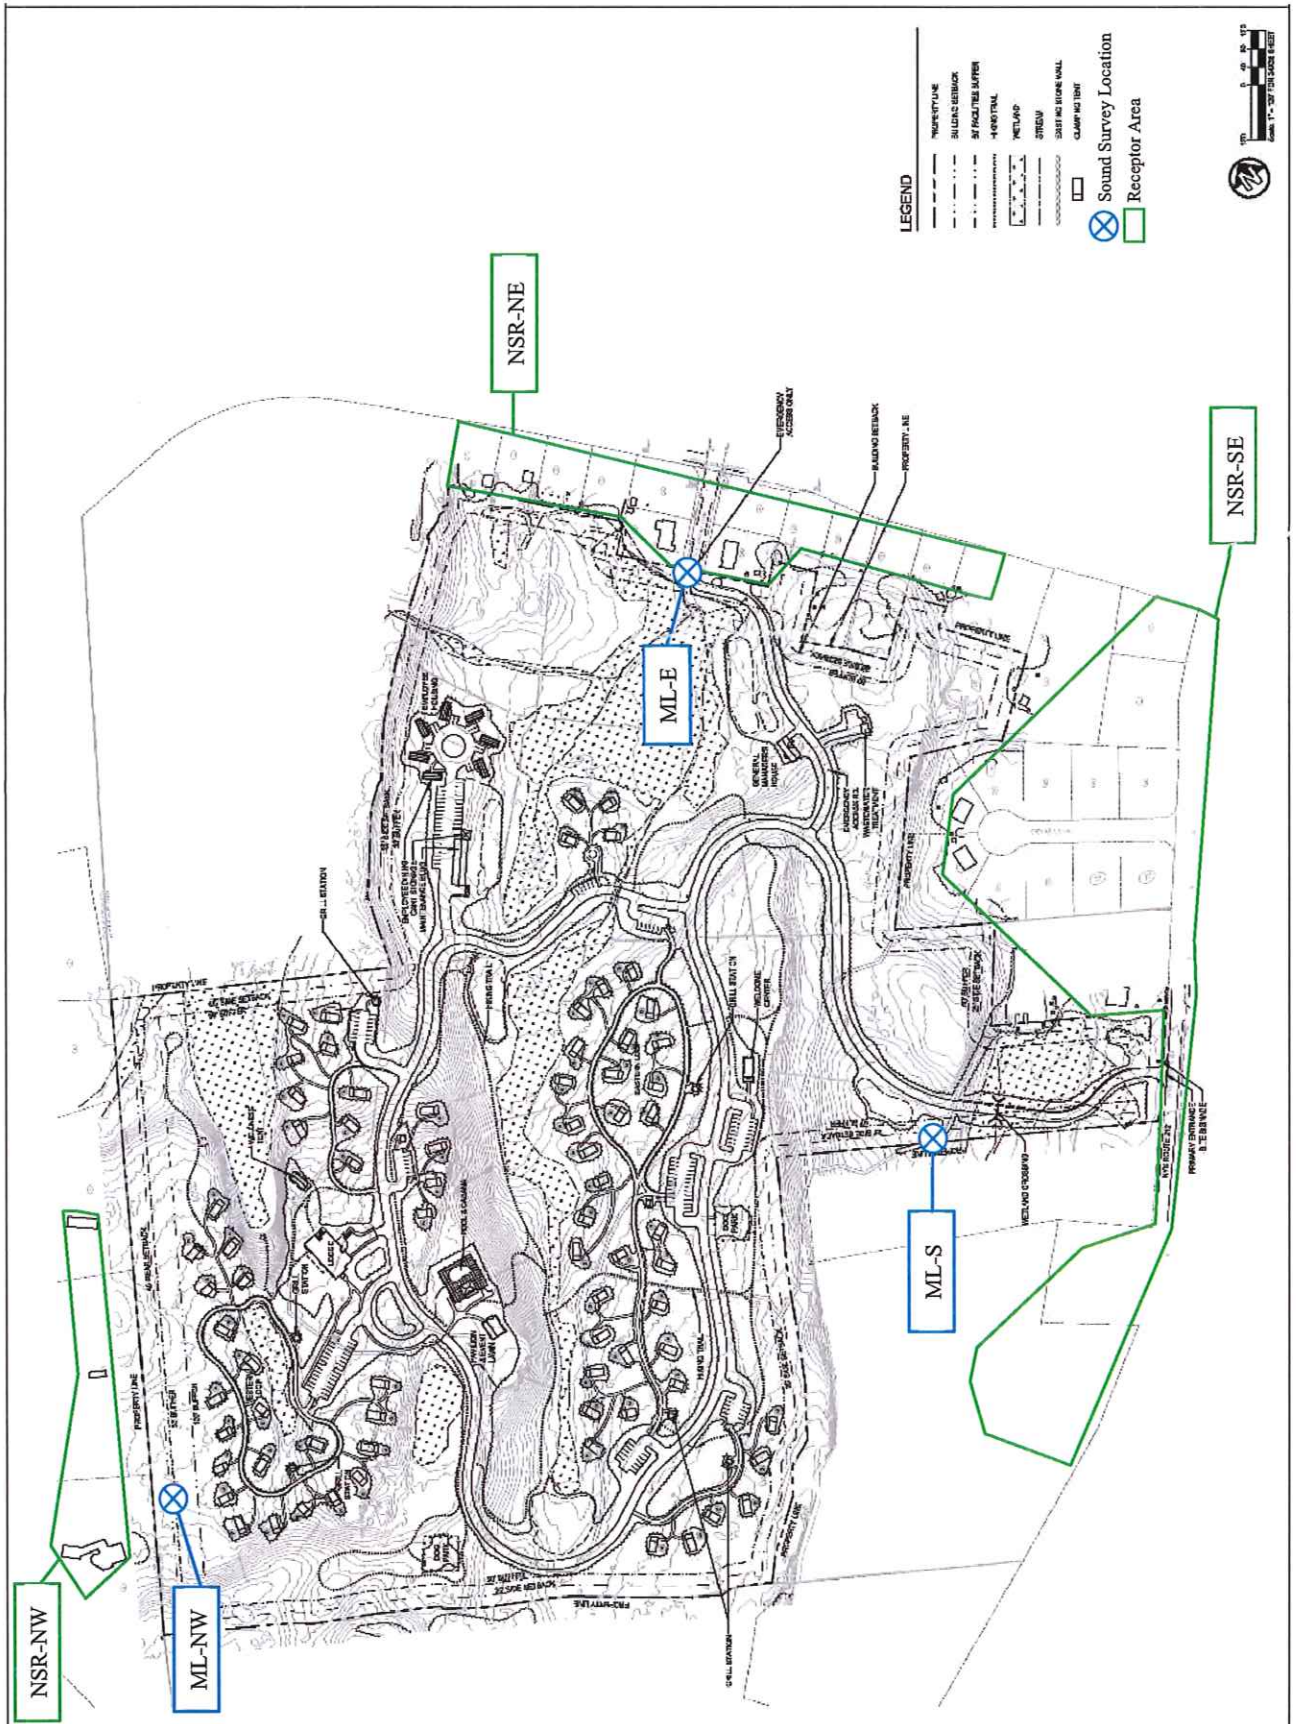
Figure 1. Catskills Project Sound Survey and Receptor Areas – August 25, 2022
